# ANT NEST CORROSION – EXPLORING THE LABYRINTH\*

## ABSTRACT

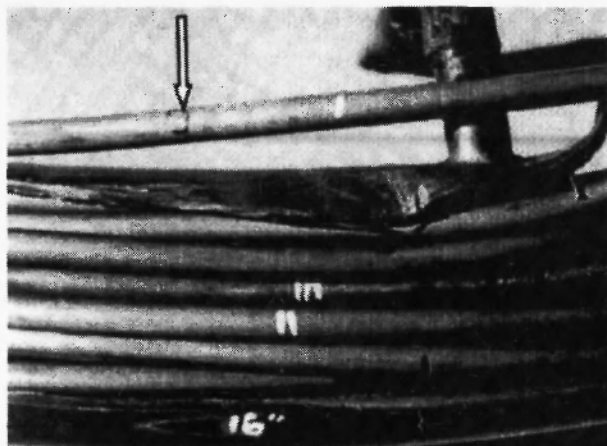
Small bore, 3/16" OD copper tubes were failing within a few months service as a result of pin-hole pitting on the inside diameter (ID) air-side of the heat exchanger tubes (Figure 1). Quench water used following brazing or for leak testing was suspect in that the water was infrequently changed, and the facility (originally) had less than rigorous control on their assembly line and warehousing practices.

**Fig. 1:** Ant-nest corrosion in 3/16-inch diameter copper heat exchanger tubes after approximately two months service. Arrow points to pin hole.

Radical changes were made to the fabrication shop conditions and methods for warehousing the final heat exchanger assemblies. The

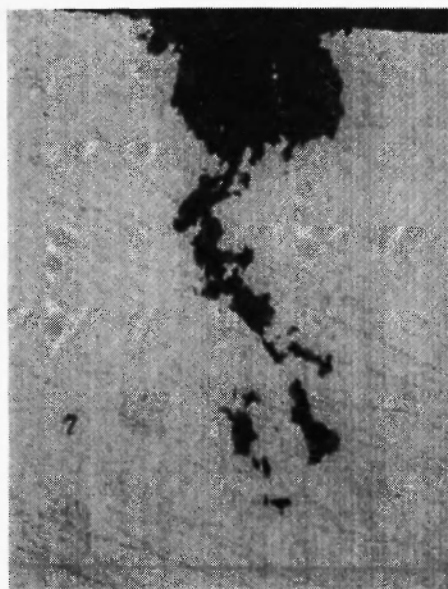
The copper ID surfaces, revealed by splitting tubes longitudinally, were typically dull-black in appearance, sometimes with an oily film present. Cross sections revealed ant nest corrosion damage (Figure 2) extending deep into the tube.

**Fig. 2:** Cross-section showing ant nest corrosion in a heat exchanger tube after 6 weeks from fabrication (original magnification 200×)

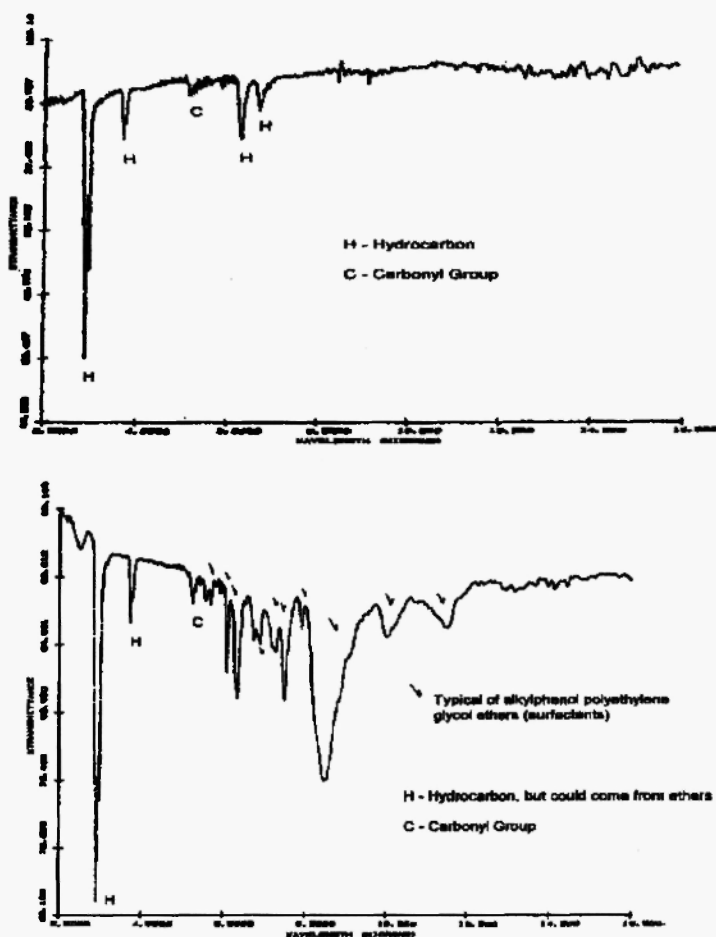
FTIR (Fourier Transformation InfraRed) analysis was conducted on wash-down products released from selected tube lengths using an acetone rinse. The FTIR spectra revealed bands due to hydrocarbon materials with a small amount of carbonyl functionality, typical of petroleum-based lubricants. Further spectra revealed alkylphenol-EO adducts (alkylphenol polyethylene glycol ethers) which are non-ionic surfactants (Figure 3). No bands were detected from FTIR spectra on the as-received tubes.

Fig. 3: Infrared (FTIR) spectra of ID products

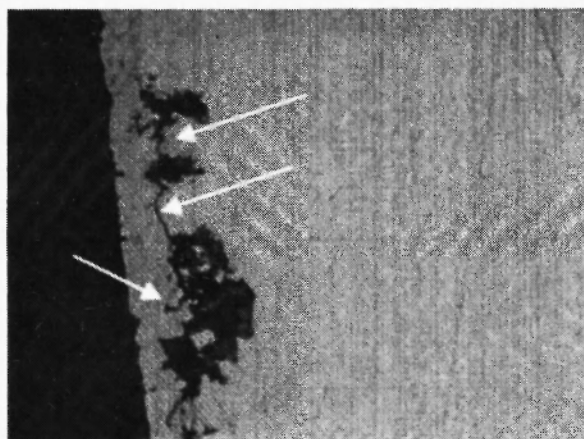
Of note in certain cross-sections was the presence of fine cracks bridging individual pitted areas (Figure 4). This may indicate some local contributions from internal stresses in the material. It is noted that cracks are not a commonly reported phenomenon in ant nest corrosion.

**Fig. 4:** Fine cracks (at arrows) interlinking pits associated with ant nest corrosion

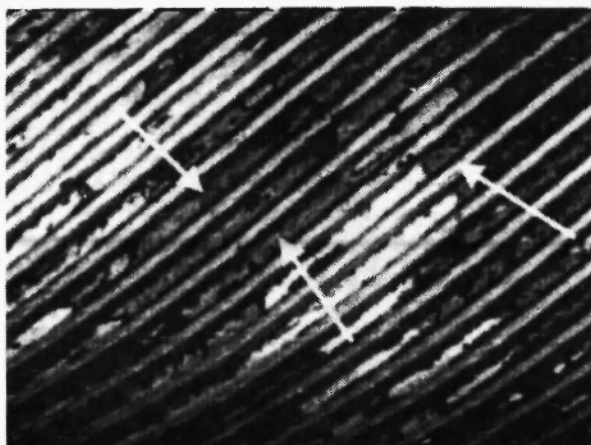
In the as-received condition, the outside diameter (OD) surfaces of the tubes had a reddish-copper color with areas of random black staining. There was no obvious attack, even under microscopic examination. Longitudinal cutting of the tubes revealed the ID surfaces. Under the microscope, small bits of debris and sand particles were observed, and presumed to have come from the cooling tower water. A random black scale (Figure 5) was present which could not be removed by mere scrubbing with a firm toothbrush. Inhibited hydrochloric acid was employed to remove the deposits on the tube; however, the black scale resisted chemical cleaning. At 40× magnification, small pit-like features

**Fig. 5:** Semi-cleaned condenser tube ID. Arrows indicate areas of black scale and pitting attack. (10× original magnification)

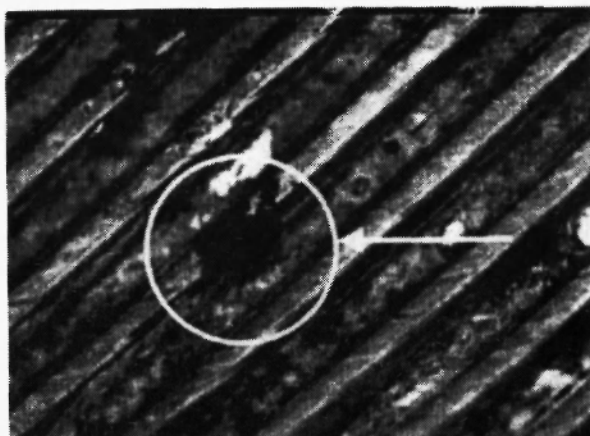
were observed in the midst of the black scale (Figure 6). Cross-sections revealed extensive ant nest corrosion extending through the tube wall (Figure 7).

**Fig. 6:** Semi-cleaned condenser tube ID. Arrow indicates area of substantial pitting attack. The rifled ridge is completely gone. (40× original magnification)

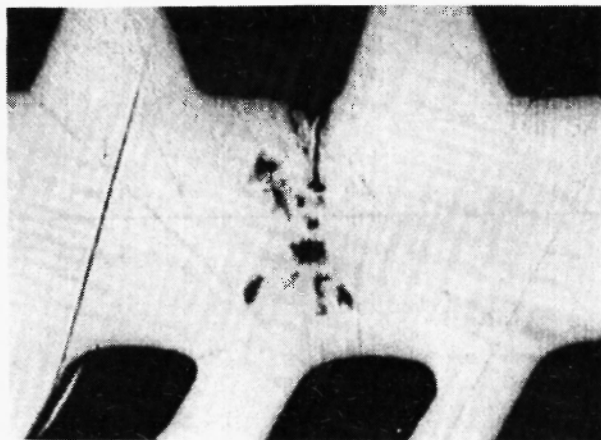
Fig. 7: Cross-section of evaporator tube (ID is at top). Note the near through-wall penetration of the tunnels. Pit originates on ID surface, top. (60× original magnification)

The tube mill and chiller manufacturer are addressing the issue of lubricants, but as yet no decision has been made to change these fluids. A more intense rinsing program has been initiated, with considerations to use copper inhibitors and hot air drying.
