FAILURE ANALYSIS OF PIPES IN RADIATE SECTION OF ETHYLENE CRACKING DECOMPOSITION FURNACE INDUCED BY SULFURIZATION

ABSTRACT

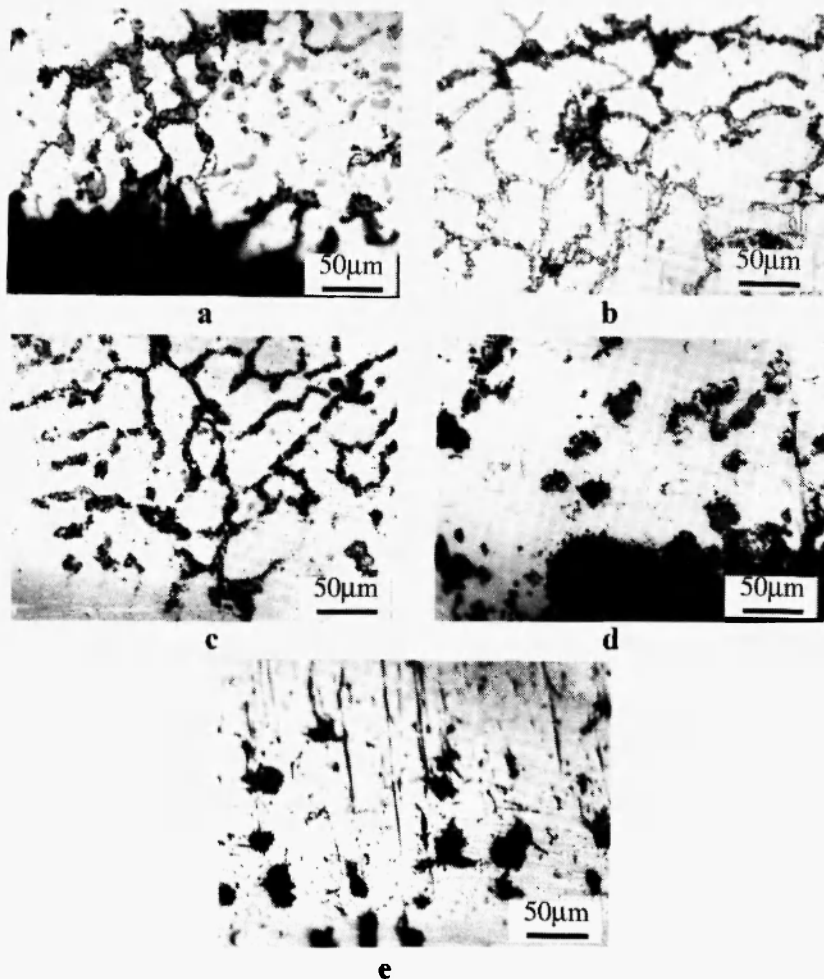
from the inner surface increases, the compounds exist only along the grain boundaries that are present in Fig. 2. The results correspond to the composition analysis of Table 1 where the contents of carbon and sulfur are almost the same as the original contents. The result of Fig. 2 indicates that the grain boundary diffusions of carbon and sulfur are much faster than the volume diffusion. On the outer surface of the pipe, there are only light pits

Fig. 2: Optical micrograph of the pipe. (a) The internal surface; (b) The second layer; (c) The third layer; (d) The fourth layer; (e) The outer surface of the pipe.

indicating the existence of Cl^- ions in the atmosphere [7,8], since the furnace is located within a chlorine factory.

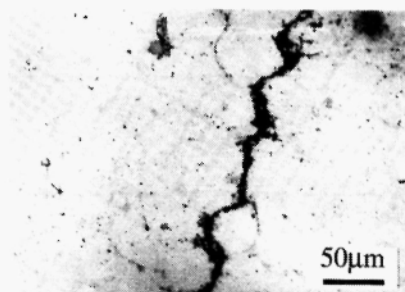
Fig. 3 shows that the crack propagates along the grain boundaries. This is because the brittle compound is formed at the grain boundaries, which leads to volume expansion and internal stress and, consequently, to crack formation and expansion. When the cracks extend along the full grain boundaries, the grains drop off from the matrix.

Fig. 3: Micrograph showing the surface cracks.

From the above results, it is known that the rapid failure of the pipe is due to the strong sulfurization tendency that was not considered during the instrument design. Since the original content of sulfur is only 0.04 wt.%, while the original carbon content is 0.4 wt.%, the volume expansion due to the formation of sulfide is more evident when the saturated contents of both the carbon and the sulfur is about 1.5 wt.%. The volume expansion should be the essential reason for the internal stress and cracks.

To improve the service life of the pipe, a substituted alloy with higher Cr and lower Ni contents should be selected. Based on this consideration, the ACI HD40 alloy (0.40% C, 30%Cr, 6%Ni and 2%Si) or the ACI HK40 alloy (0.40%C, 28%Cr, 18%Ni and 2%Si) should be utilized to substitute the HP40 alloy.
