# Coating Degradation of First and Second Stage Gas Turbine Blades

Can Maralcan, Bora Derin\* and Onuralp Yucel

*Metallurgical and Materials Eng. Dept., Istanbul Technical University, 34469, Turkey*

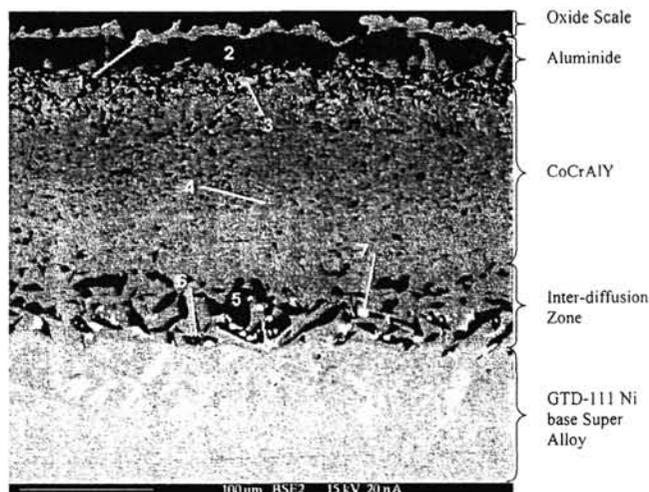
Fig. 1: The backscattered electron image (BSE) of the specimen displaced from the trailing section of first-stage-blade at 25% airfoil height.

The EPMA/BSE image of the specimen from the trailing edge section of the first stage blade shown in Figure 1 proved that the coating was severely degraded. Because of the up-diffusion from substrate region, nickel distributed all over the coating system. For example, top aluminide transformed from  $\beta$ -CoAl to  $\beta$ -(Co,Ni)Al matrix containing approximately 30 mass % Ni. Below the  $Al_2O_3$  protective coating layer, some part of top aluminide transformed to  $\gamma$ -phase which is explained by Al diffusion to the surface in order to

satisfy the need of Al<sub>2</sub>O<sub>3</sub> reformation. σ(Co,Cr) formation was also observed just below the β(Co,Ni)Aluminide layer. The enlargement of CoCrAlY/substrate alloy interface zone (~60 μm) was caused by the element diffusion occurred between the bond coat and the substrate. Primary MC carbide formations in (Ta<sub>x</sub>Ti<sub>1-x</sub>) phases were observed where the growth zones of γ+β existed in the inter-diffusion layer. Most of β- phase precipitates in the CoCrAlY region dissolved due to inter-diffusion reactions in CoCrAlY/substrate alloy interface [2]. Quantitative analyses results of numbered locations in Figure 1 was identified by WDS and given in Table 2.

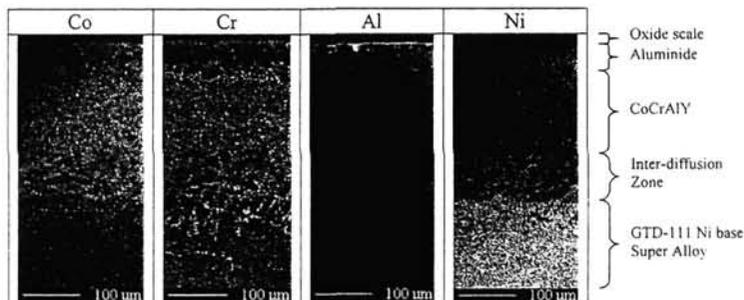
Fig. 2: EPMA XRD mapping for Co,Cr,Al,Ni of the specimen displaced from the trailing section of first-stage-blade at 25% airfoil height.

The EPMA elemental mapping images of Co,Cr,Al and Ni in over aluminized first stage turbine blade coating is shown in Figure 2. As also mentioned above, Ni diffusion is clearly noticeable in both interdiffusion and top coat aluminide layer. The chromium rich layer below top aluminide bond coat corresponds to σ (Co,Cr) solid solution. Highest Al concentration detected on the surface represents Al<sub>2</sub>O<sub>3</sub> protective layer. The dark area in CoCrAlY region of the Al mapping image proves the aluminum depletion.

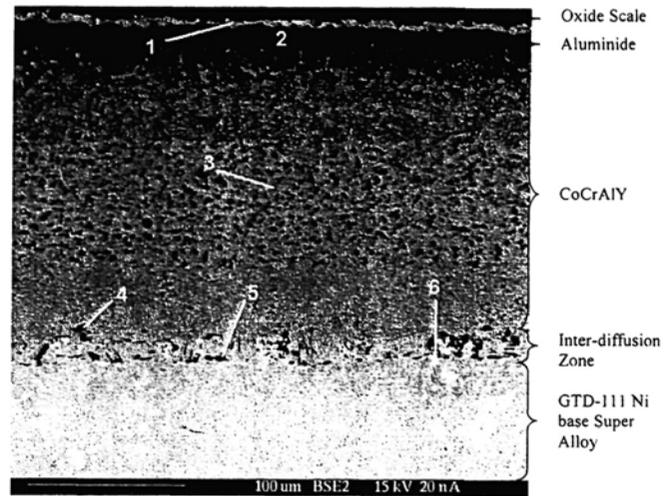
The EPMA/BSE image of the specimen from trailing edge section of the second stage blade shown in Figure 3 proved that the degree of degradation of the coating was much less severe. Al<sub>2</sub>O<sub>3</sub> dispersoids observed in the interface zone can be explained by the grit blast cleaning of GTD-111 substrate prior to VPS coating process [4]. The width of CoCrAlY/substrate

**Fig. 3:** The backscattered electron image (BSE) of the specimen displaced from the trailing section of second-stage-blade at 25% airfoil height.

alloy interface zone (~20 μm) and the grain sizes of γ, β, and (Ta,Ti)C phases which constituted the interface zone were found much smaller than that of first stage blade. CoCrAlY coating region still consisted of considerable amount of β- CoAl formations as small precipitates dispersed in γ-matrix. No σ (Co,Cr) formation was detected in the CoCrAlY coating region. The extent of nickel up-diffusion rate to the complete coating system was much less than that of first stage blade. For example top aluminide layer β-CoAl contains only 1 mass % Ni, whereas, γ-phase formation above top aluminide contains 1.44 mass % Ni. Quantitative analysis results of numbered locations in Figure 3 was identified by WDS and given in Table 3.

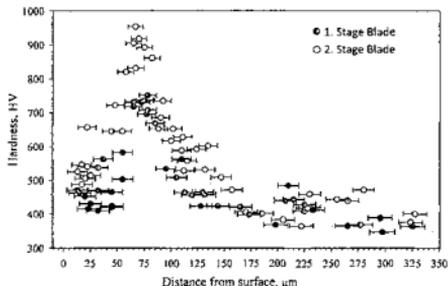
The Vickers hardness test is essential to evaluate the effect of microstructural changes on coating hardness. Figure 4 shows the Vickers hardness test results performed on top aluminide coated CoCrAlY/substrate specimens taken from both blades as a function of distance from coating surface. Horizontal bars shown in the figure represent the arithmetic mean length of two diagonals of the indentations left in the specimen's surfaces after removal of the 100 g load. The results show that the hardness values of both substrates change along the coating thickness. As can be expected, first stage turbine blade specimen has lower hardness values, since Al depletion resulted in a decrease in aluminide formation within duplex coating region. The hardest regions for both specimens were found where the small  $\beta$ -CoAl precipitations take place intensively at CoCrAlY region close to top aluminide single layer. However, high depletion of Al and formation of  $\sigma$ (Co,Cr) in the first stage blade specimen resulted in lower toughness values. After this region, the hardness value decreases with decreasing Al content along CoCrAlY coating. Lowest hardness values within both duplex coatings were found at the CoCrAlY region adjacent to inter-diffusion zone where the maximum Al depletion takes place. A small increase in hardness values was observed in the inter-diffusion zone due to the existence of  $\beta$ -(Co,Ni) rich grains having higher aluminum content and also MC formations.

Fig. 4: Vickers hardness of first and second stage turbine blade specimens displaced from trailing section at 25% airfoil height.
