# Failure Analysis of a New Turbine Parting Plane Stud

H. Roy\*, A. Saha, D. Ghosh, S. Ray and A.K. Shukla

## ABSTRACT

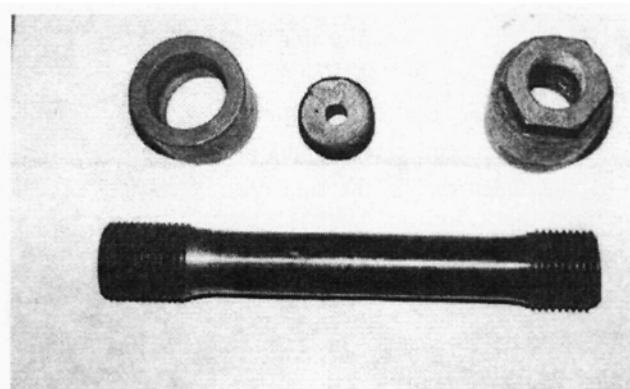
Fig. 1: As received failed stud samples.

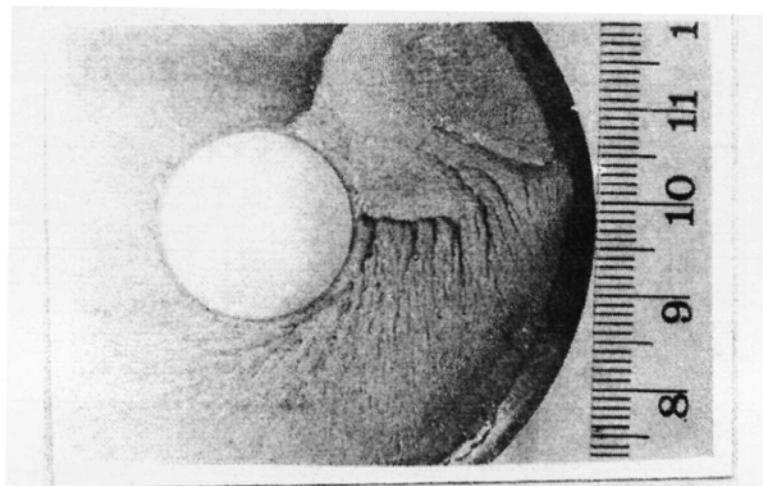
The entire failed stud including the fracture surfaces was visually examined before cleaning. It was observed that the fracture occurred through the 7-8<sup>th</sup> thread from the nut end. Moreover, approximately 75% of the fractured surface was smooth without any visible deformation (Figure 2). Few radial marks were also observed on the fracture surface. Deep tool marks on the centre hole surface along with weld spatter like deposit and some pits at isolated locations could also be seen (Figure 3).

Fig. 2: Fracture surface of the failed stud.

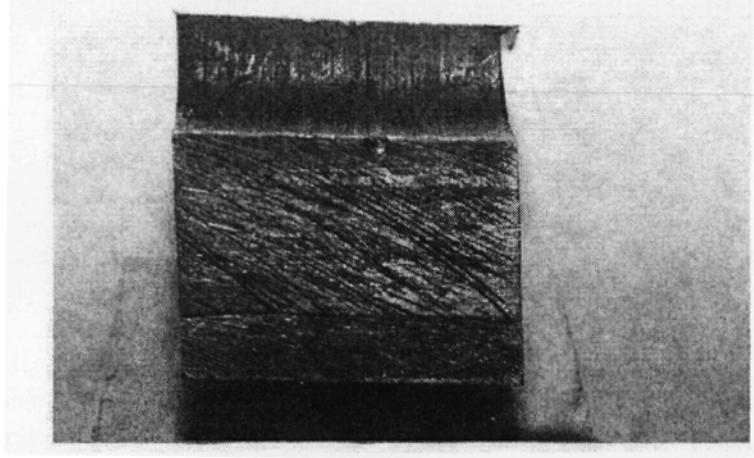
Fig. 3: Deep tool marks along with weld spatter deposit.

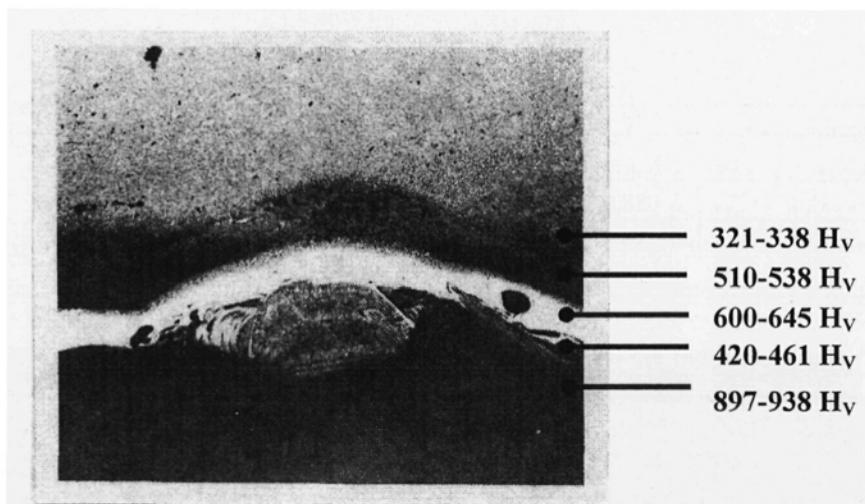
**Fig. 6:** Metallograph of the central bore surface of the stud. Microhardness measurements of the different layer has also been shown.

A uniform metallographically distinguishable layer of thickness of about 0.2-0.3 mm was found both on the outer surface and on the central bore surface of the stud, where weld spatter like deposits and craters were observed (Figure 6). The microhardness examination of the observed layer (510-538 Hv) was found to be higher than that of the core (321-338 Hv). Maximum hardness (897-938 Hv) was observed on the outermost layer. As the microstructure of the layer resembled that of a case carburized layer, the sample obtained from the outer surface was separately processed for carbon estimation. The carbon content of the sample at hand was found to be 0.6%, in contrast to the value of 0.2% of the core material. The higher carbon content of the

sample collected from the outer surface as well as its higher measured hardness value support carburization of the outer surface and central bore surface of the stud. Considering the chemical composition and service requirements of the stud, as well as the normal engineering practice, it is thought that the stud was not intentionally carburized but resulted from improper control of furnace atmosphere during hardening. The SEM examination of one of the fracture surfaces revealed the presence of small crater on the central bore surface at the plane of fracture, the depth of the notch was about 0.8-1.0 mm, along with some amount of plastic deformation at the tip of the crater (Figure 9a). A large half elliptical macro crack of several millimetre length and almost 1 mm width at its maximum depth at the edge of the central bore was also observed (Figure 9b); just in front of the macrocrack several transverse cracks were also observed (Figure 9c).

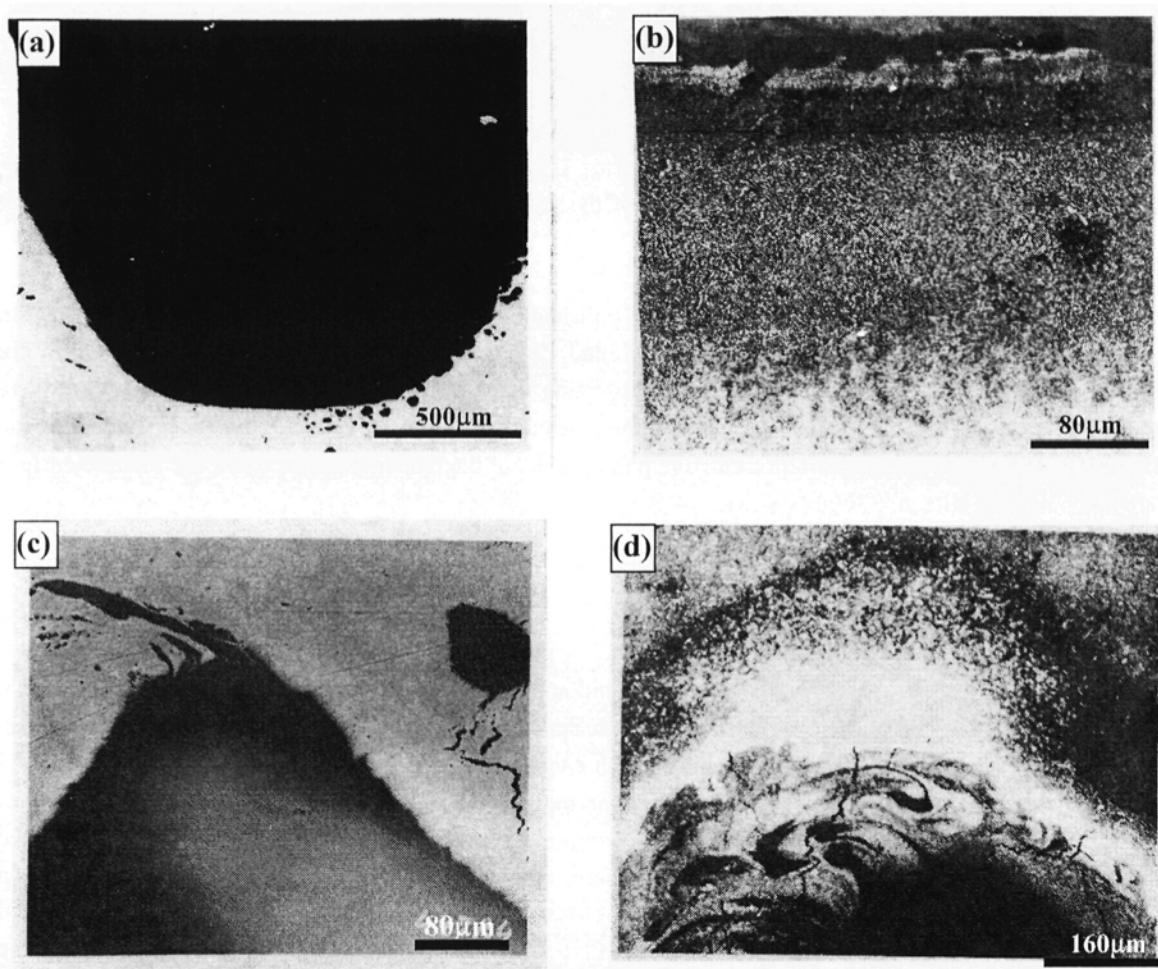
**Fig. 7:** Micrographs taken (a) near the thread root region revealing absence of thread root radius (b) near the central bore region showed three distinct etched regions (c) near the pit root showing cracks originating from the inclusion and (d) near the central bore surface showing cracks propagating along subsequent layers.

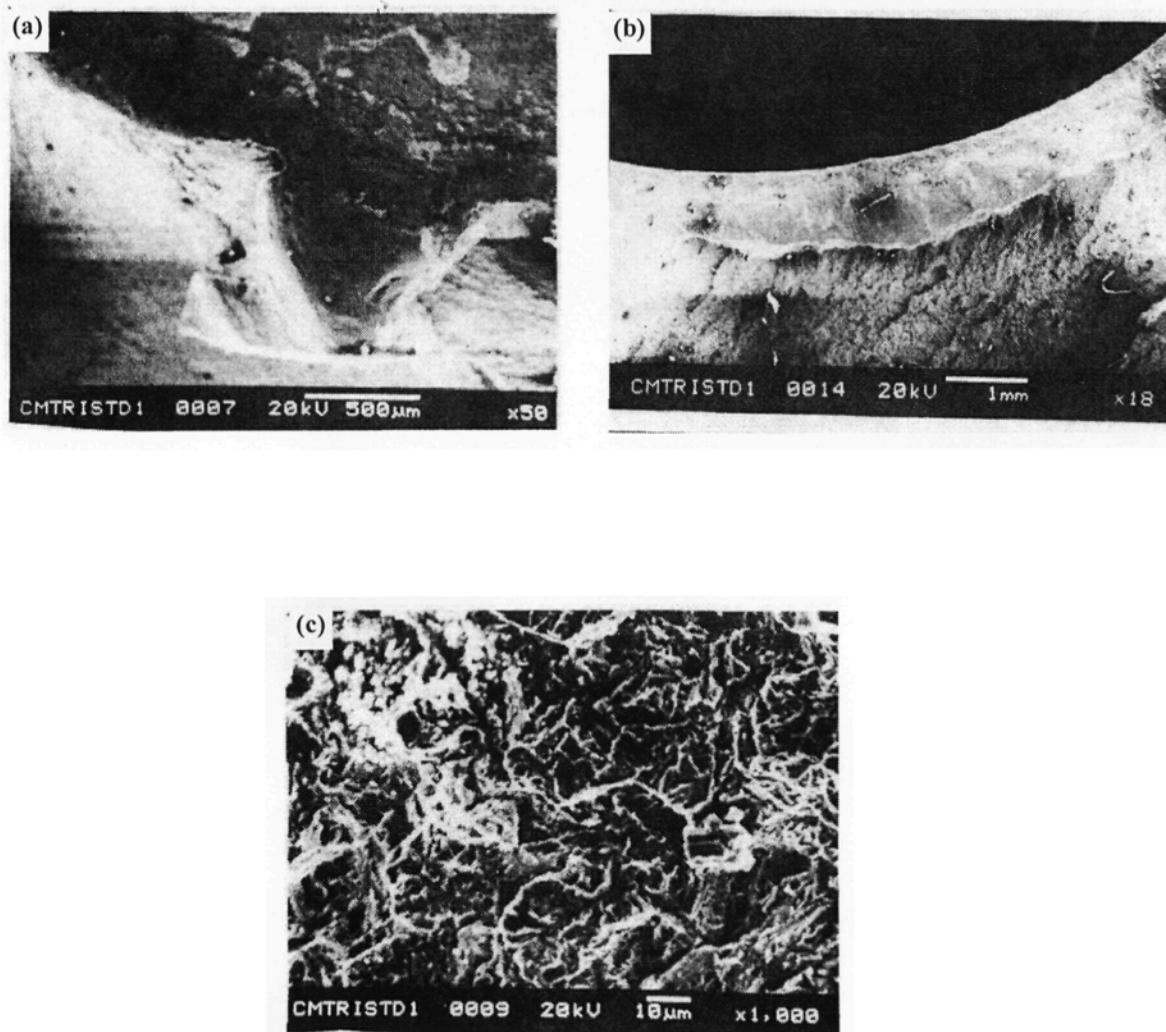
**Fig. 9:** The SEM photograph of (a) small crater on the central bore surface at the plane of fracture showing some amount of plastic deformation at the tip of the crater (b) half. Elliptical macrocrack and (c) several transverse cracks ahead of macrocrack.

To conclude, momentary intense heating, possibly due to formation of an electrical spark at the time of heating the stud through the central bore during assembly, caused adverse metallurgical conditions of the material of the stud at isolated locations on the surface of the central bore as well as formation of craters and cracks leading to failure of the stud. Adverse effect of thermal stress and metallurgical changes due to faulty heating was aggravated by the presence of a brittle carburized layer on the central bore surface as well as the presence of inclusions in the material. The cracks initiated from the brittle carburized layer and traversed towards the surface of the central bore leading to its failure.
