Inspection of Thick Composites for Near Surface Flaws

A. Fahr*, B. Roge, M. Brothers and D.G. Zimcik

*Structures, Materials and Propulsion Laboratory
Institute for Aerospace Research
National Research Council Canada
Ottawa, Ontario, K1A 0R6*

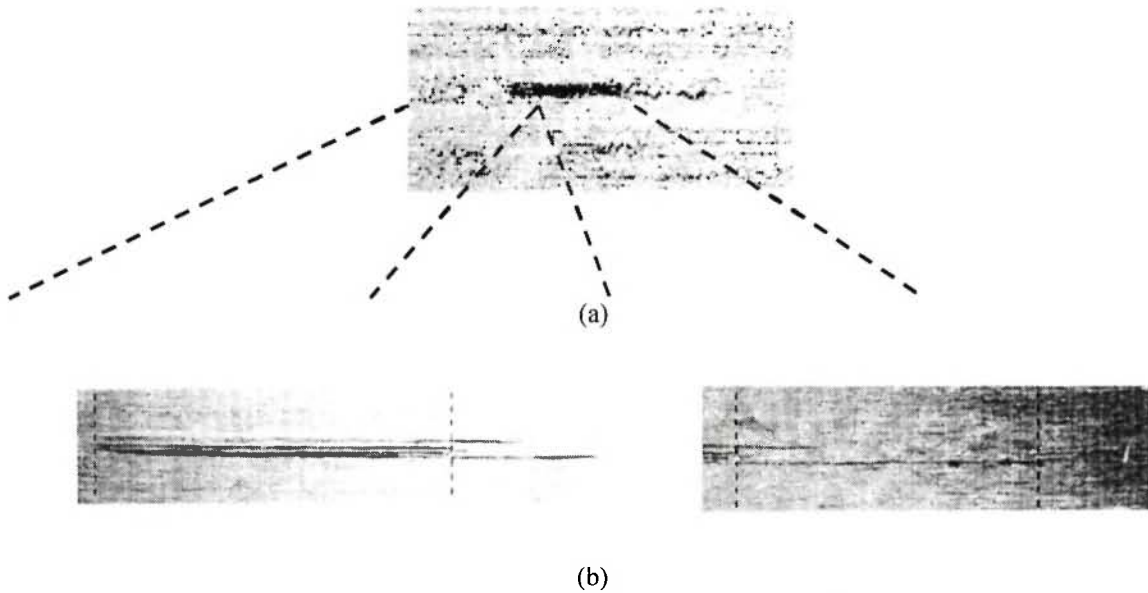
In addition, Method B was used to look at the very end of the areas where fibers had separated in an attempt to identify possible cracks perpendicular to the outer surface. An example of the results is shown in Fig. 7-a, indicating the presence of cracks along the fibers. These cracks were neither visible to the naked eye nor under a microscope. However, using solid rubber replication followed by microscopy of the replica, these cracks could easily be identified, as seen in Fig. 7-b and 7-c, verifying the ultrasonic results.

Fig. 7: (a) Amplitude C-scans of the tip of the surface damage using ultrasonic defocusing Rayleigh wave method and (b-c) the corresponding micrographs of the rubber replica.
