Technical analysis of the renovation works of the wooden palace floors

<https://doi.org/10.1515/eng-2021-0013>

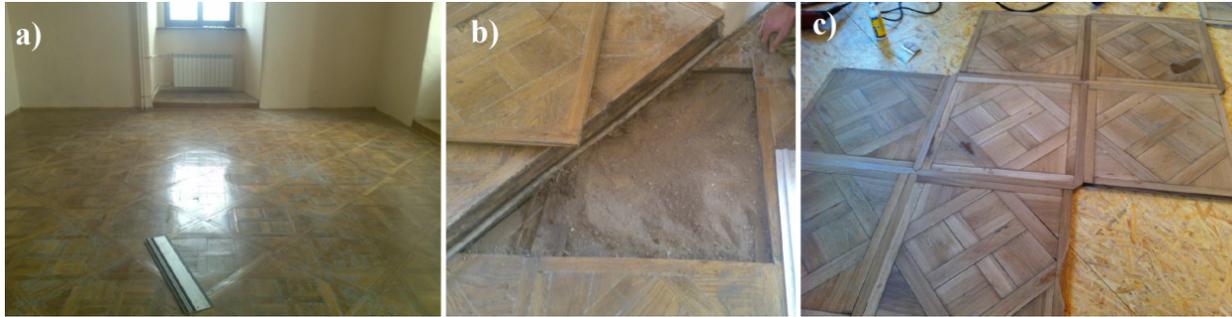
The case study was developed based on the completed renovation process. After the initial inspection, significant damage and abrasions of the varnish on the entire surface of the room were found. The execution of the local excavation made it possible to notice the laying of the palace floor on a sandy ground with wooden joists supporting the palace panels (Figure 1). The investor and the contractor decided to completely demolish the palace tiles, replace the subfloor with a new one, restore the palace panels in the workshop conditions, re-arrange and then finish them. The contractor decided to take all the sand out of the ground and clean it after all other cleaning works had been done, then they installed joists in order to level the entire room and a load-bearing grid for the “blind” floor, made of OSB board with a thickness of 22mm. Next, the boards were transported to the workshop and the process of dimensioning of each element took place. The dimensioning showed significant deviations of the plates with respect to each other. Dimensional deviations could be as large as 1 cm, so the decision was made to reformat each sheet into format files and give it dimensions 98×98 cm from the original of about 100×100 cm. After the formatting, there was a problem with the consistency of the pattern that the floor showed before dismantling and the formatting process. Steps were taken to add a frame around each plate to change the target dimensions of the element. Originally, the palace panels had a thickness of approx. 28 mm, yet the inspection showed significant differences between individual elements of the sheet reaching 4mm. Plate thickness was therefore reduced to 23 mm to level individual components. The process of exchanging components proved to be very laborious, because each element

Figure 1: a) Palace floor in the monastery building in Kalwaria Zebrzydowska before renovation; b) The local excavation; c) Matching individual elements of the sheet

There was also a problem of material nature because all the original panels were made of oak, which over time, due to natural processes and use, had become darker. The idea was to use elements made of oak wood which had undergone the smoking process making the wood look older. Then surface grinding with a belt grinder began in order to obtain equal sizes of individual elements, after which it was necessary to clean the edges connecting the individual elements manually from the accumulated sand and other impurities.

After the restoration phase of the palace floor in the workshop and the execution of the “blind floor” in the Monastery in Kalwaria Zebrzydowska, the contractor proceeded to install the floor. The investor accepted the diagonal layout of the panels in the room and the gluing of the floor using resin-synthetic adhesive. Gluing required accuracy and commitment from the workers because of the diverse shapes of the panels to install, which made it hard to put them in a straight line. Next, the mutual convergence of individual elements was checked, in order to adjust the individual plates in relation to each other and find them

a proper place on the floor surface. The work took more time than anticipated due to the dimensions of individual elements and their minimal differences in dimensions (Figure 1).

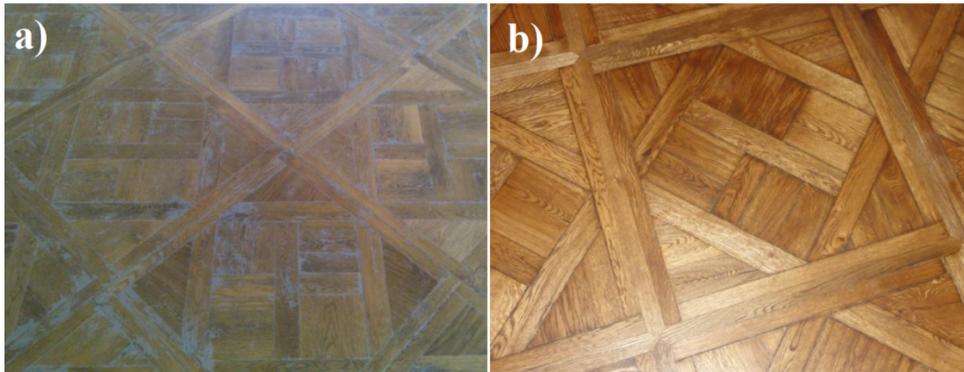
Figure 2: a) Palace floor before renovation; b) The final effect of the renovation

After finishing the work, the floor was left for a period of about 2 weeks for the adhesive to fully bond. Subsequently, the whole surface of the room was sanded using a drum grinder, gradually reducing the graininess of the paper, until smoothing. Coloring stain and primer were applied to give depth to the color and visually age the floor. The purpose of using a two-component topcoat was to increase the strength and abrasion resistance of the floor surface (Figure 2).

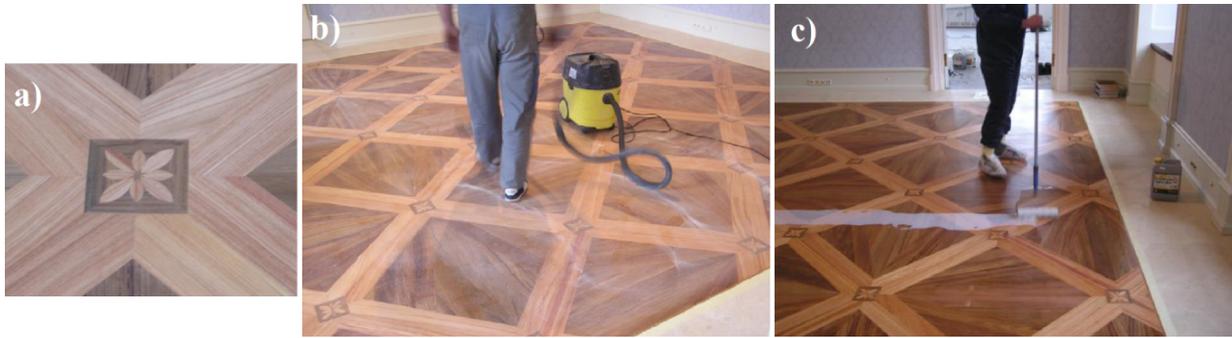
Figure 3: a) Decor on a parquet joining b) Vacuuming the grinded surface c) The painting

tile elements for the palace mosaic were prepared earlier in the workshop. Due to aesthetic and technological requirements, a 10 mm thick laminated parquet made of several exotic wood types was applied, which were later glued onto 5 mm thick plywood. Joining was made using a polyurethane contact adhesive, additionally with waterproof properties. The cubes were formatted to the dimensions imposed in the project. Internal elements, connecting frames and decors were made separately and then fastened during laying on the construction site (Figure 3).

The laying process began with determining the center of the floor according to strict guidelines regarding the arrangement of the individual elements of the patterns throughout the room. Before gluing the floor, the panels were adjusted to each other to find a suitable place on the floor plane. Since it was necessary to insert the panels into the existing marble, edge cuts were made right next to the edge of the marble, while all expansion joints were cut after sticking the tiles to the subfloor. Given the layered nature of the floor, for gluing particular parts one-component polyurethane adhesive was used. After the assembly, grinding works started. Due to the very delicate nature of the material and its previous workshop treatment, the grinding process did not start with the paper of the highest granularity. Instead, smoothing sanding was applied using abrasive paper with a smaller grain size, which made it possible to give the entire surface evenness and homogeneous appearance. Prior to painting, small corrections had to be made locally, which was primarily required for decors. Parts of the surface were individually laid, for individual types of wood to prevent edge discoloration caused by the filling putty. Before applying the primer varnish, the whole surface had to be thoroughly vacuumed from dust and impurities (Figure 3).

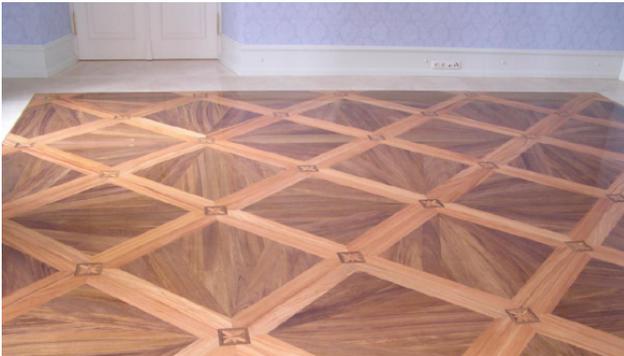
Figure 4: The final effect of surface of the wooden palace floor

tractor made additional floor care using a matte preservative to prolong the life of the floor without the necessary regeneration (Figure 4).
