# Management strategies for refurbishment projects: A case study of an industrial heritage building

### 3 Case study: Small hydropower plant (SHP)

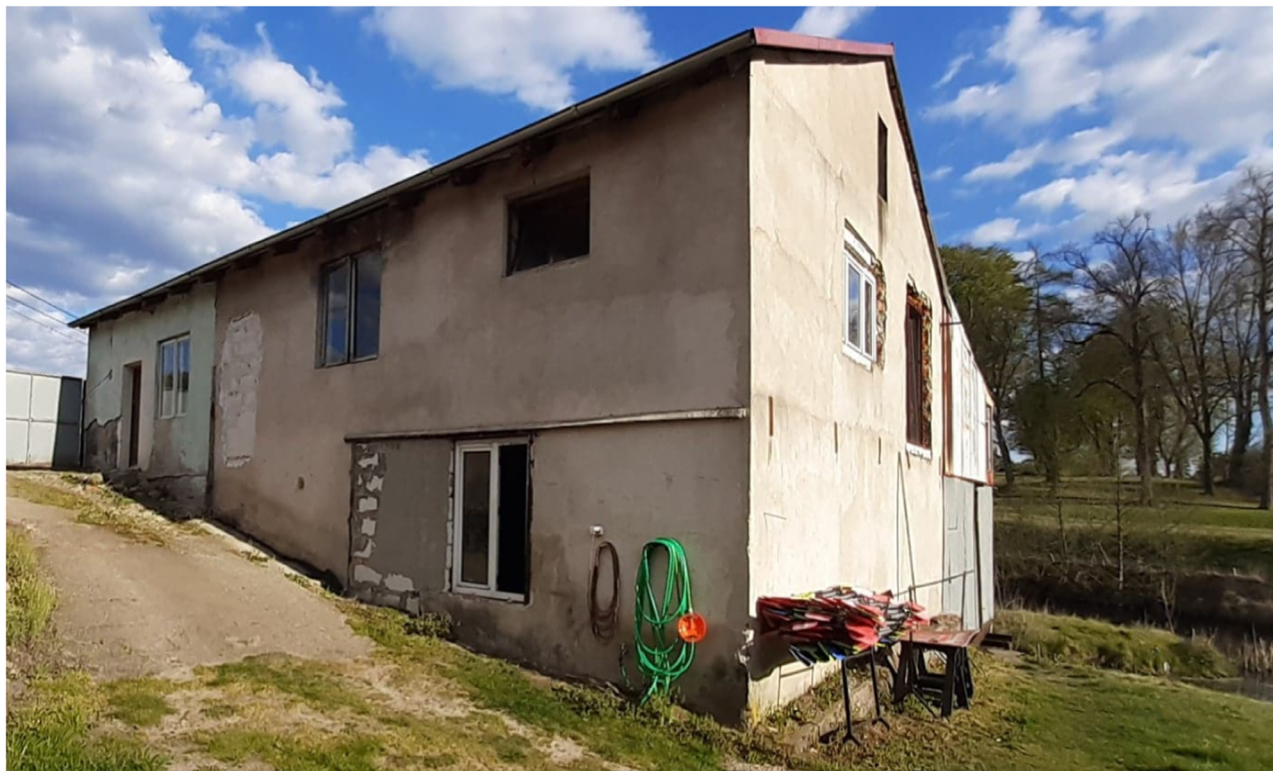
**Figure 4:** View of the north and west walls.

In the 30.00 cm thick load-bearing walls, masonry made of cinder blocks, aerated concrete blocks, or solid bricks, respectively, the repair of numerous vertical cracks with polymer-cement repair mortar is envisaged. In the north-east corner of the building, a steel anchor is to be used due to uneven ground settlement. The deviations of the load-bearing walls from the vertical are up to 3.00 cm (Figure 4).

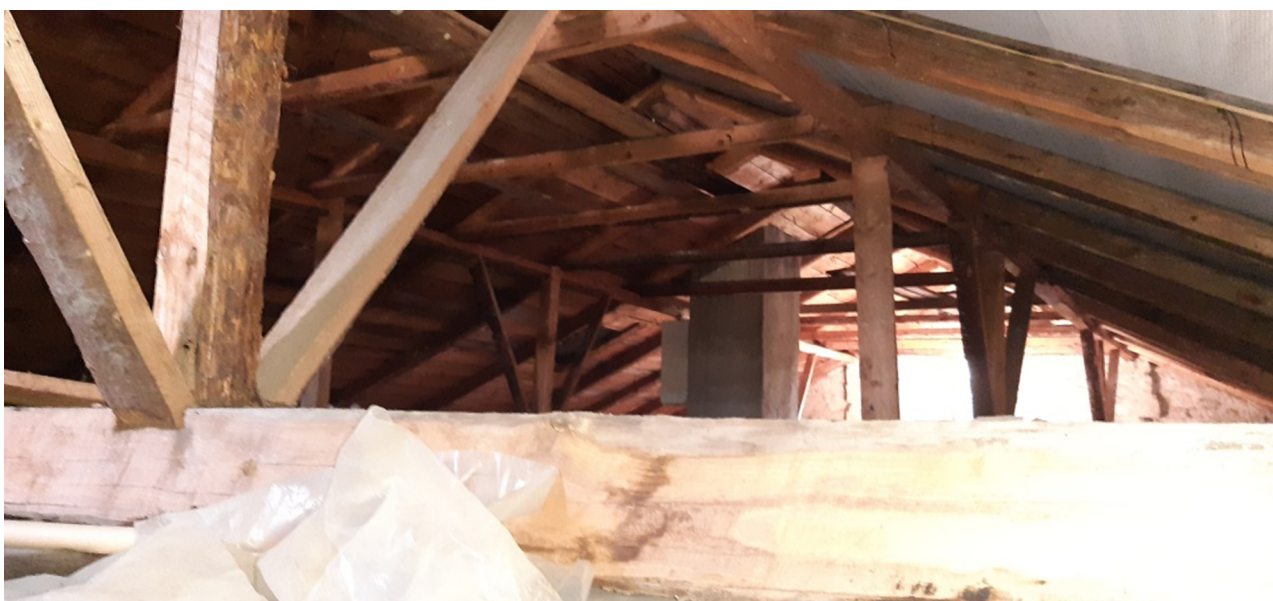
**Figure 5:** View of the roof structure.

The timber collar beam roof truss with two joist walls is in good condition, as can be seen in Figure 5. There are

no visible deflections, cracks, or cavities. The roof truss elements are not waterproofed.

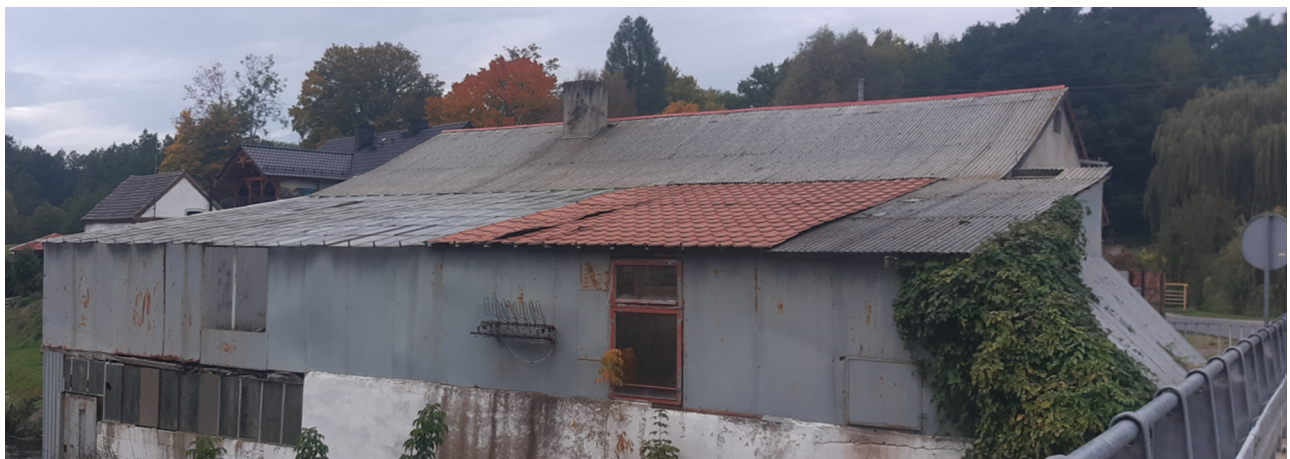
**Figure 6:** View of the building from the south.

between the wooden structure and the roof slope, ensuring no absorption. On the southwest side, the single-pitched roof slope consists of glass elements (as in Figure 6) supported by steel structures. A glass insulation layer was used

to lower the plate. Automatic replacements of the glass occur with new elements that have improved thermal and acoustic properties.
