Research Article

Emilio Trigueros, Manuel Cánovas*, Javier Arzúa, and Manuel Alcaraz

Stability of an abandoned siderite mine: A case study in northern Spain

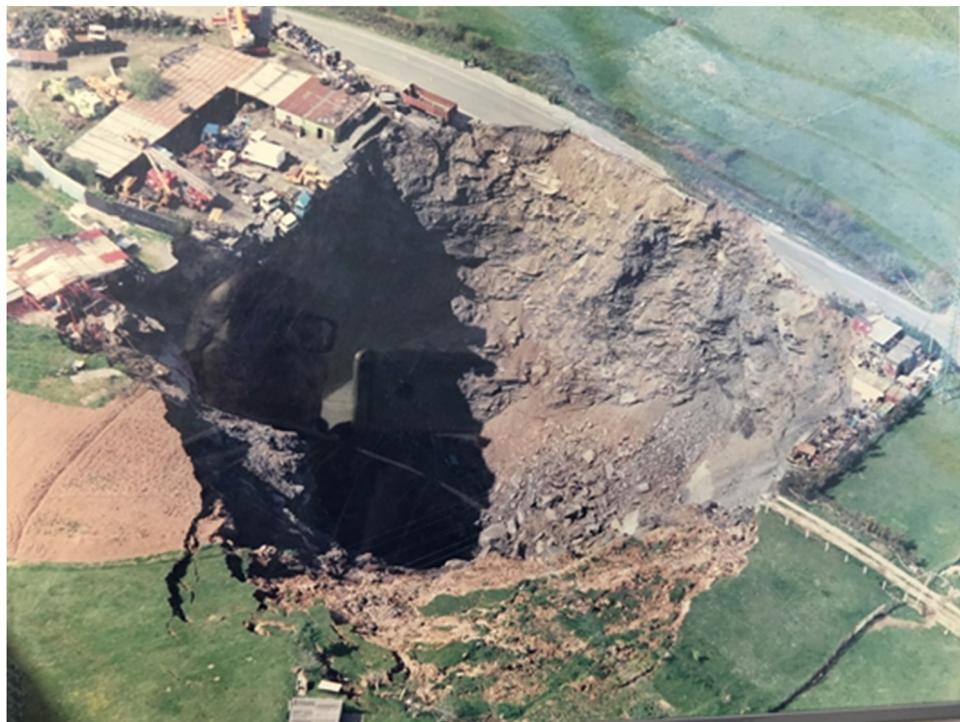
The main geotechnical incident was a progressive pillar failure that occurred in the NW1N zone (Figure 1). The pillar, damaged due to a reduction in its width in order to increase the extraction ratio, finally collapsed in 1999 (Figure 2). The collapse, preceded by noises audible on the surface, resulted in a 60-m diameter crater on the surface, which was improved by backfilling (28% of granular backfill and 72% of cement-based backfill) and subsidence monitoring. A similar event occurred in 1986 in the same zone, when a progressive caving process reached the surface, resulting in the formation of a 35-m

Figure 2: Aerial photograph of the surface crater resulting from the 1999 collapse (image by the authors).

deep sinkhole, with a small-diameter opening that later grew into a crater measuring 30 m in diameter. The crater was improved through backfilling from the surface. The

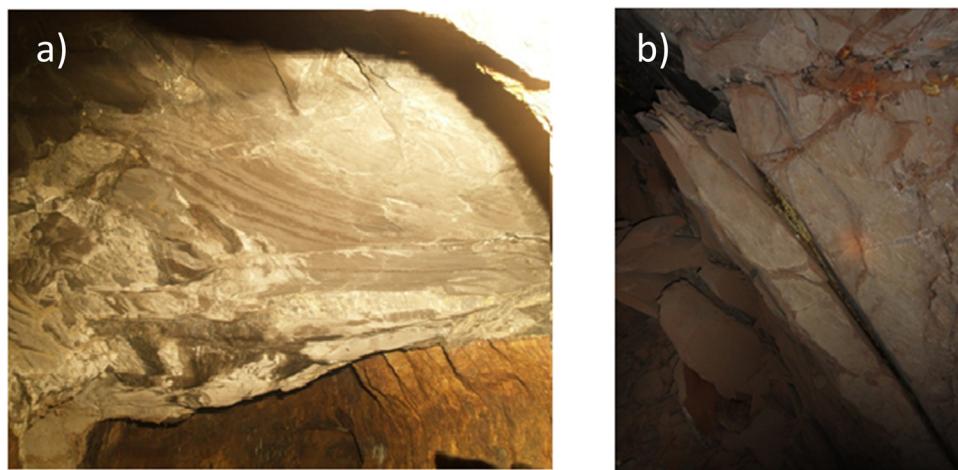
Figure 3: (a) Hard *cayuela* in the roof of SE room #8. (b) Weak *cayuela* near the collapse location (images by the authors).

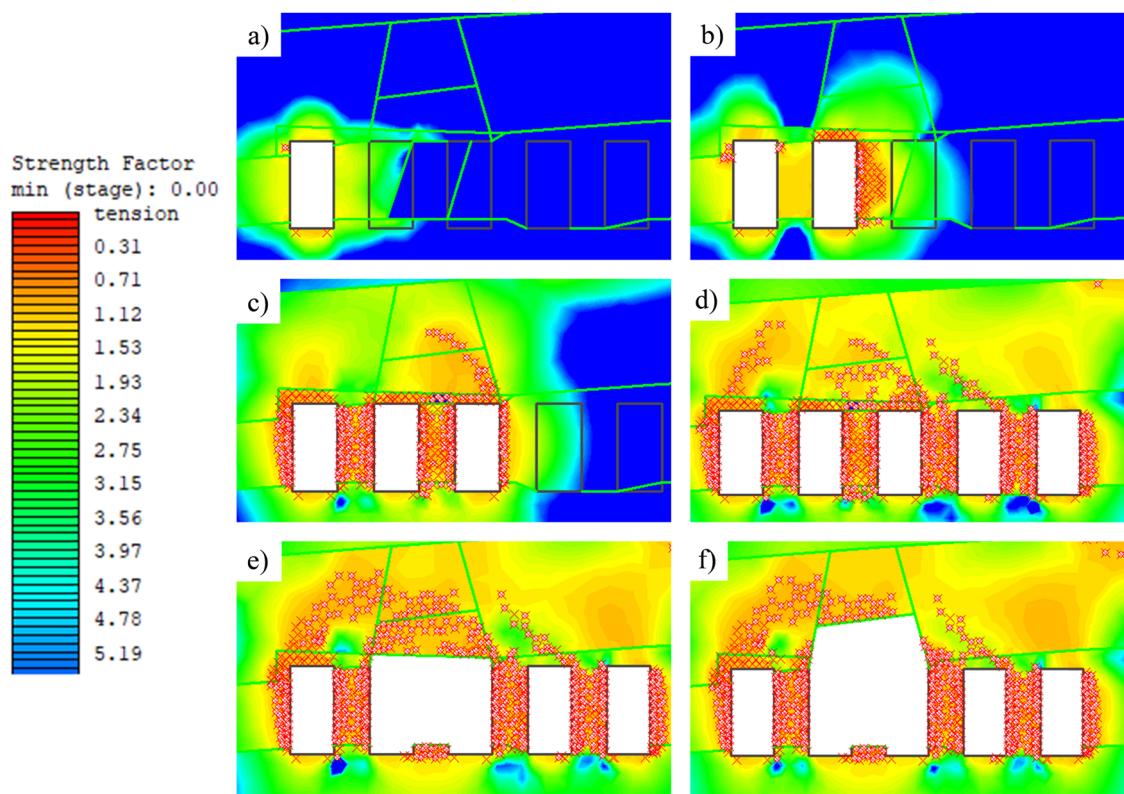
Figure 5 depicts the collapse sequence, which follows the different stages of the excavation. After excavation of room #1, yielding rock appears in the limestone floor, in the upper part of the left wall and in the *cayuela* roof because of the damage produced by production blasting, although dilation prevents rock blocks from falling. The left wall of room #1 does not yield, apparently because of the mylonitized ore a few meters to the right (inside the rock mass), which, rather than loading that left wall, liberates energy in the form of displacement (Figure 5a). When room #2 is excavated, developments are similar.

Again, deformation tends to concentrate in the mylonitized ore in the future pillar #2. The yielding occurs mainly in the wall of this future pillar #2 due to its poorer quality (resulting from mylonitized ore, blasting damage and over-excavation), which bears most of the deformation in order to accommodate stresses (the upper right corner of room #2 is vertically displaced by 1 cm, while a similar displacement of 0.8 cm occurs in the upper left corner) (Figure 5b). After excavation of room #3, pillar #2 deteriorates further and deformation continues (the upper right corner of room #2 is vertically displaced by 4.5 cm)

to the point that yielding begins to occur in the previously healthy pillar #1 (Figure 5c). After excavation of room #4, further tension yielding points appear in the roof of rooms #2 and #3, pillar #2 is further vertically displaced (6.85 cm in the upper right corner of room #2) and yielding now extends to pillar #3 (Figure 5d). After excavation of room #5, pillar #2 is vertically displaced by 10 cm and the deformation leads to progressive damage of the pillar (Figure 5e). The pillar finally collapses, leaving a 70-m roof span, where yielding progresses upwards to reach the full height of the weak *cayuela* (70 m) (Figure 5f). The progressive collapse finally reaches the surface.

Figure 5: (a–f) Excavation and collapse sequence of NW1N zone rooms, explanation in the text.

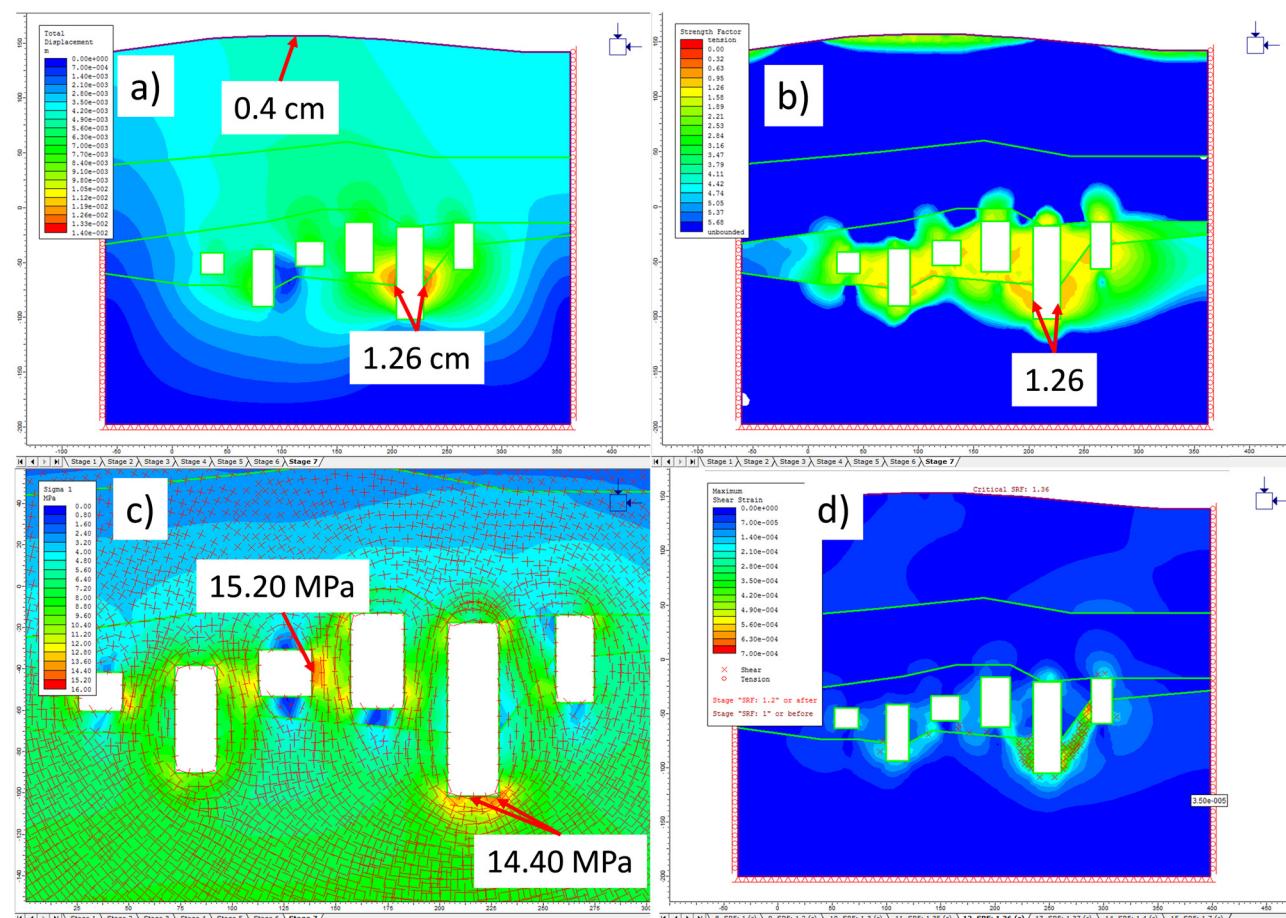
Figure 8: Finite element method results for the northern cross-section of the SE zone rooms. (a) Total displacement. (b) Strength factor. (c) Major principal stress. (d) Strength reduction factor.

- The largest displacements (around 1.3 cm) are in the walls of room #6, while surface displacements are around 0.4 cm and occur approximately over room #3 (Figure 8a).

- High concentrations of principal stress (mostly vertical) occur in the left walls of the pillars between rooms #4 and #5 and between rooms #5 and #6, reaching values of 15 MPa (Figure 8c). The floor of room #6 also achieves this principal stress value (mostly horizontal), with the square corners of room #6 as the probable cause.

- In applying the SRF, Phase² points to a critical value of 1.36 (the strength parameters should reduce a 36% to get the non-convergence of the model, i.e. the failure of the rooms), with the failure surface occurring between the lower parts of rooms #6 and #7 (Figure 8d). According

to the results of the model, if the SRF value reaches 1.4 (the strength parameters reduce a 40%), the failure could become generalized and affect the rest of the rooms, and if it is higher than 1.7 (the strength parameters reduce a 70%), the collapse could affect the surface.

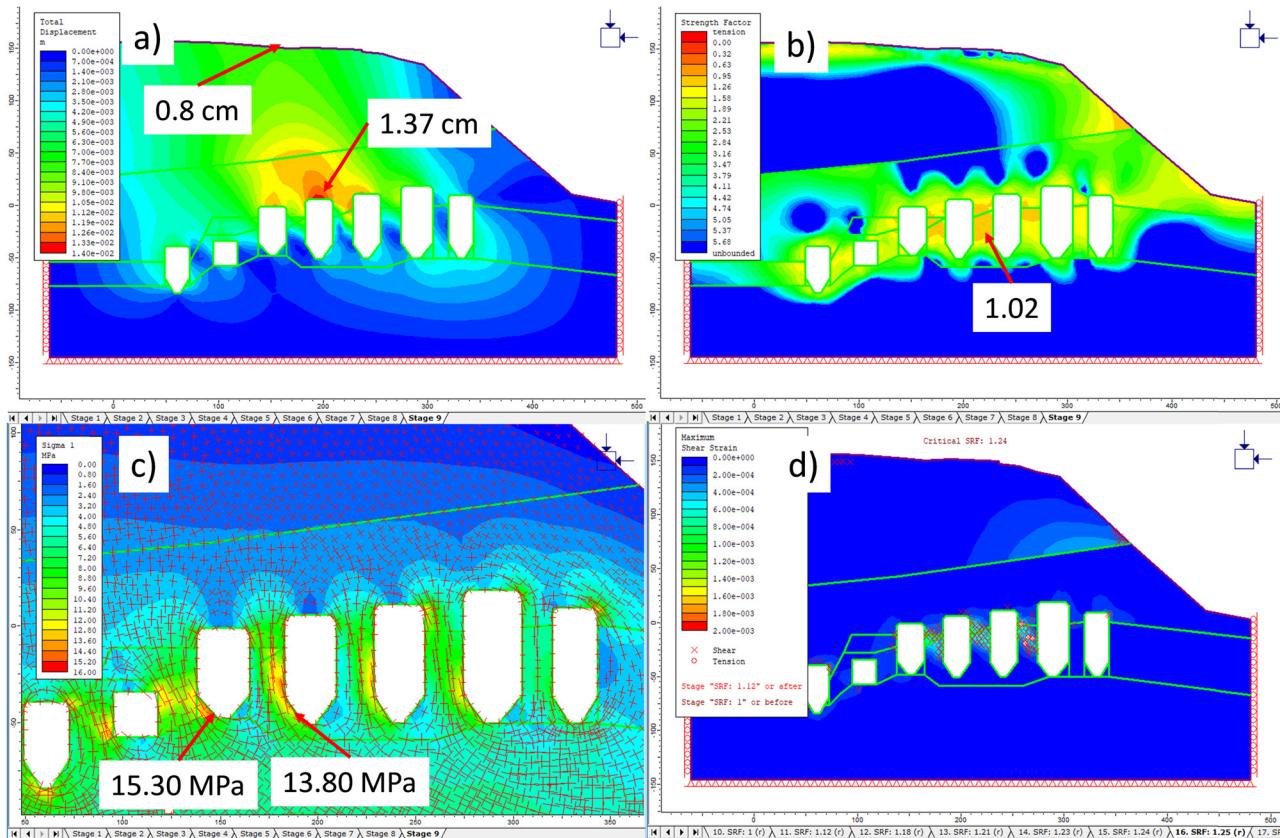
Figure 10: Finite element method results for the central cross section of the SE zone rooms. (a) Total displacement. (b) Strength factor. (c) Major principal stress. (d) Strength reduction factor.

- The displacements are small, reaching a maximum of around 1.4 cm in the roof of room #5. The shape of the displacements is very influenced by the open pit, which causes asymmetry of the loads and, therefore, of the displacements. Surface subsidence in the order of 0.8 cm occurs approximately over room #4 (Figure 10a).

- SF reaches a value as low as 1.02 in the pillar between rooms #5 and #6 (Figure 10b). This low value occurs because there is no longer damaged *cayuela* in the roof. The asymmetric load (because of the open pit) combined with the great height of the pillars produces some buckling in the pillars, which ultimately causes yielding in some elements (Figure 10d).

- In applying the SRF, Phase² points to a critical value of 1.24, with the failure surface occurring in the middle of

- Note also that, according to FEM results, room #8 does not play a key role in the stability of the cross section.

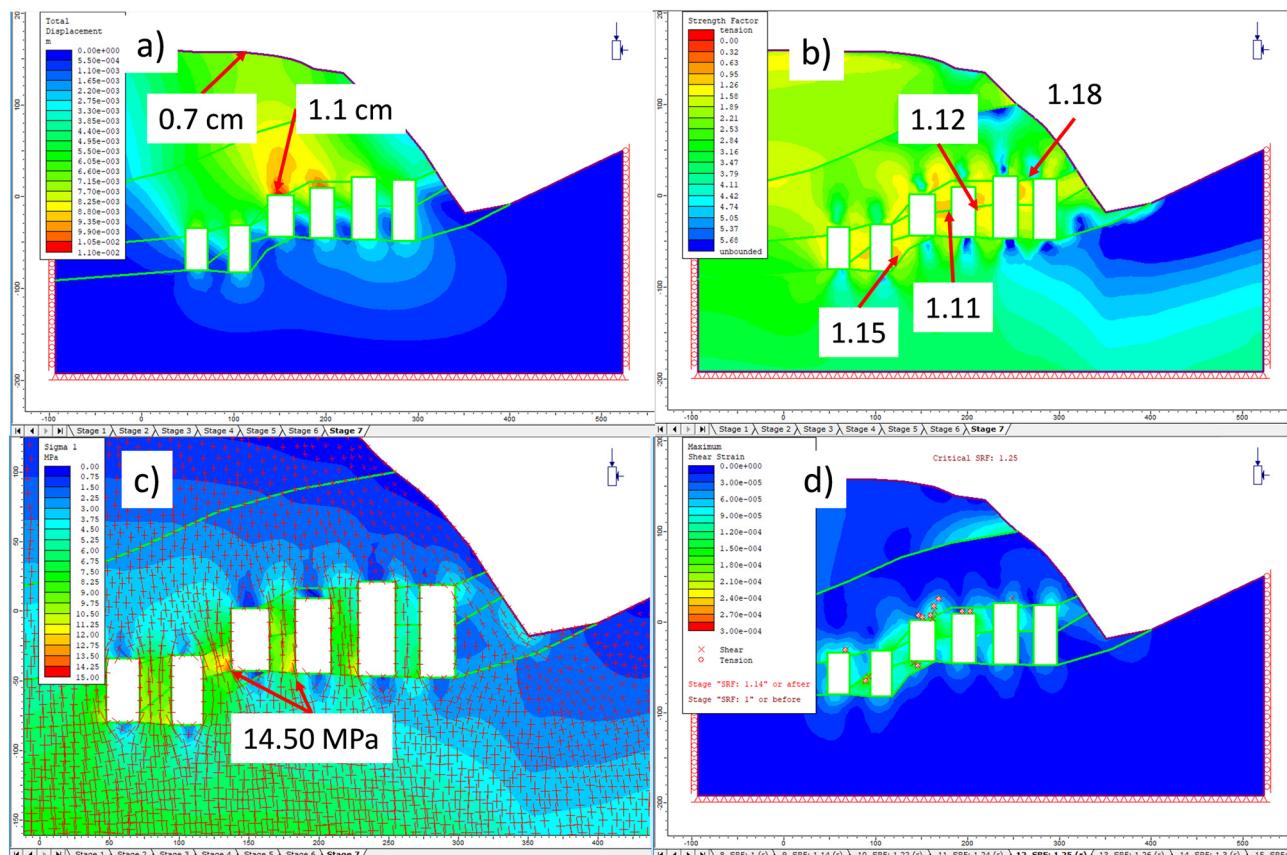
Figure 12: Finite element method results for southern cross section I of the SE zone rooms. (a) Total displacement. (b) Strength factor. (c) Major principal stress. (d) Strength reduction factor.

- The displacements are small, at a maximum of around 1.1 cm in the roof of room #4 and 1 cm in the roof of room #5. The shape of the displacements is, again, very influenced by the open pit, which causes asymmetry of the loads and, therefore, of the displacements. Surface subsidence in the order of 0.7 cm occurs approximately over the pillar between rooms #3 and #4 (Figure 12a).

- As in the central cross section, the largest compression values do not occur in the pillars but in the ore base of the pillars between rooms #3, #4 and #5 (Figure 12c), reaching values of 14.5 MPa. Similarly, maximum tension values occur in the pillar between rooms #5 and #6. The reason is, again, the asymmetrical loads caused by the open pit.

- In applying the SRF, Phase² points to a critical value of 1.25, with the failure surface occurring in the pillars between rooms #3, #4 and #5 (Figure 12d).

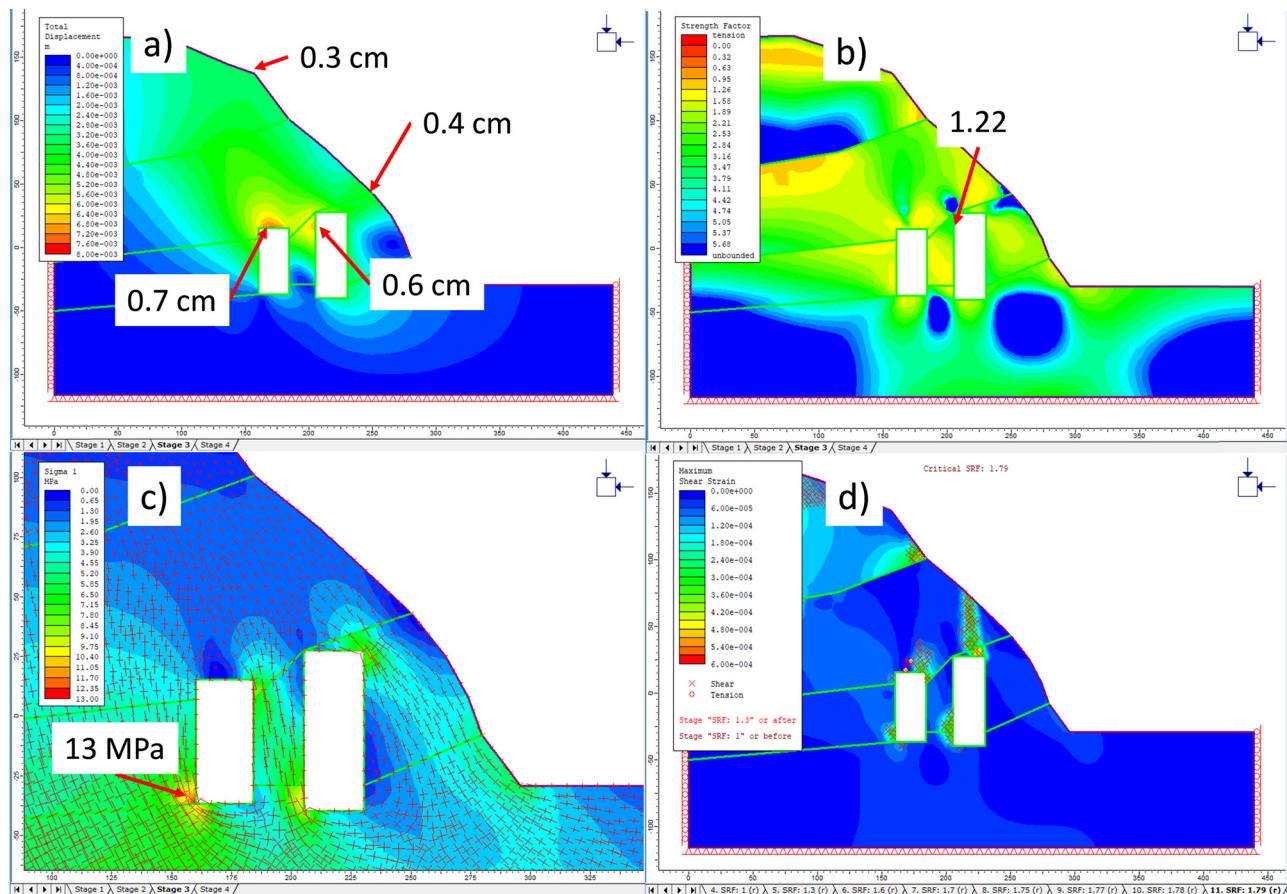
- The displacements are small, at a maximum of around 0.7 cm in the roof of room #5 and 0.6 cm in the upper left corner of room #6. Deformation of the slope of the open pit becomes evident but is only 0.4 cm at the nearest point to room #6 (Figure 14a).
- The SF reaches a minimum value of 1.22 in the upper left corner of room #6, where there is contact between hard *cayuela* and ore (Figure 14b).
- The maximum compression stress occurs in the left base corner of room #5, reaching a value of 13 MPa (Figure 14c). Tension stress occurs in the remaining rock mass between the slope and room #6, reaching a value of -0.35 MPa.

- In applying the SRF, Phase² points to a critical value of 1.79, with the failure surface vertically connecting the roof of room #6 with the slope of the open pit (Figure 14d).

Figure 14: Finite element method results for southern cross section II of the SE zone rooms. (a) Total displacement. (b) Strength factor. (c) Major principal stress. (d) Strength reduction factor.

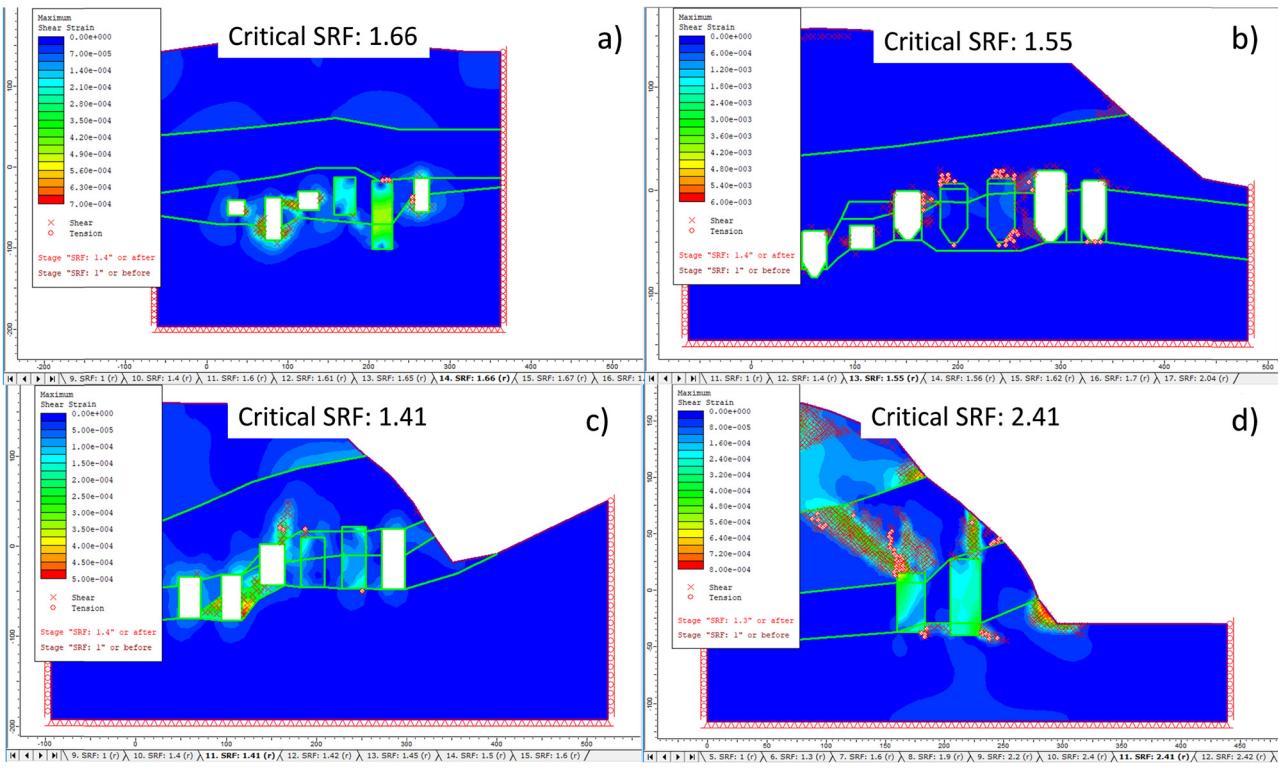
Figure 15: Strength reduction factor results after backfilling. (a) Northern cross section. (b) Central cross section. (c) Southern cross section I. (d) Southern cross section II.

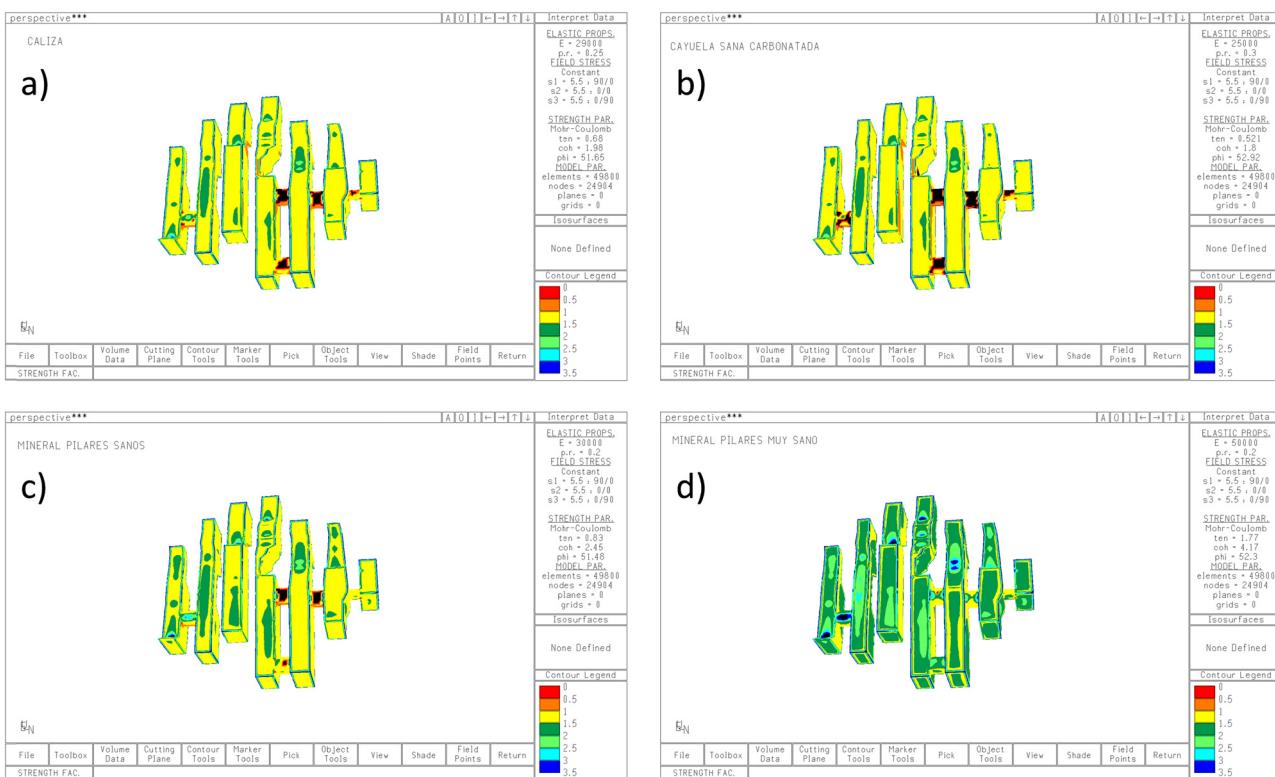
In Figure 17, which depicts the 3D BEM results for the different materials, it can be observed that some yielding seems to occur in the galleries connecting the rooms, in

limestone and in hard *cayuela* (Figure 17c and d, respectively) but decreases as the geomechanical quality of the material improves (ore and hard ore, Figure 17c and d, respectively). The yielding zones are small, nonetheless, so if a failure occurs, the surviving pillars will support the remaining rock mass. A horizontal yielding zone also occurs in the east wall of room #4 that, again, is small.

Figure 17: 3D boundary element method strength factor results. (a) Limestone. (b) Hard *cayuela*. (c) Ore. (d) Hard ore.

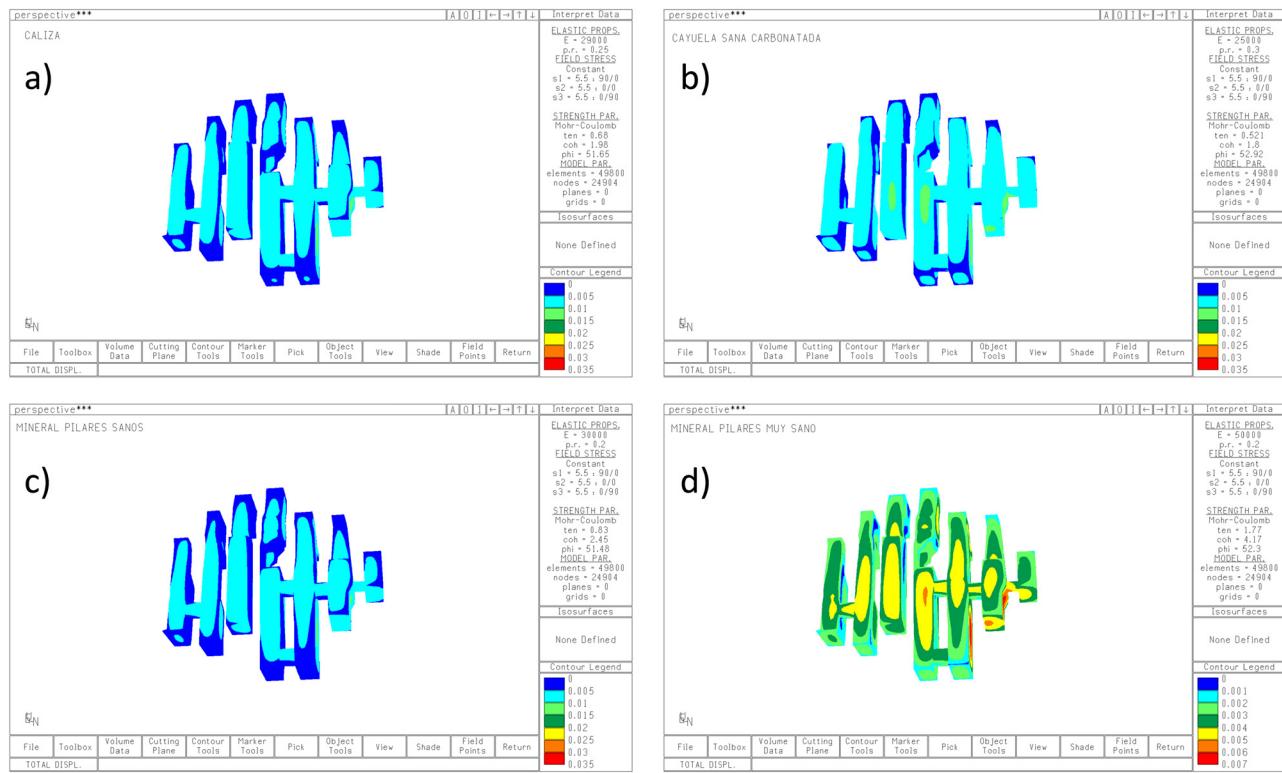
constant in all the graphics in Figure 18. Nevertheless, the computed displacements do not exceed 2 cm, corroborating the obtained FEM results.

Figure 18: 3D boundary element method displacement results. (a) Limestone. (b) Hard *cayuela*. (c) Ore. (d) Hard ore.
