# High-Temperature Graphitization Failure of Primary Superheater Tube

DOI 10.1515/htmp-2014-0137

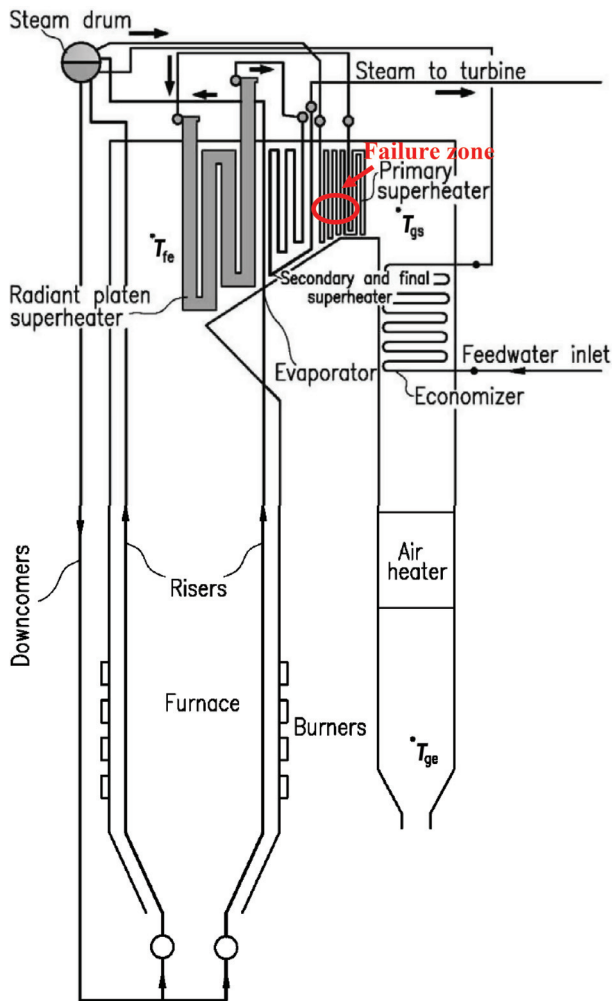
Figure 1: Location of failure region in thermal power plant boiler.

In this paper, an attempt has been made to investigate the probable cause/causes of premature failure of primary superheater tube located in the furnace zone of the boiler. The location of failure zone is shown in Figure 1.

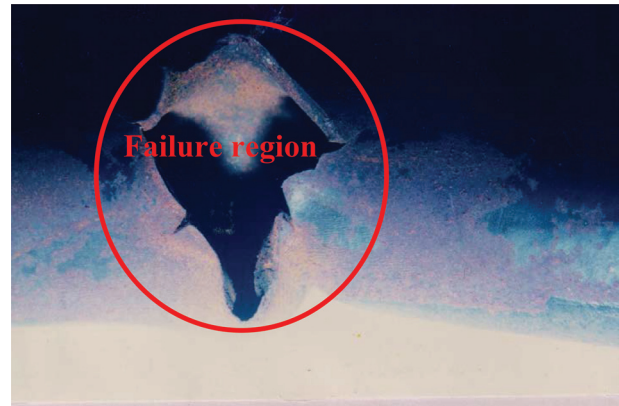
Visual examination shows that the failure is wide open burst (Figure 2). No appreciable bulging is observed in and around the failure zone. The failure is taken place at the flue gas side of the tube. The maximum length of the opening is found 32 mm at the longitudinal direction and 56 mm at the transverse direction. The failure is thick lip type, indicating no appreciable thickness reduction at the edge of the fracture. No abnormal deposits are found in ID side of the tube. No significant scale buildup is also noticed at the outer surface of the tube.

Figure 2: As received failed region of primary superheater tube.

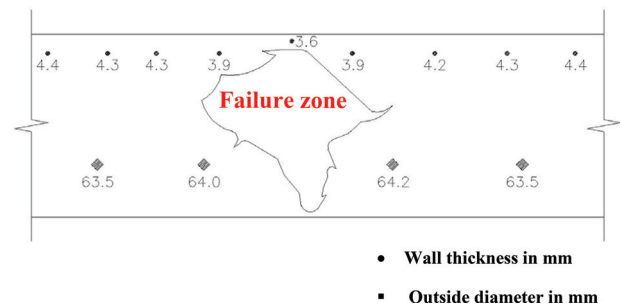
The outer diameter (OD) and wall thickness are measured on the failed tube, by using digital vernier caliper and ultrasonic wall thickness gauge (type: DM-3, Krautkramer, Germany). The result (Figure 3) shows no significant changes of outside diameter and wall thick around the failure zone.

Figure 3: Wall thickness and outside diameter measurement of the failed tube.

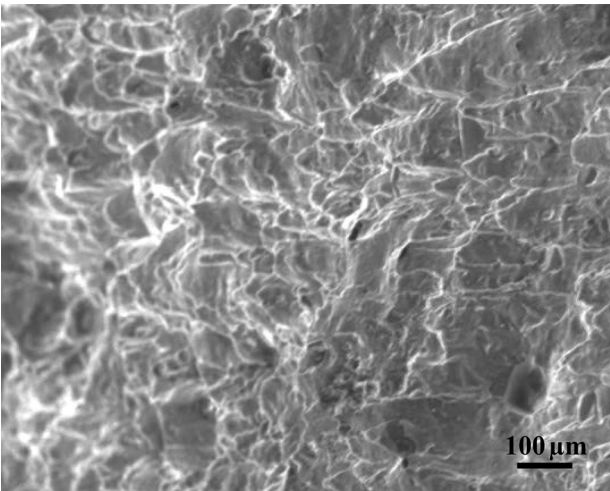
The fracture edge of the failure is sectioned carefully and cleaned with acetone by ultrasonic cleaner. The cleaned fracture surface is examined in scanning electron microscope (Model – S-3000N, Make- Hitachi limited, Japan) for fractographic analysis. The fractograph (Figure 5)

Figure 5: Fractographic examination of failed primary superheater tube.

shows the evidence of brittle fracture. This clearly indicates the embrittlement of the fracture edge due to escaping steam immediately after failure.

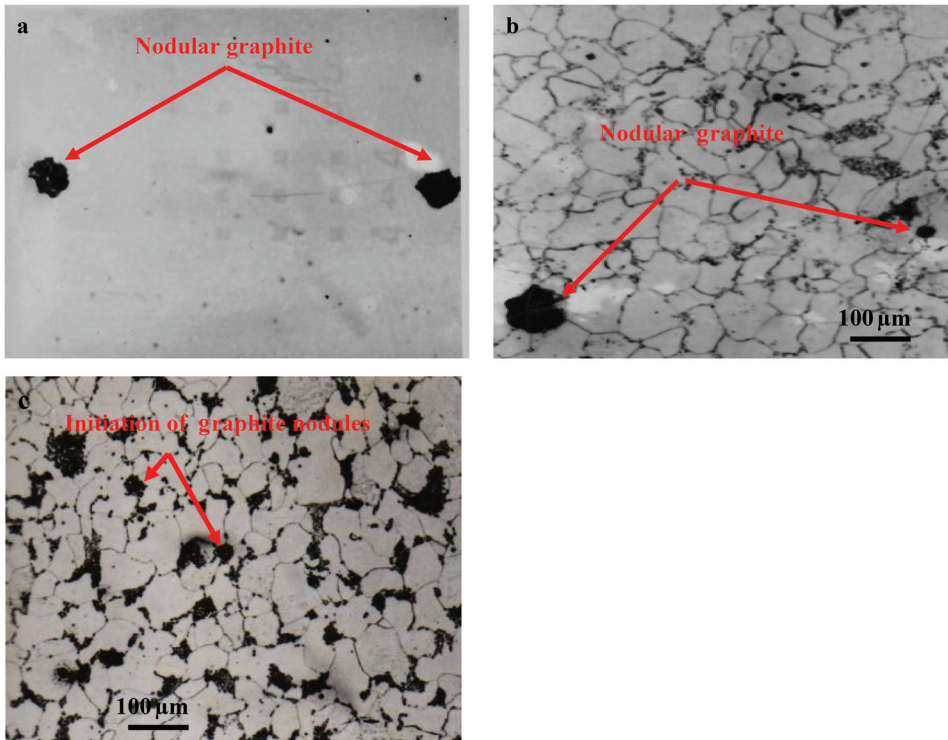
at the failed region at unetched condition shows the presence of randomly distributed nodular graphite in the unetched matrix (Figure 4(a)). The microstructure at etched conditions reveal complete breakdown of pearlite, which finally results in nucleation and growth of graphite nodules in ferrite matrix (Figure 4(b)). The microstructure away from the failure also shows the complete breakdown of pearlite in association with initiation and growth of graphite nodules (Figure 4(c)).

Figure 4: Microstructure showing (a) graphite nodules at unetched matrix at failure region; (b) complete breakdown of pearlite resulting in growth of graphite nodules at etched condition at failure region and (c) breakdown of pearlite and initiation and growth of graphite nodules at away from the failure zone.

graphite. The graphite is randomly distributed in the ferrite matrix (Figure 4(b)). The microstructure away from the failure zone confirms to the presence of decomposed pearlite and initiation of graphite nodules mostly within pearlite colonies (Figure 4(c)). Few graphite are grown in size within the ferrite matrix. The hardness survey shows the reduction of hardness around the failure zone in comparison to the normal hardness value. The mechanical properties (Table 2) also show the significant reduction in UTS and also increase in ductility in this type of steel. The undesired value of strength, ductility and hardness can be attributed to the formation of graphite from decomposed pearlite due to prolonged exposure to the high temperature.

The observed graphitization is attributed to the use of plain carbon steel (SA 210 grade A1) instead of designed specified material (SA 209 T grade) in that particular zone for long period of time. The permitted tube metal temperature of this grade of steel is 727 K (454°C) [24], which is much lower than operating temperature 783 K (510°C). The higher temperature at this region for extended period of time leads to premature failure of the tube. The fractographic analysis of the fracture edge shows the evidence of brittle fracture (Figure 6). The escaping steam during failure causes quenching effect and leads to brittle failure.

As a recommendation, all the plain carbon tubes (SA 210 grade A1) used in this region may be replaced by higher grade C-0.5 Mo steel (SA 209 grade T1) to avoid the similar kind of failure in this region. At the same time the temperature mapping in this region is also suggested to measure the exact temperature profile in this region.

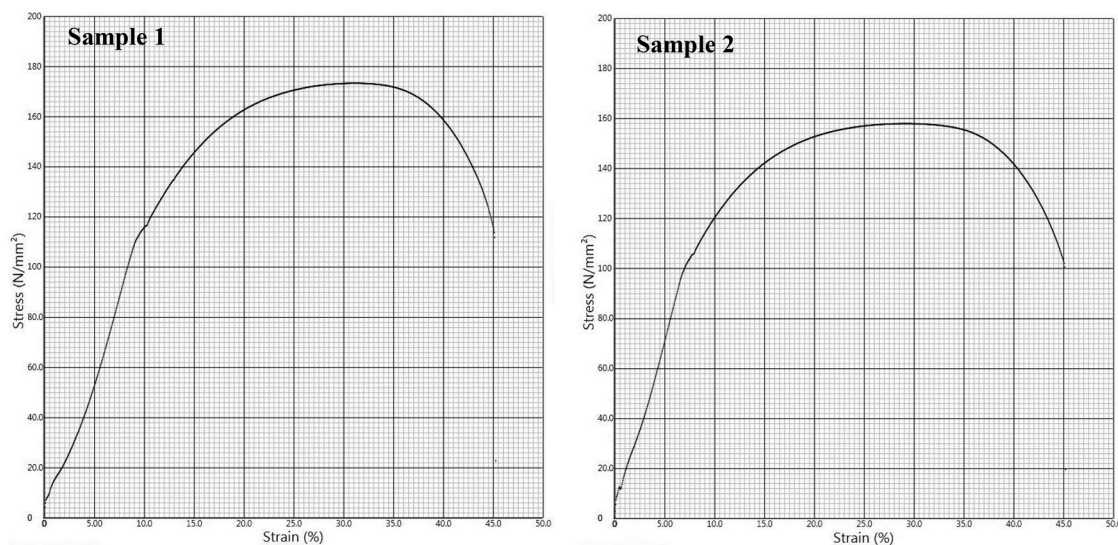
The tensile samples are prepared from the unfailed tube adjacent to the failure. The tensile test specimens are tested in universal testing machine (Instron Wolpert, UK). The stress–strain plot is incorporated in Figure 6 and Table 2. The results of ultimate tensile strength (UTS) and elongation in failed tube show significant decrease in UTS (380 MPa) and also increase in ductility (30%) as compared to the normal value of SA 209T1 grade steel.

**Figure 6:** Stress–strain plot for the tensile specimen taken from the failure zone.
