Research Article

Effects of metallurgical factors on reticular crack formations in Nb-bearing pipeline steel

Keywords: surface defect; reticular crack; pipeline steel; oxidized round spots

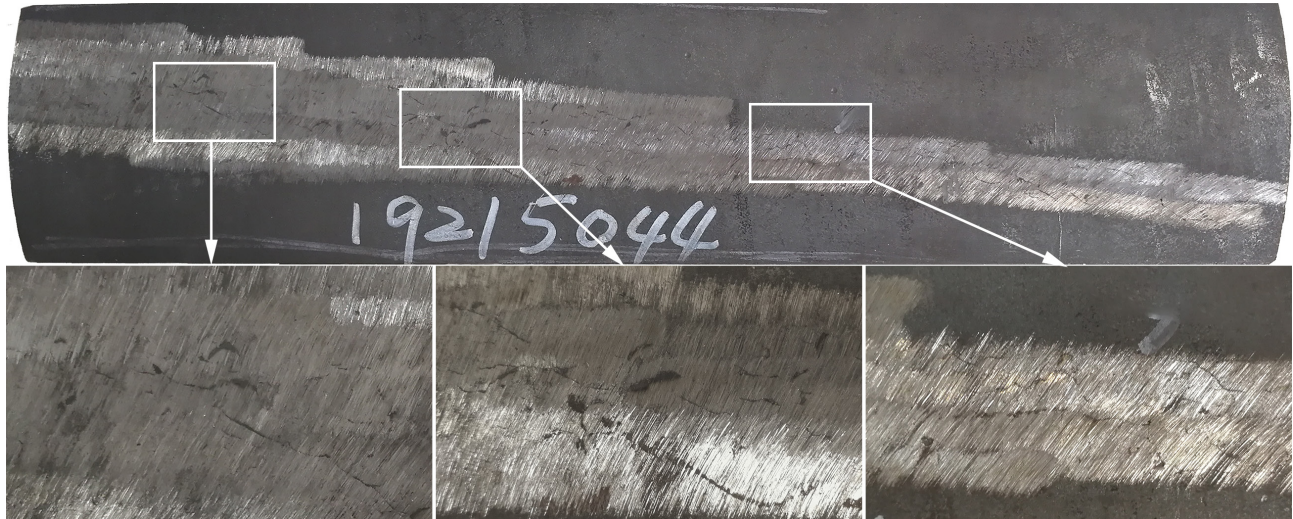
**Figure 1:** Typical morphology of reticular cracks on the surface of an Nb-bearing pipeline.

Figure 1 shows the typical reticular cracks on an Nb-bearing pipeline surface. It can be seen that a great deal of cracks is distributed along the rolling direction. SEM was used to observe the widths and depths of microstructures from reticular cracks on radial and circumferential sections after polishing. Figure 2 shows a typical example of the microscopic morphology for a reticular crack. The crack extends from the outer surface of the steel pipe inwards at a depth of 0.24 mm and is filled with FeO. The reticular cracks are discontinuously distributed along the radial direction. It is seen from the cross-section and end profile views of the crack that it experienced a certain radial deformation during the rolling process. Thus, it is presumed that the reticular crack was formed before the rolling process.

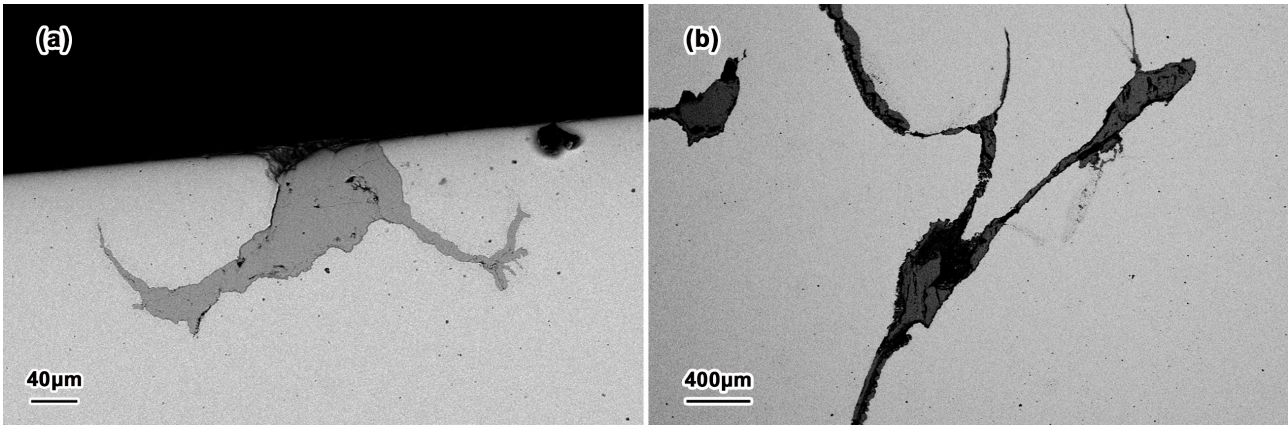
Figure 2: Cross-sectional (a) and polished surface (b) morphology of a reticular crack.

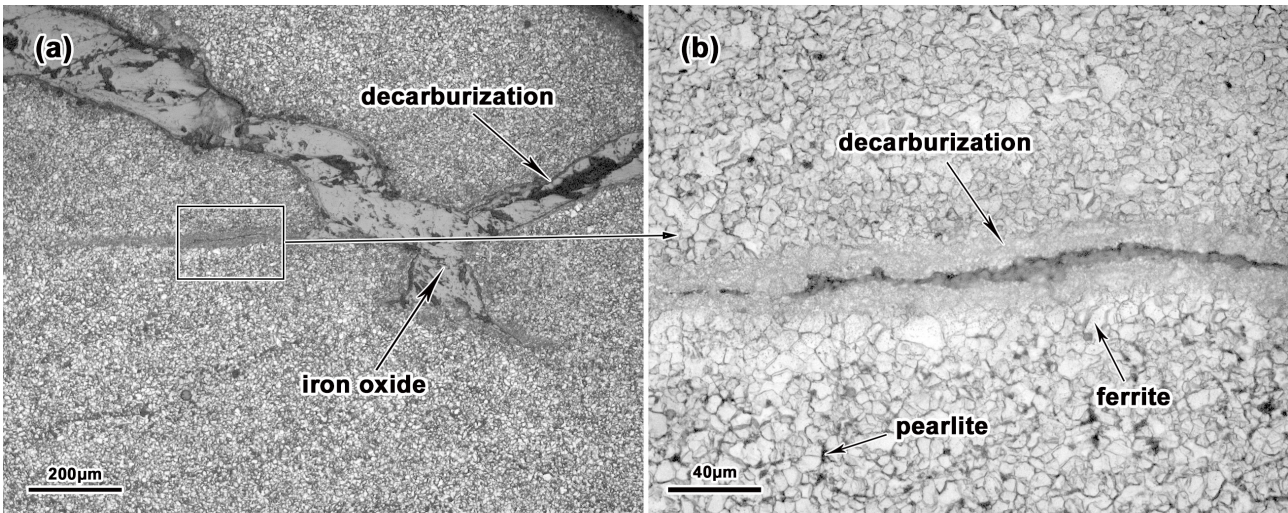
Figure 3: Metallographic structure near the reticular crack at (a) 100× and (b) 500× magnifications.

The metallographic structure near the crack was observed after etching with a 4% nital solution. As shown in Figure 3, the metallographic structure is ferrite (black) and pearlite (white). The grain size of the ferrite near the crack region is larger, while it is smaller in the steel matrix. The crack is filled with iron oxide and there are obvious decarburization layers on both its sides that are approximately 15 μm thick. It is inferred that the reticular cracks form before the heat treatment, and that their inner wall oxidized during the heat treatment to form the large amount of observed iron oxide. A decarburization layer appeared on the inner wall of the crack, which grew over time.

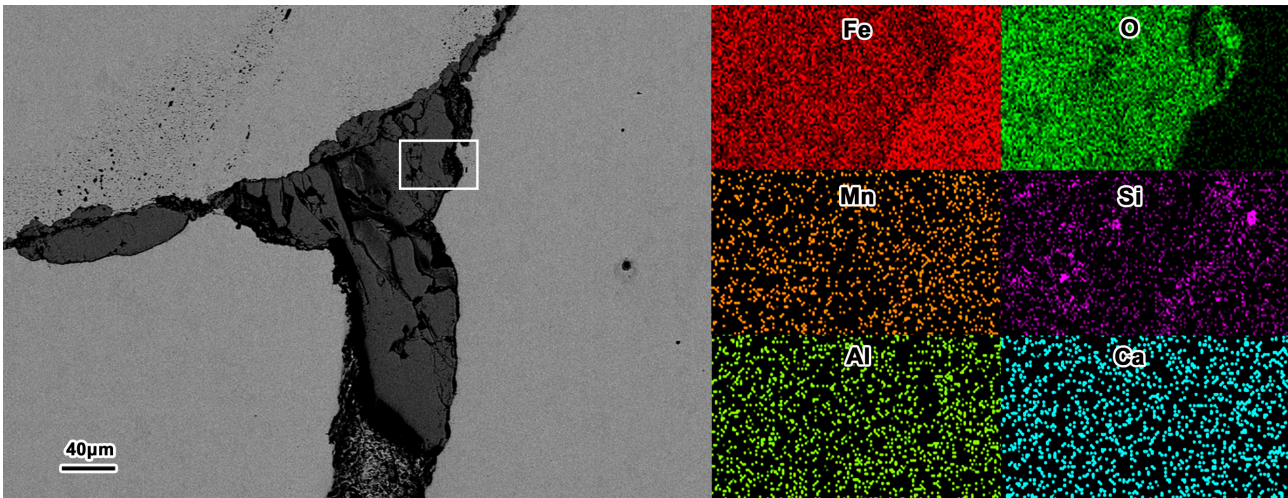
Figure 4: Element mapping of typical reticular crack zone.

The end of the reticular crack was characterized using both SEM and energy dispersion spectroscopy (EDS), as shown in Figure 4 and Figure 5. Figure 4 and Figure 5a shows that the crack end is filled with a significant amount of iron oxide, and there is a large number of oxidized round spots on both sides of the crack ends. The maximum oxidized spot diameter is up to 3 μm. The spots near the crack side are larger and more intensive, while those in the steel matrix are smaller and more dispersed. Figure 5b shows the chemical composition of the oxidized round spots as

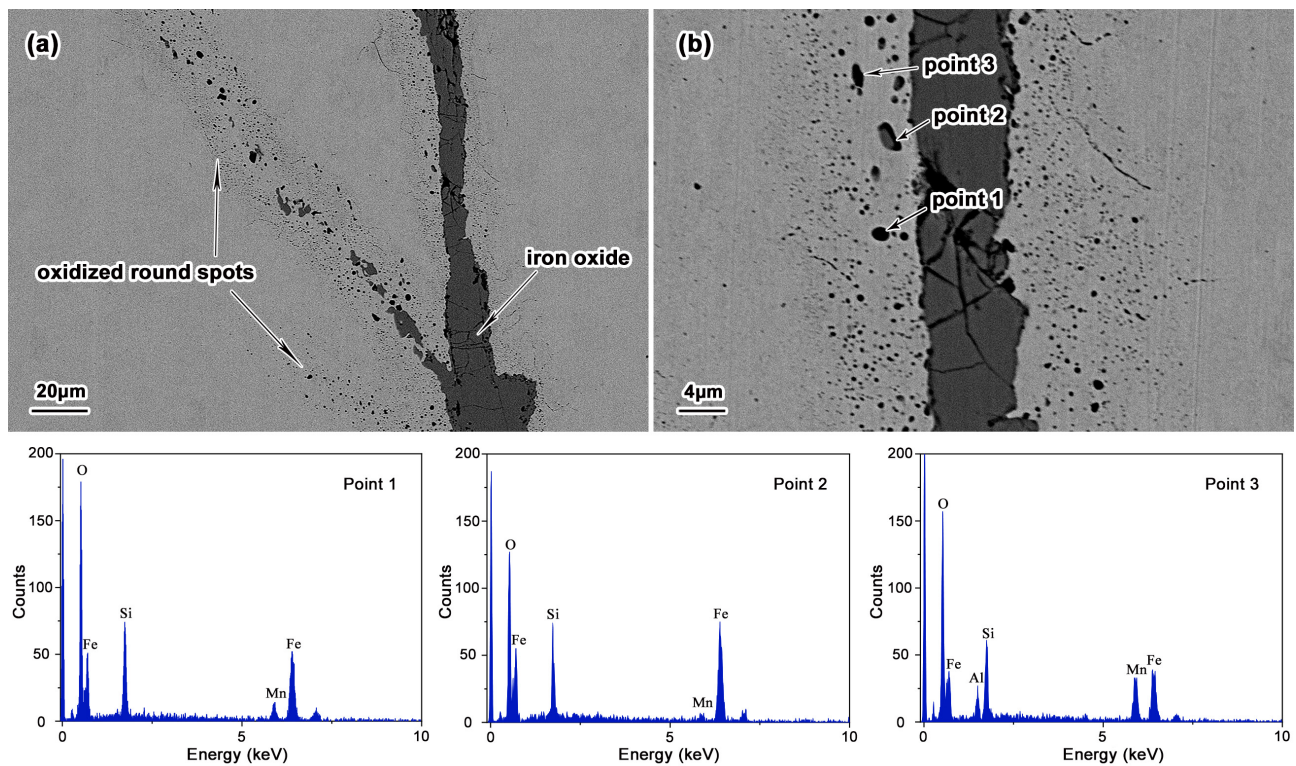
Figure 5: Microscopic morphology (a) and energy spectrum analysis (b) of the oxidized round spots in the reticular crack zone.

determined using EDS. Points 1, 2, and 3 show the presence of Fe, Mn, and Si oxides, while point 3 also shows the existence of aluminum, which was used as a deoxidizing agent in the ladle furnace refining process.

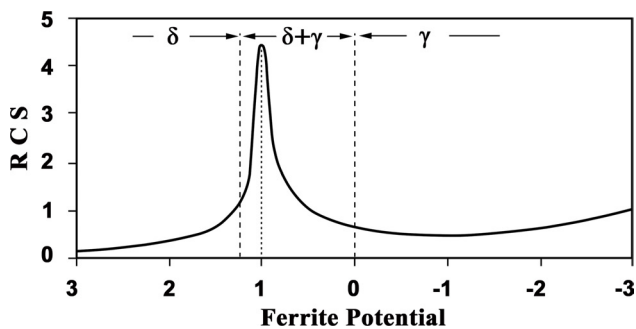
Figure 6: Relationship between the relative crack susceptibility (RCS) and ferrite potential (FP).

The $\%C_P$ denotes the carbon equivalent, which considers the effect of the other alloying elements in the steel. Using the chemical composition of the investigated crack samples given in Table 1, The FP value for the Nb-bearing pipeline steel is found to be 1.05. The relative crack susceptibility is maximized when the FP is around 1, as shown in Figure 6 [16].

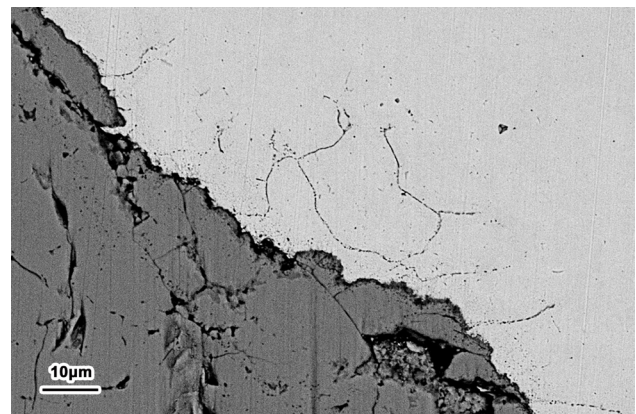
Figure 7: Microscopic morphology of the microcracks along the grain boundary.

Intergranular cracks are the most predominant when the FP is around 1. The coarse grains are further embrittled because of the precipitation and enrichment of residual elements. Figure 7 shows the microscopic morphology near the crack zone, which includes intergranular microcracks. The intergranular microcracks are distributed along the primary grain boundary, while the crack boundary is decarburized. This indicates that the crack is formed before the austenite transformation at approximately 1400°C in the mold. The nascent solidified shell is formed during the solidification process with a phase transition of δ to γ . Austenite grain boundary cracking then appears due to volume shrinkage and bulging, tension, and static pressure in the molten steel. As the continuous casting process progresses, the microcracks expand to reticular cracks due

to the fabrication parameters, such as tension, bulging, misalignment, and uneven cooling.

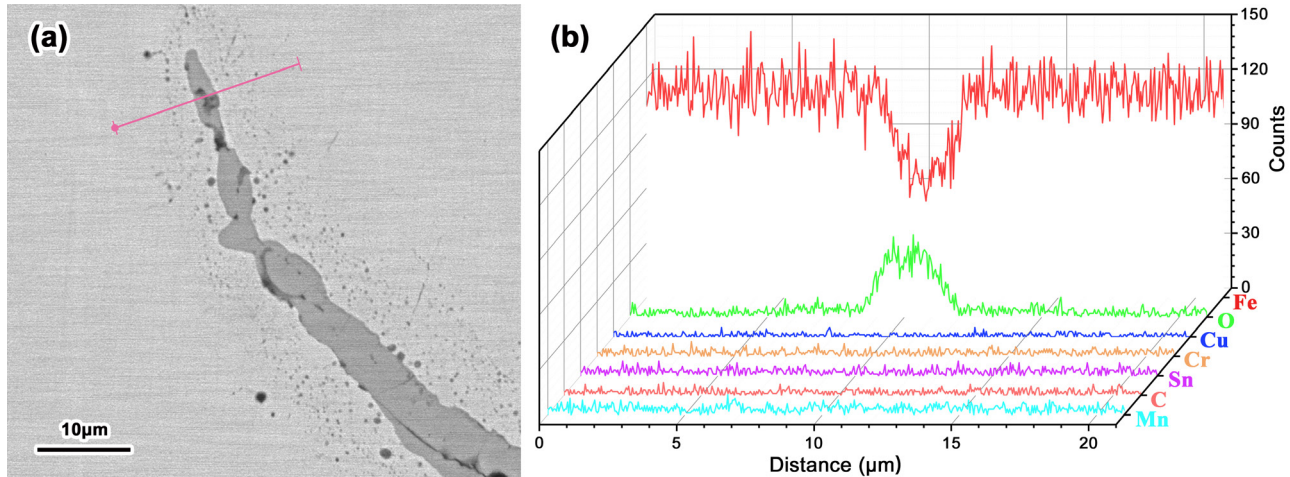
Figure 8: Line scanning analysis over the line shown in (a) for (b) Fe, O, Cu, Cr, Sn, C, and Mn.

Liu *et al.* [17] and Zhu *et al.* [18] observed the crack area of a tube bloom and slab and found that they were enriched with Cu and Cr elements near the cracks. This was mainly because the chromium coating shed from the inner wall of the copper mold during the continuous casting process, which led to a direct contact between the inner wall of the mold and tube bloom. The melting point of Cu is 1085°C, which can penetrate into the austenite grain boundary through the iron oxide skin. This reduces the grain boundary bonding force, induces intergranular cracks, and results in the formation of reticular crack. For the considered reticular crack samples, the distributions of elements, such as Cu, Cr, and Sn, near the reticular crack zone were detected using the line scanning analysis shown in Figure 8. The results indicate that the fillers in the reticular crack are Fe and O elements, and there are no obvious enrichments of Cu, Cr, or Sn within the scanning range. It is speculated that the copper mold worked as intended and that the chromium coating did not peel off. Therefore, the influence of residual elements on the reticular cracks is ruled out.
