Derek Kennet

Chapter 4

The Brick Temples in Trench A

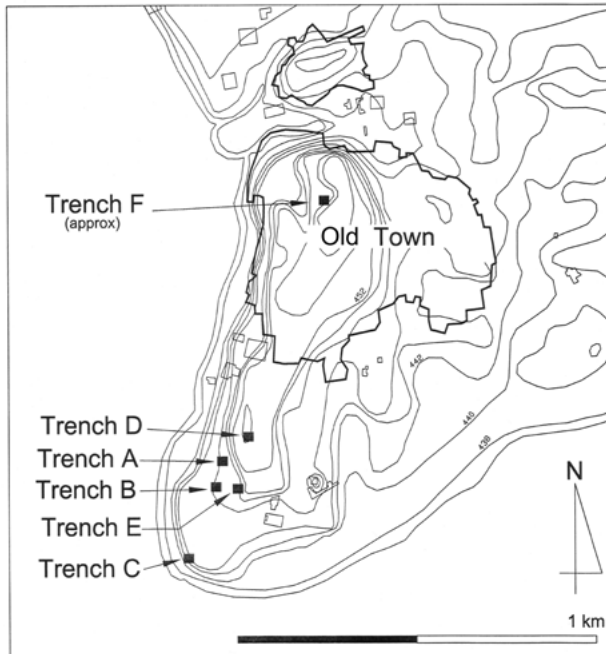
Fig. 4.1: Plan showing the central mound at Paithan and the location of the main trenches. Note that the trenches are not shown to scale in this plan.

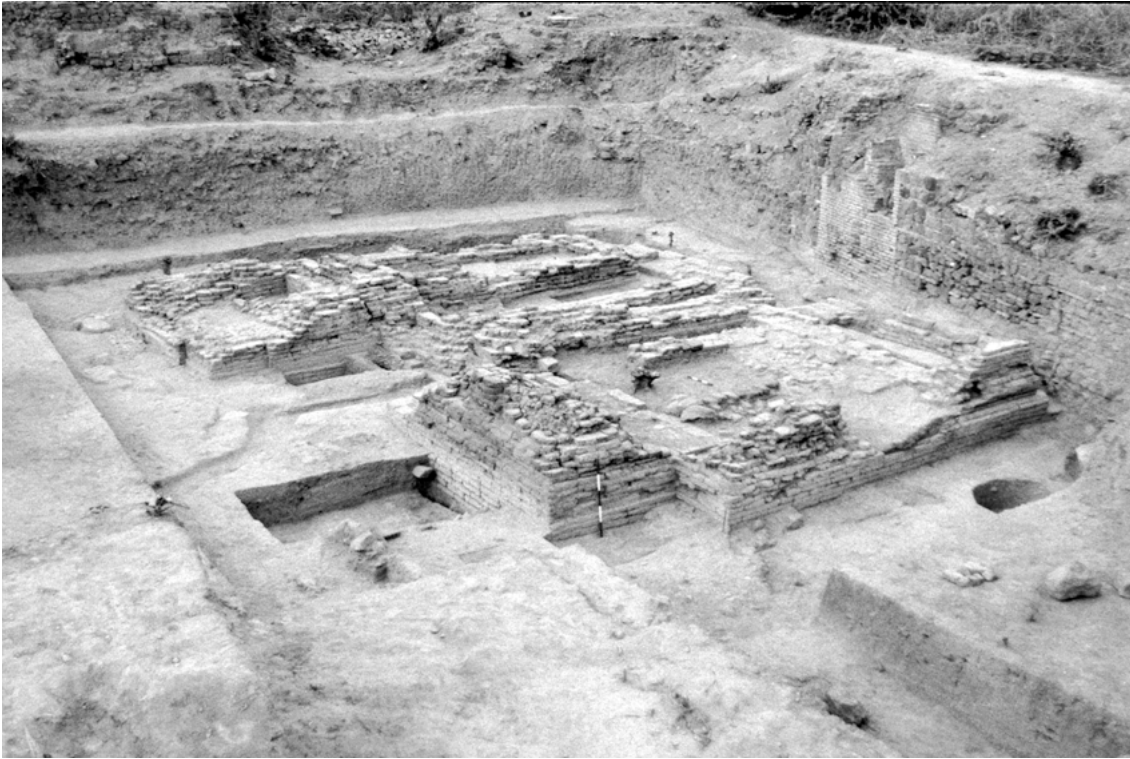
Fig. 4.3: View of Trench A from the south-west at the end of the 1998 season.

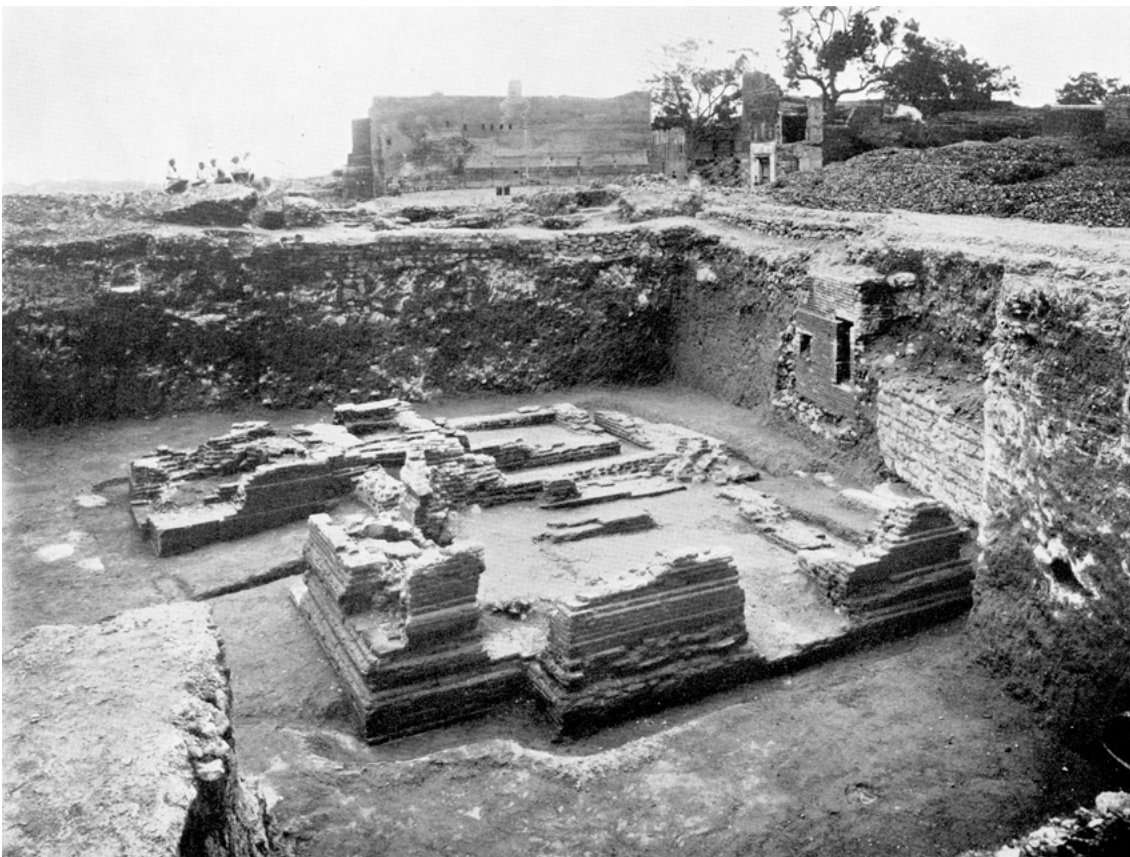
Fig. 4.4: Yusuf's photograph of the 1937 excavations showing the two brick temples from the south (from Yusuf 1938: pl. v; 1939: pl. XVIIb).

The photographs that Yusuf published of the same trench at the end of excavation suggest that the two brick structures that he uncovered at the lowest level of excavation were two early temples (Yusuf 1938: pl. V; 1939: pls

The best record of this wall is the photograph taken by Yusuf in 1937 shortly after the structure was first revealed (Fig. 4.4). In this photograph, it is clear that wall 383/544 still stood higher than the top of wall 556. Since then, the wall has survived very badly, possibly because it was not well made in the first place, and all that remained to be recorded in 1998 was a row of

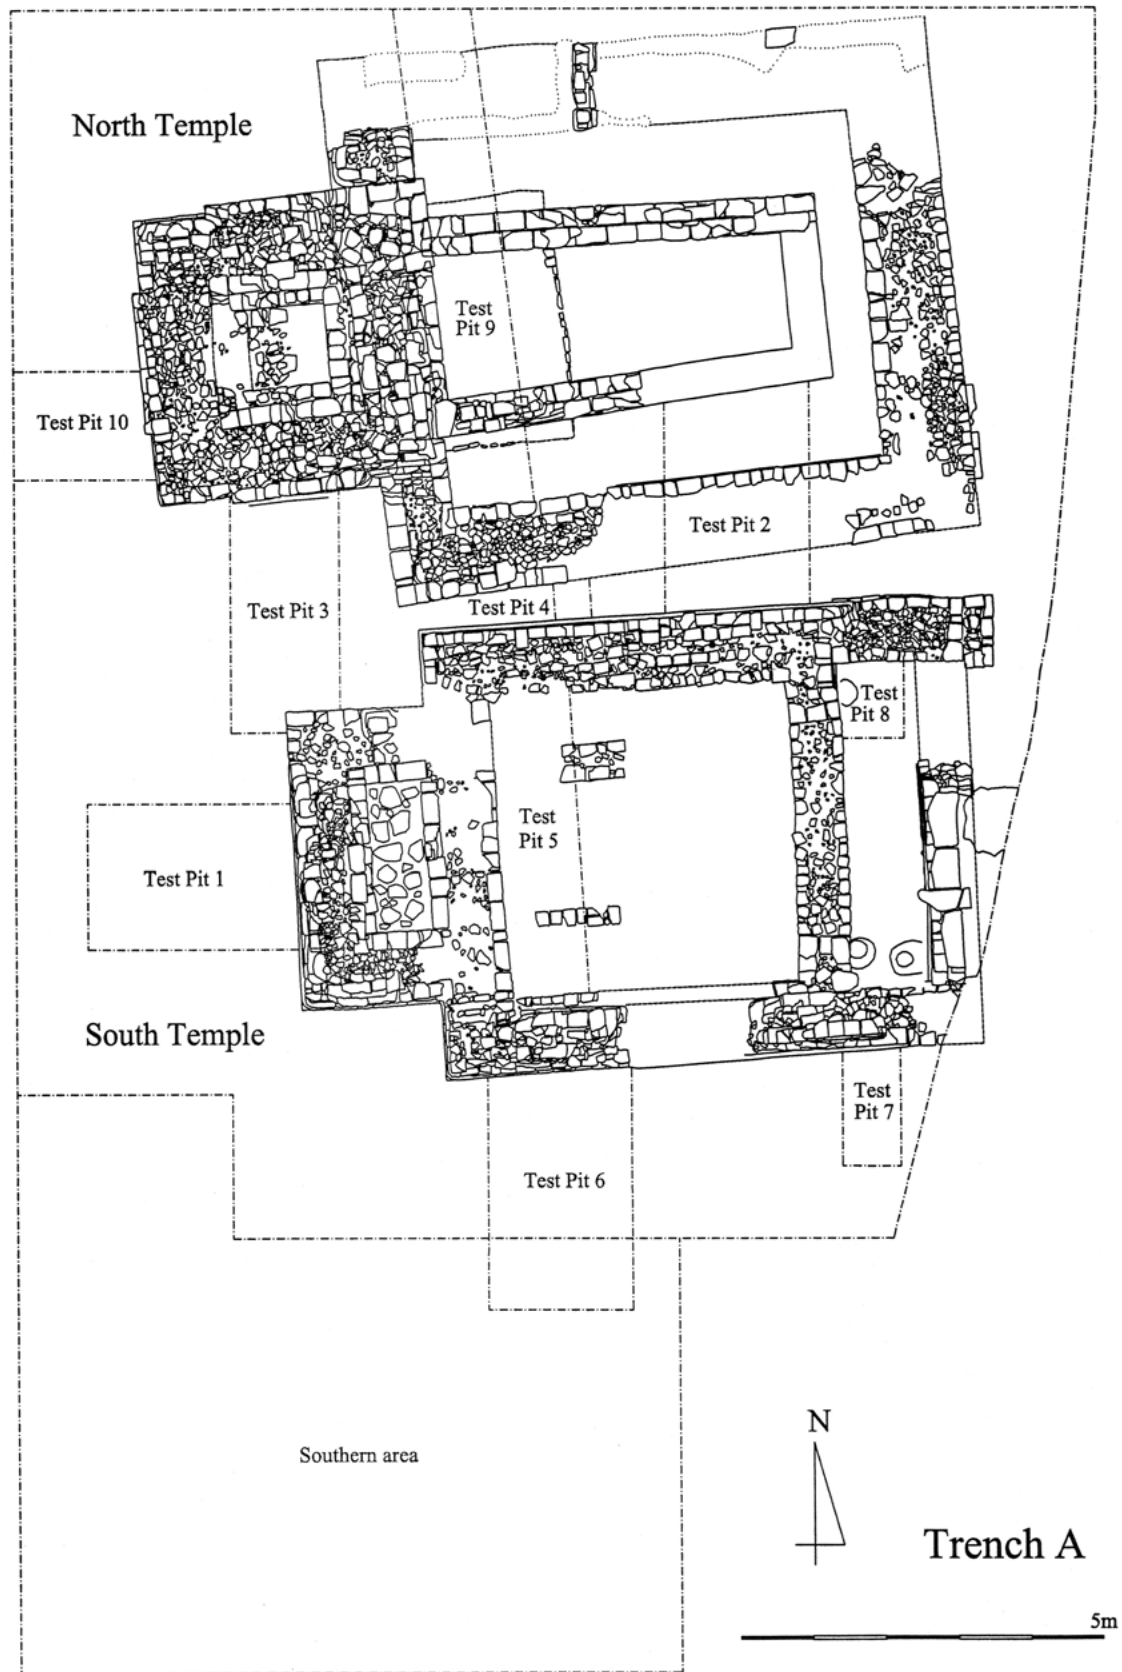
Fig. 4.5: Plan of Trench A showing the location of test pits and excavation areas.

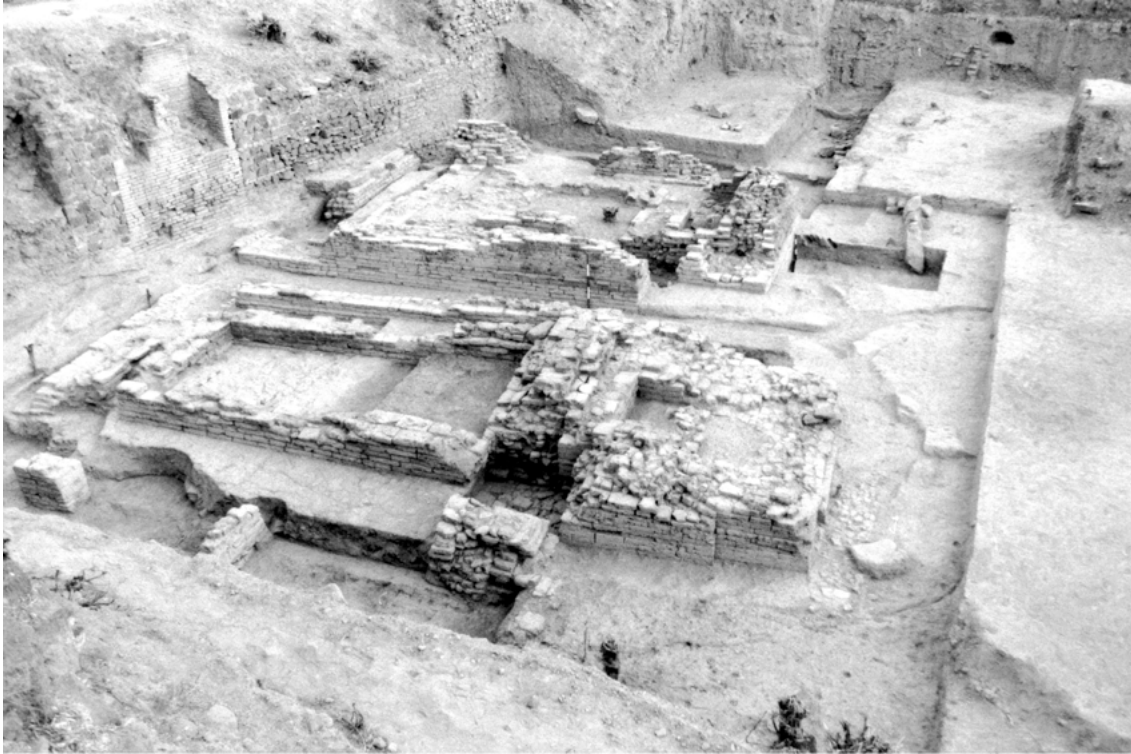
Fig. 4.6: General view of the temples from the north at the end of the 1998 season.

In the 1998 season, the two temples were carefully cleaned (Fig. 4.6). Brick-by-brick plans and elevations were made of both of them at a scale of 1:20 using an archaeological drawing frame. The temples were photographed and studied in detail and a preliminary architectural phasing was worked out. In the 1999

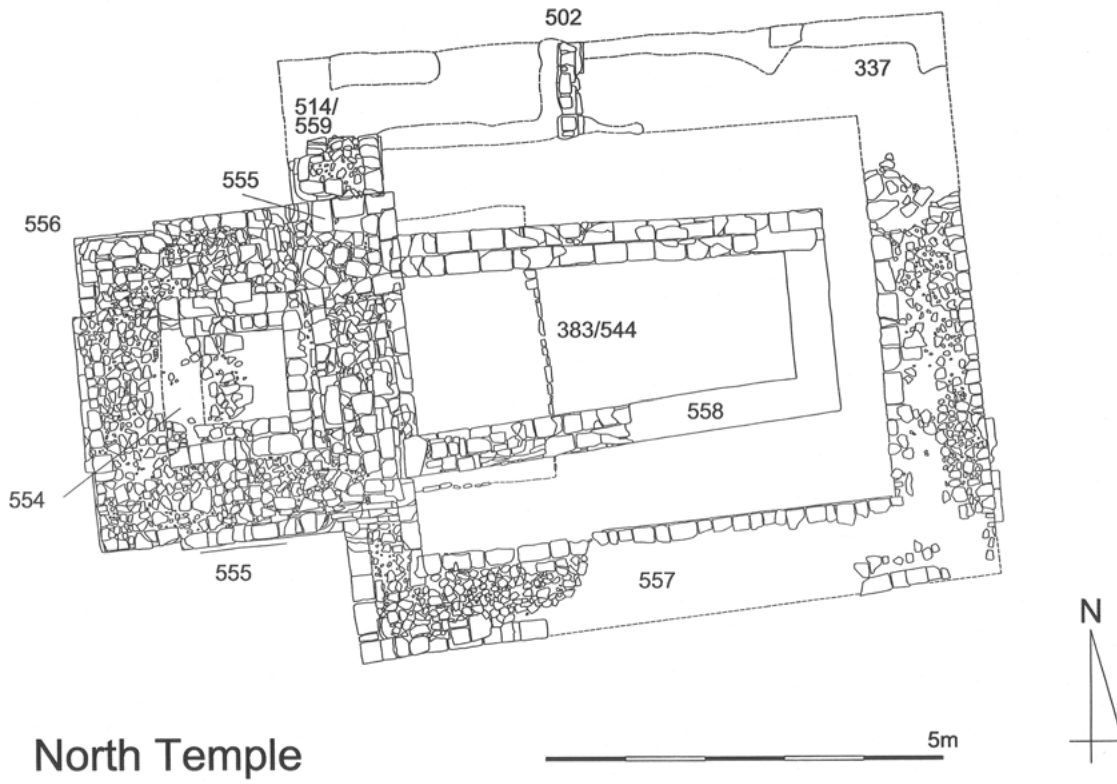
Fig. 4.7: Plan of the North Temple showing the locations of the main walls.

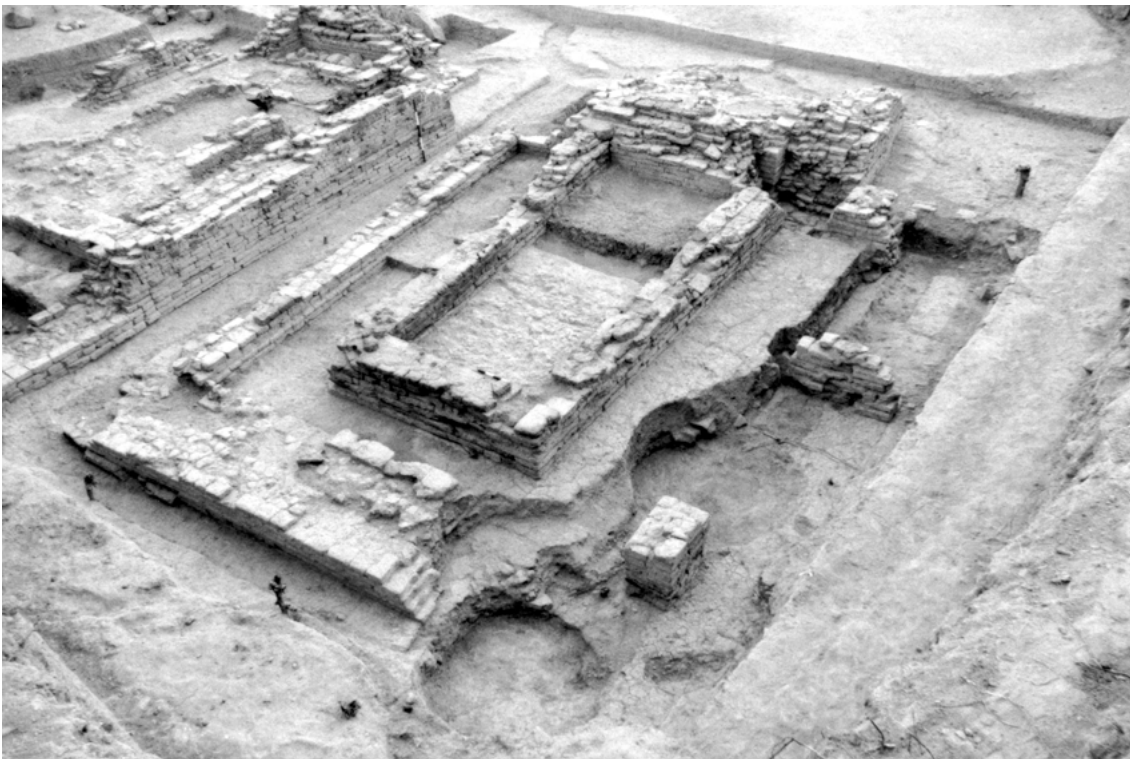
Fig. 4.8: The North Temple from the north-east.

The North Temple consists of a square sanctum with a tapering *mandapa* attached to its eastern side (Figs 4.7 and 4.8). The *mandapa* is subdivided by an internal wall which abuts the eastern face of the sanctum and forms a narrow passageway between itself and the *mandapa* wall. The maximum dimensions of the whole structure are 11.30 m east-west and 7.64 m north-south.

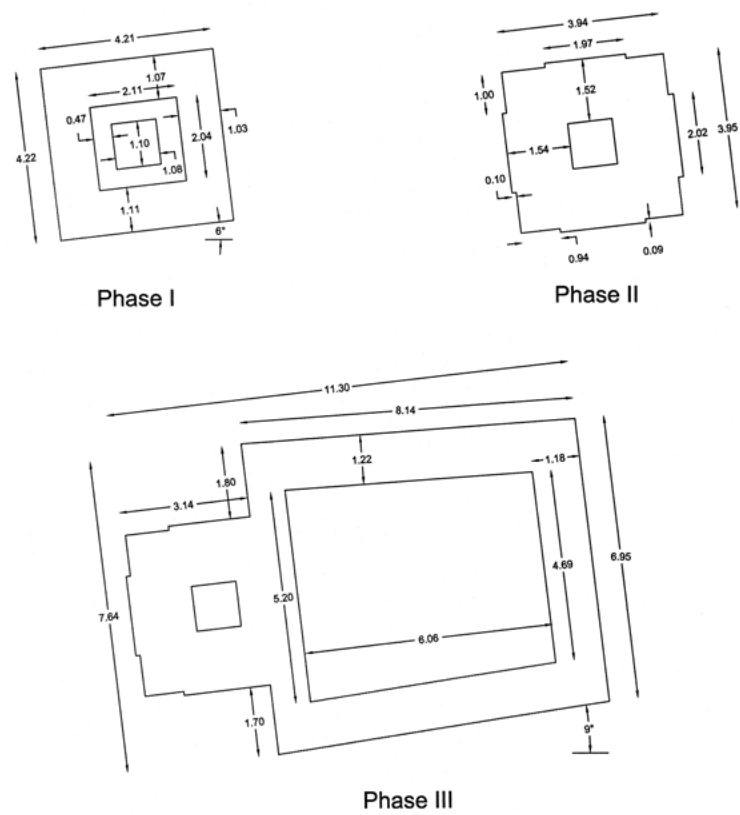
Fig. 4.9: Dimensions of the North Temple.

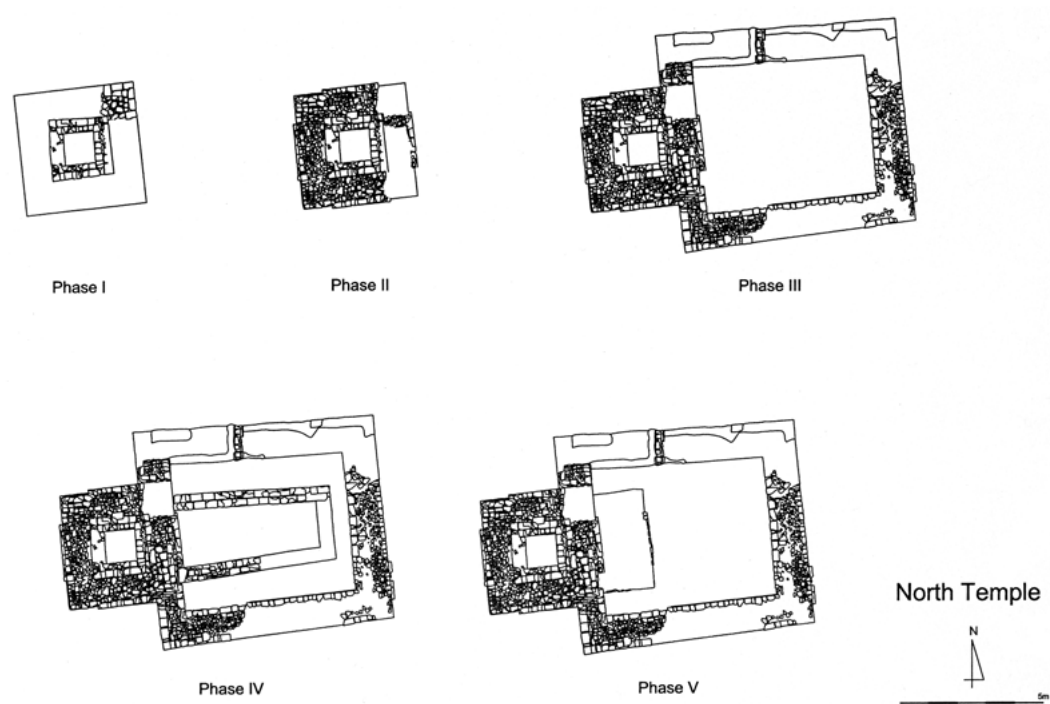
Fig. 4.10: Phases of the North Temple.

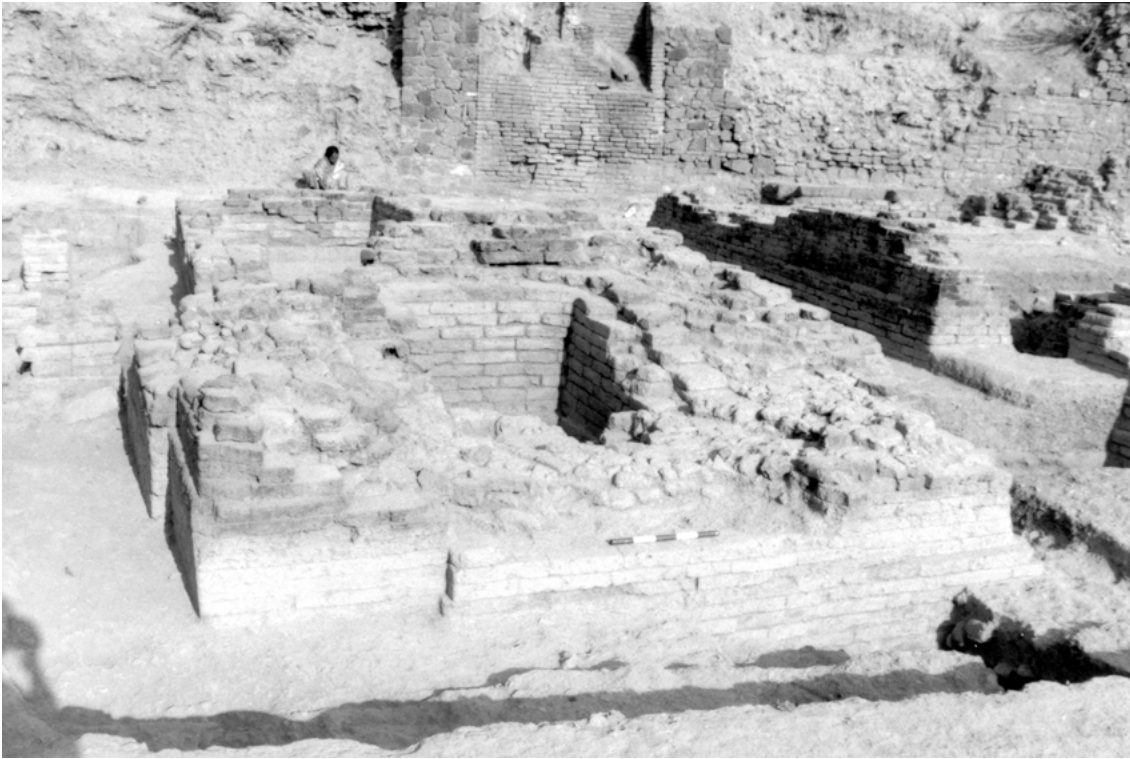
Fig. 4.11: The west end of the North Temple from the west.

The earliest phase consists of a small square shrine (wall 554) measuring about 2 m along each side, which is situated in the centre of a square brick platform (walls 555, 969) that was 0.55 m high and 4.2 m along each side (Fig. 4.11). The original height of the shrine is unknown as only 20 courses of the wall are preserved and no indications remain of the way in which it was roofed. In fact not very much of the structure is now visible as it is largely concealed by the thick Phase II wall (556) that was built on top of it. A later pit (341), however, has cut into the north-east corner of the Phase II wall and has exposed the construction of the Phase I shrine and platform. In addition, excavation of the fill of the *garbhagriha* and the levels below it has exposed the foundations of the shrine, as has Test Pit 3 that was

Phase II represents the construction of a structure (556) directly upon the Phase I platform, encasing the free-standing *garbhagriha*. The resulting construction is square, about 4.2 m along each side, with a *triratha* pattern of 10-cm projections along the central two metres of each face (Figs 4.7, 4.9, 4.11, 4.15). The wall is one-brick thick and stands on the outer edge of the Phase I platform. The space between this wall and the wall of the Phase I *garbhagriha* is filled with a thick hearting of roughly coursed brick bats and silt, resulting in a wall with a total thickness of about 1.5 m. Up to 13 courses of the wall are preserved on the south face, the lowest course being a levelling course resting directly upon the Phase I platform, some of the bricks of which have been thinned in order to establish a level base. There is evidence of a later rebuilding in the upper courses of the wall, which is discussed below (see 'Later use and robbing').

A series of rough brick-bat steps over the top of the remains of wall 556 indicate that there has been access to the ruined *garbhagriha* from the west or river side for some time (Figs 4.11 and 4.28). This may of course relate only to the period since the 1937 excavations, but the height of the walls surrounding the *garbhagriha* indicates that this is the only direction from which it could have been approached, at least during its final form. It therefore seems most likely that the shrine was also approached from this direction during its early stages of use, but it would be impossible to verify this without dismantling some of the later walls.

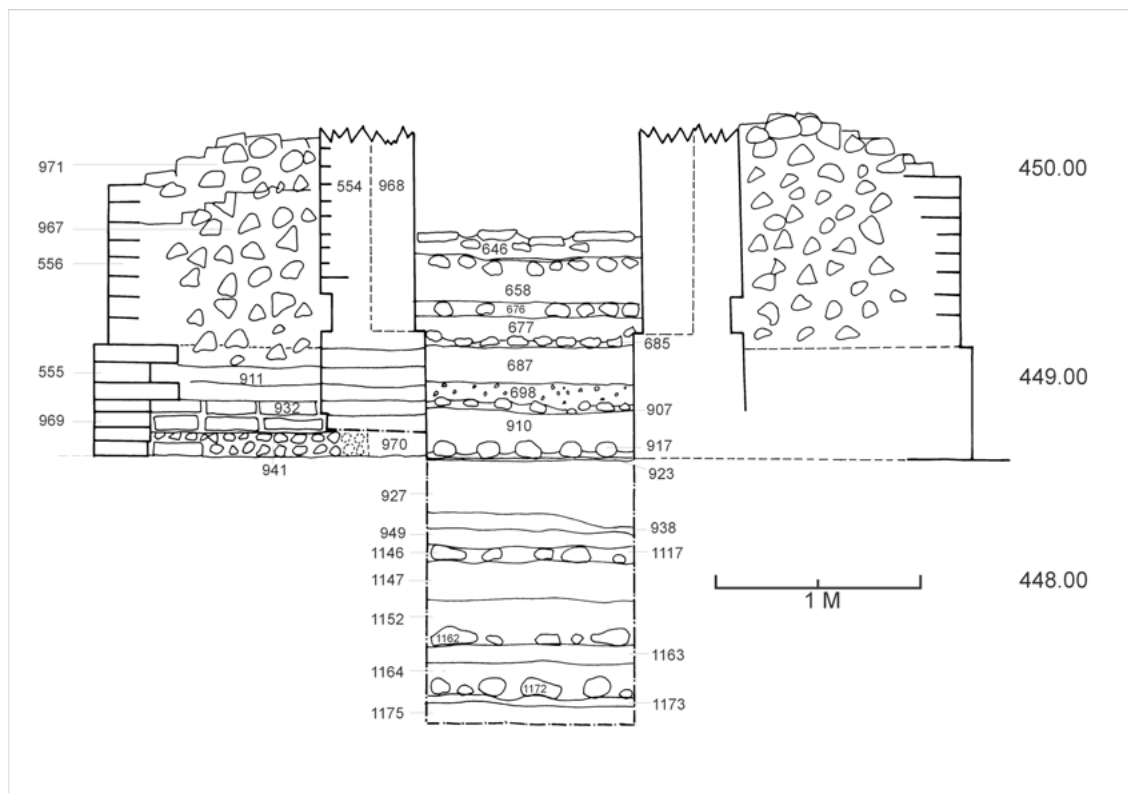
Fig. 4.12: Schematic section through the *garbhagriha* of the North Temple from the north.

Construction probably began with the lowest two courses of wall 554 (labelled 970) where the solid brick wall is thinner than it is above and the lowest courses of wall 555 (labelled 969) (Fig. 4.12). Once these walls were in place, loose rubble made up of silt, stone and brick (941) was deposited in between them and flattened. The upper part of wall 554 was then constructed, against which a two-course brick surface (932) was put down on top of 941. It is possible that construction of the platform stopped at this point, at which time it would have been about 30 cm high, and that the upper part of wall 555 and the related fill (911) represent a later phase of construction. Alternatively, it is possible that the platform was simply built in two stages. The top of 911 was destroyed by the cut of the pit

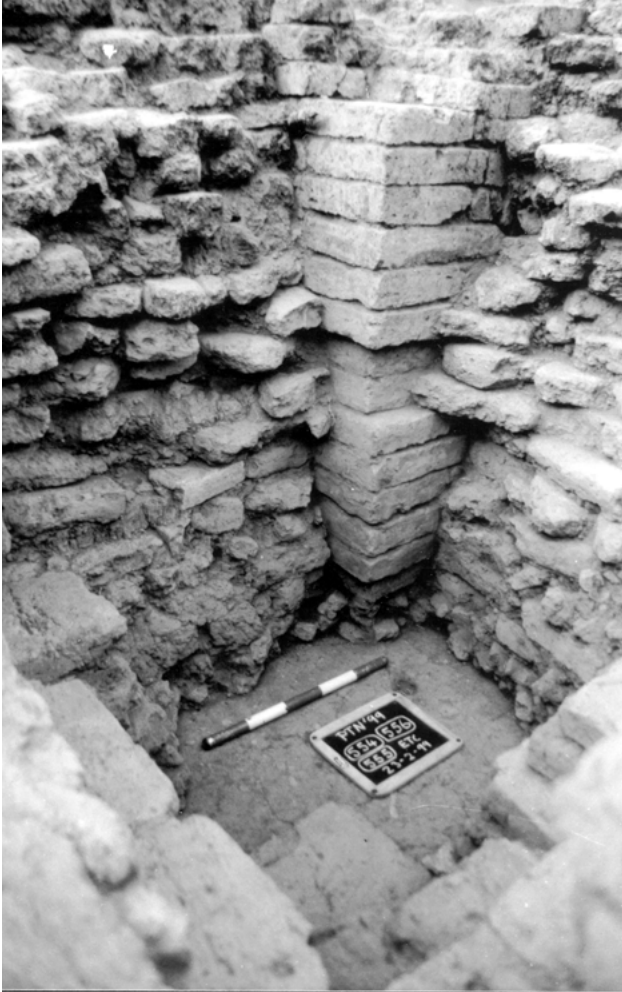
Fig. 4.13: The Phase I structure of the North Temple showing wall 554 and the simple 'Ramtek-like' moulding exposed in a post-Medieval pit cut.

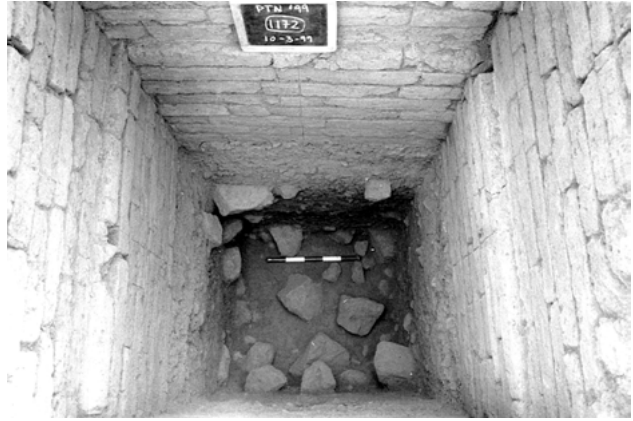
Fig. 4.14: The *garbhagriha* of the North Temple after excavation to the lowest foundation fill of boulders. Note the vertical incised lines in the middle of each wall beneath the level of the blackboard.

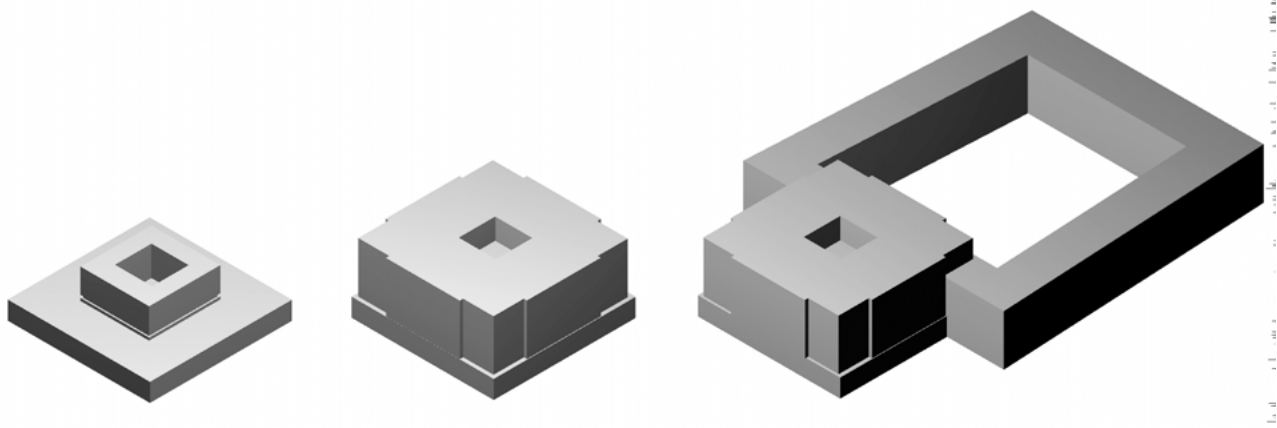
Fig. 4.15: Isometric reconstruction of Phases I, II and III of the North Temple from the south-west.

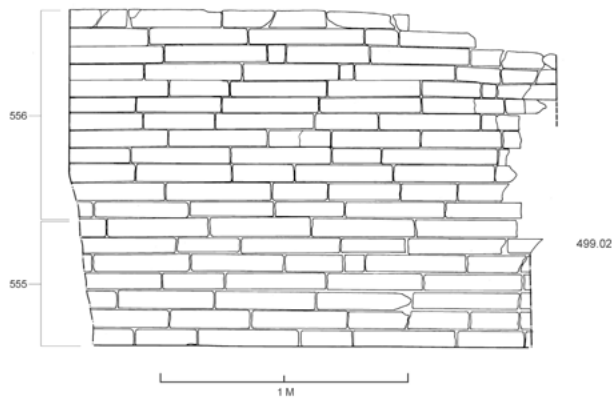
Fig. 4.16: Elevation of walls 555 and 556.

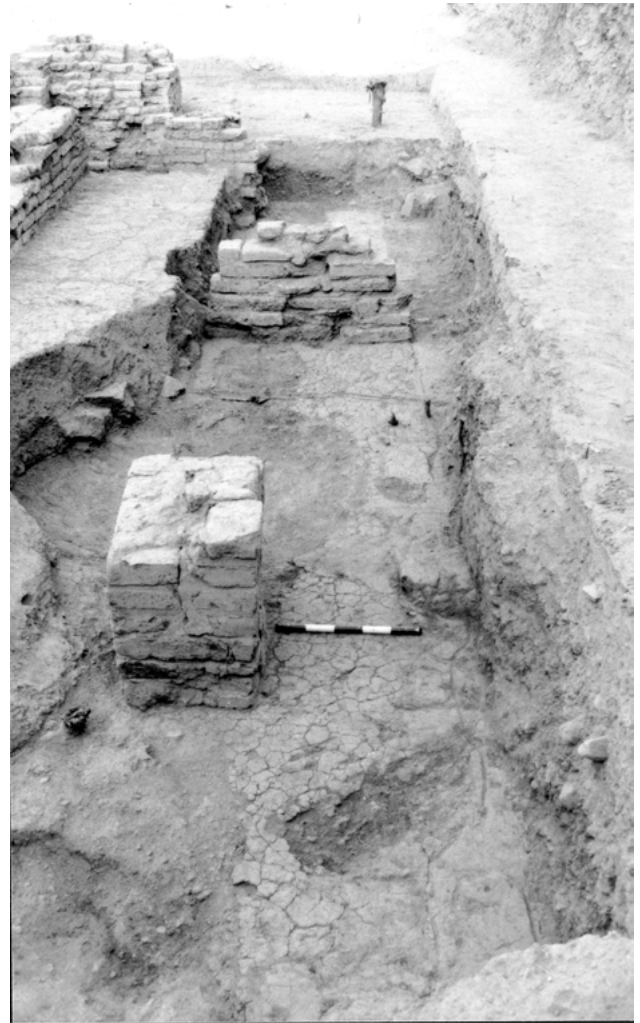
Fig. 4.17: The robbing on the north side of the North Temple from the east.

Wall 557 is preserved only in a few places. On the north side, it was removed by robbing, leaving only two stumps standing (502 and 514) (Fig. 4.17). The exact location of the original wall is, however, discernible due to the preservation of the lowest course of mud mortar in the bottom of the robber cut. At the east end, the wall has not been robbed but it has been damaged and partly concealed by later rebuilding and restoration. Along the south side, most of the south face of the wall has also been removed by robbing so that only two stretches of the original outer face are preserved. At the west end of the south side, where the wall abuts the Phase II structure, the wall is better preserved and stands a maximum of 11 courses high.

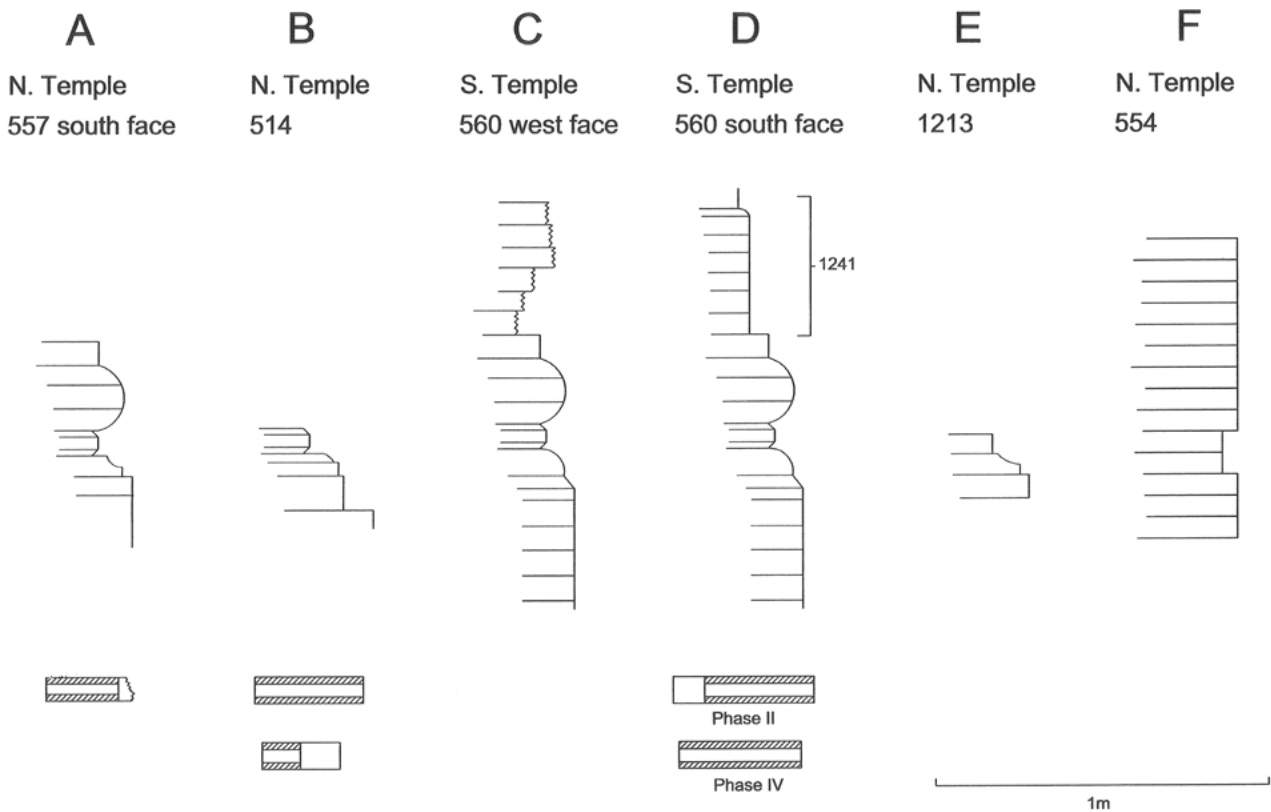
Fig. 4.18: Details of plinth mouldings from various walls from both the North and South Temples.

It should be noted that the double chamfered bricks of the Phase II walls have a particular feature that is not present in the Phase IV mouldings. At one end of each brick, a short 9-cm section has been left unchamfered (Fig. 4.18D). This end is always laid towards the south on the west face and towards the east on the south face. These bricks have the appearance of a simple fluted pilaster with a square base laid on its side. The equivalent bricks of the Phase IV mouldings are chamfered along their whole length.

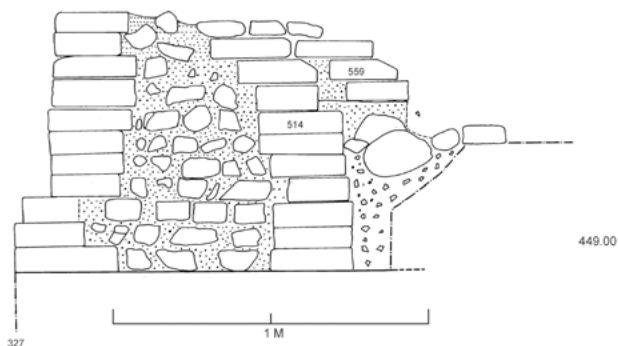
Fig. 4.19: East-west section through wall 514 showing extra face 559/1213.

As can be seen in Fig. 4.19, a crude later facing (559) was added to wall 514 which included similar mouldings at the same height, although the base of the facing is much higher than the base of the original wall. This represents a later thickening of the wall to the west, the reason for which is not known. This part of the wall has had its stratigraphic relationships removed by robbing and later excavation, making it impossible to understand the circumstances or date of this development. There is no evidence for a similar thickening anywhere else on the wall.

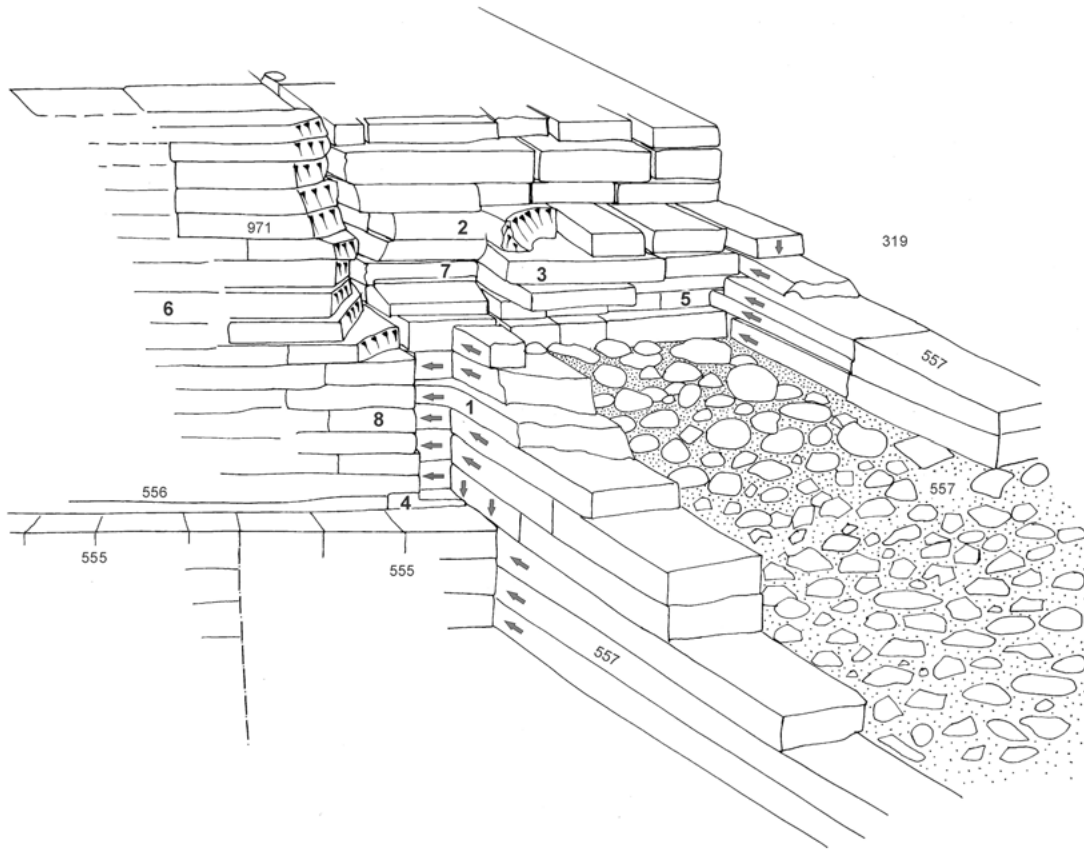
Fig. 4.20: Sketch of the joint between walls 556 and 557 at the southwest corner of the North Temple from the south-west. Arrows indicate where a brick abuts another.

2. Although broken, this brick, in the middle of the curved moulding, is 'L' shaped, suggesting that it turned the corner from the south face to the west face. It is too broken to be certain.

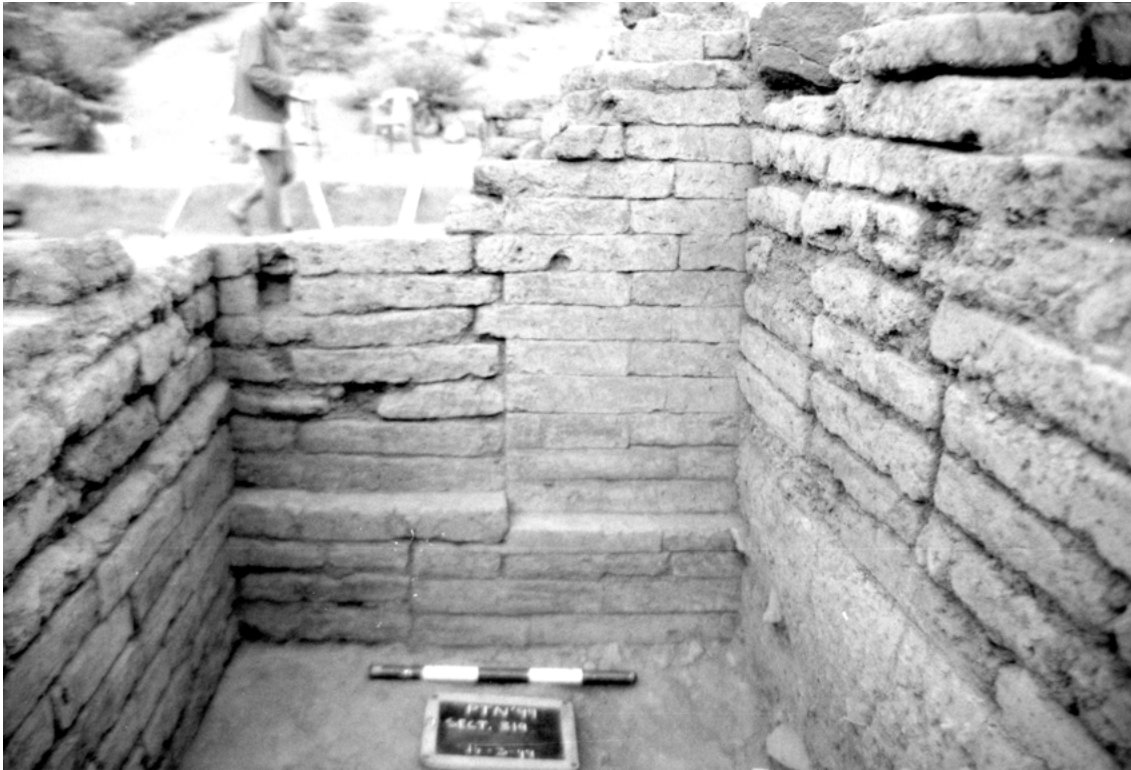
Fig. 4.21: The joint between the Phase II and Phase III brickwork of the North Temple, looking west in the southern half of the *mandapa*, with wall 558 to the immediate right.

Fig. 4.21 shows the same joint between the two phases, this time looking towards the west from the interior of the southern aisle of the *mandapa*. Here it can be seen that the lower courses of the *mandapa* clearly abut and overlie the Phase II wall and platform, with some brick cutting and inter-keying that must have been achieved by the removal and replacement of bricks in wall 556. In Fig. 4.21, a slight decline in the quality of the jointing of the Phase II brickwork is evident above about the 10th or 11th course, which may be indicative of a later rebuilding above at this point.

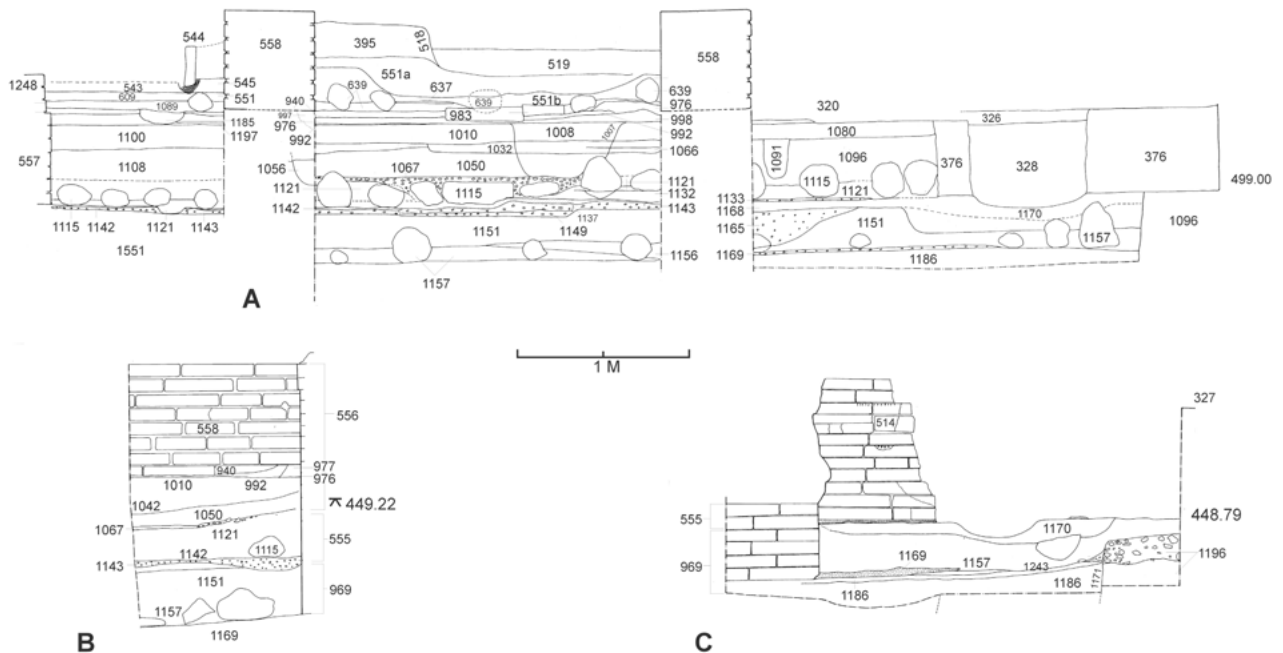
Fig. 4.22: Test Pit 9 sections. (A) Composite section across the whole test pit and the *mandapa* of the North Temple looking west. (B) East-west section against wall 556 below the southern part of wall 558 where it crosses the test pit. (C) The western section of the test pit to the north of the Phase I structure showing the edge of foundation cut 1171.

bricks and tiles standing on end in lime mortar within a shallow cut and a row of brick bats and tiles lying on the soil retained behind them (Figs 4.22 and 4.26). The presence of lime mortar demonstrates that these were placed here during the 1967 restoration and probably represent a rather desperate attempt to preserve an already very badly damaged structure. They serve only to indicate the approximate location of the wall, and perhaps the bricks and tiles from which it was built.

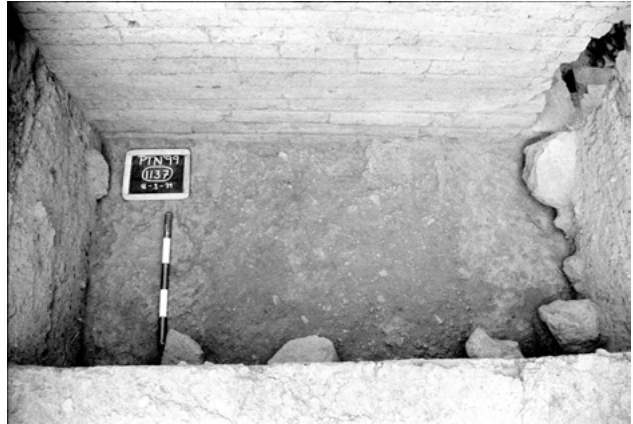
Fig. 4.23: Feature 1137, the earliest evidence for a possible shrine in the west end of the *mandapa* of the North Temple.

The addition of a *mandapa* to the east of the Phase II shrine is problematic because it would appear to indicate that the entrance to the Phase II shrine was from the same direction. As has been noted above, however, there is absolutely no evidence that the Phase II shrine was ever open to the east; indeed, it is more likely that the entrance was from the west, towards the river. In this respect, the traces of possible cultic activity uncovered by Test Pit 9 from the earliest levels inside the west end of the *mandapa* are very important (Fig. 4.22) (see Section 2 of this chapter). Although no sculpture has come to light, a stratigraphic succession of at least three rectangular impressions or arrangements of bricks against the eastern wall of the Phase II structure within the *mandapa* indicates that this place was most likely used for cultic activity, albeit consisting of simple, crude constructions. The earliest shrine (1137), a simple rectangular depression, is located directly on top of the *mandapa* foundation deposits (Fig. 4.23). Evidence for a second shrine was found immediately

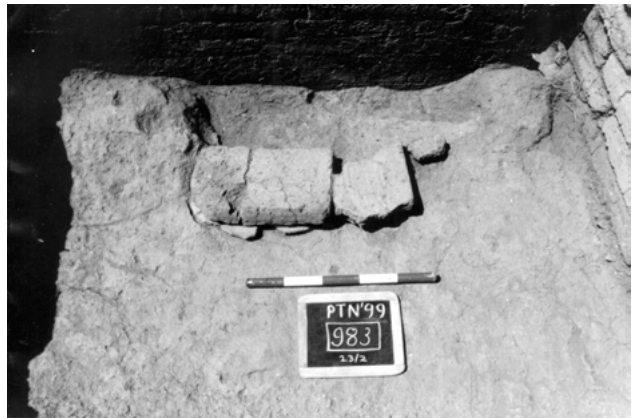
Fig. 4.24: North Temple, showing the remains of a possible simple shrine 983 against the western wall of the Phase III *mandapa*.

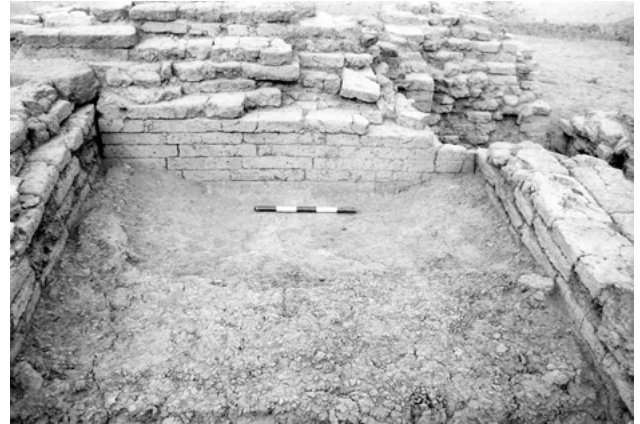
Fig. 4.25: Photo of the rectangular depression in layer 551 that might indicate the location of a shrine.

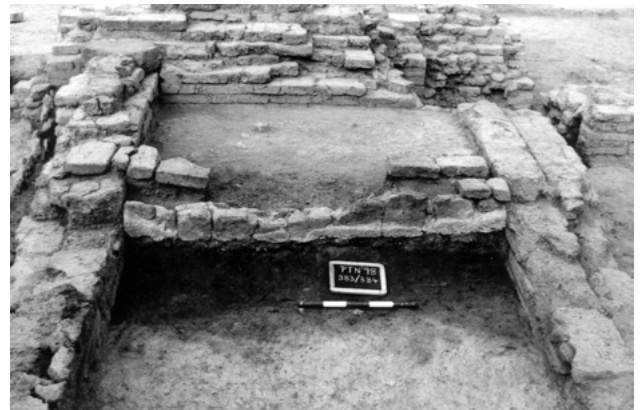
Fig. 4.26: Wall 383/544 of Phase IV in the North Temple before the excavation of Test Pit 9.

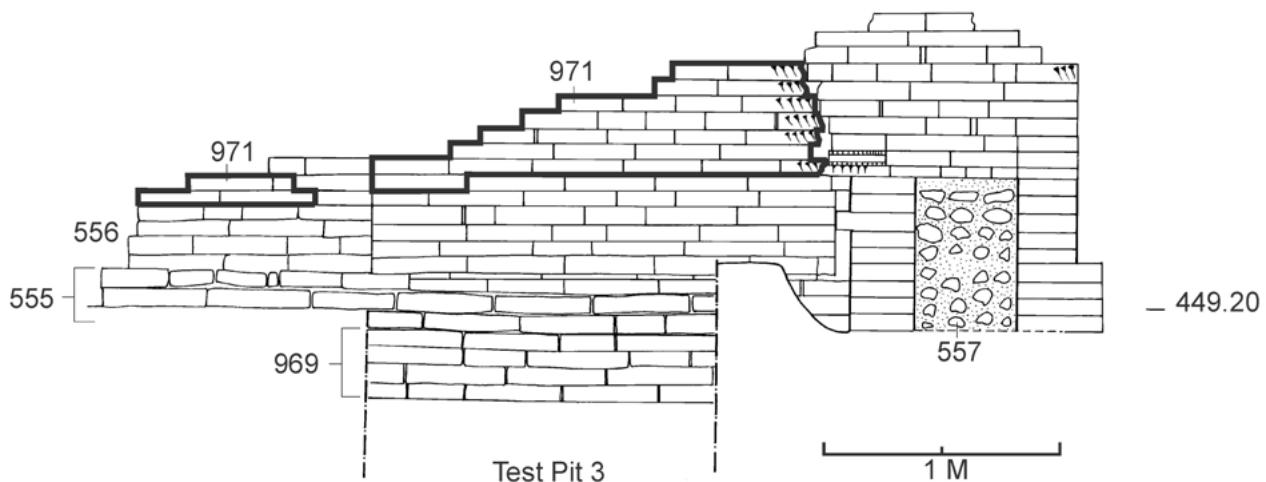
Fig. 4.27: Schematic section/view of the *garbhagriha* wall of the North Temple looking north showing the extent of later rebuild 971.

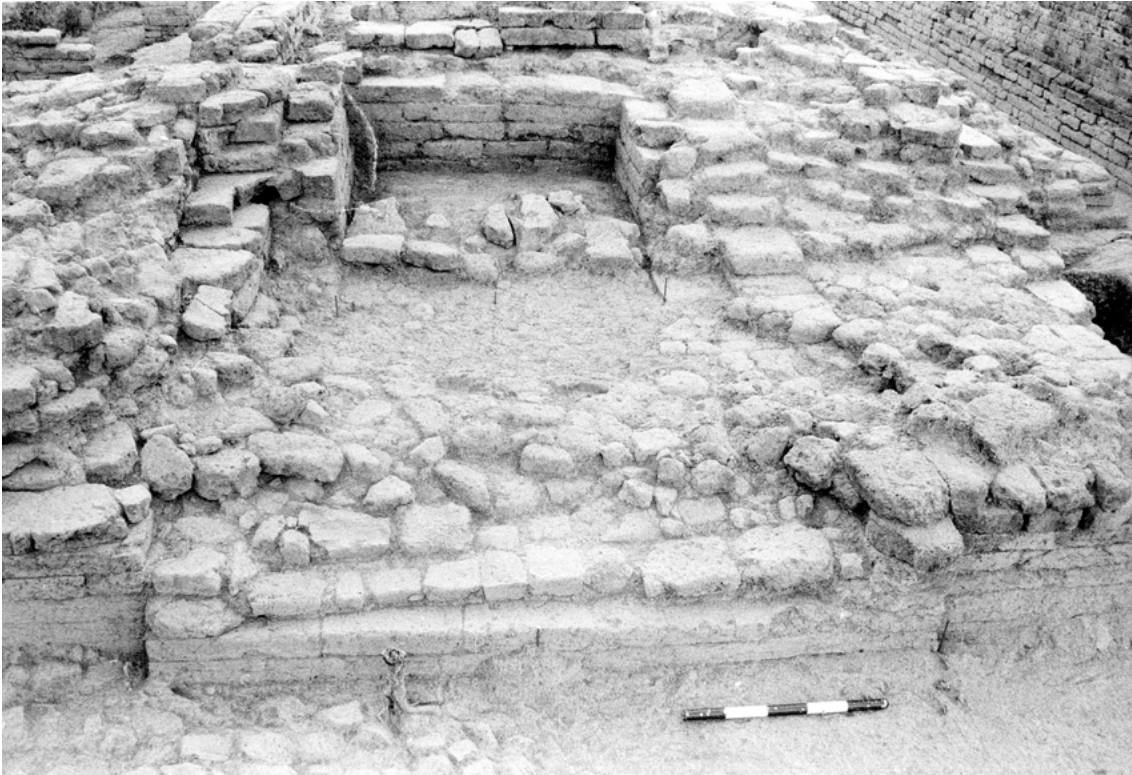
Fig. 4.28: The *garbhagriha* of the North Temple from the west showing possible evidence of late use.

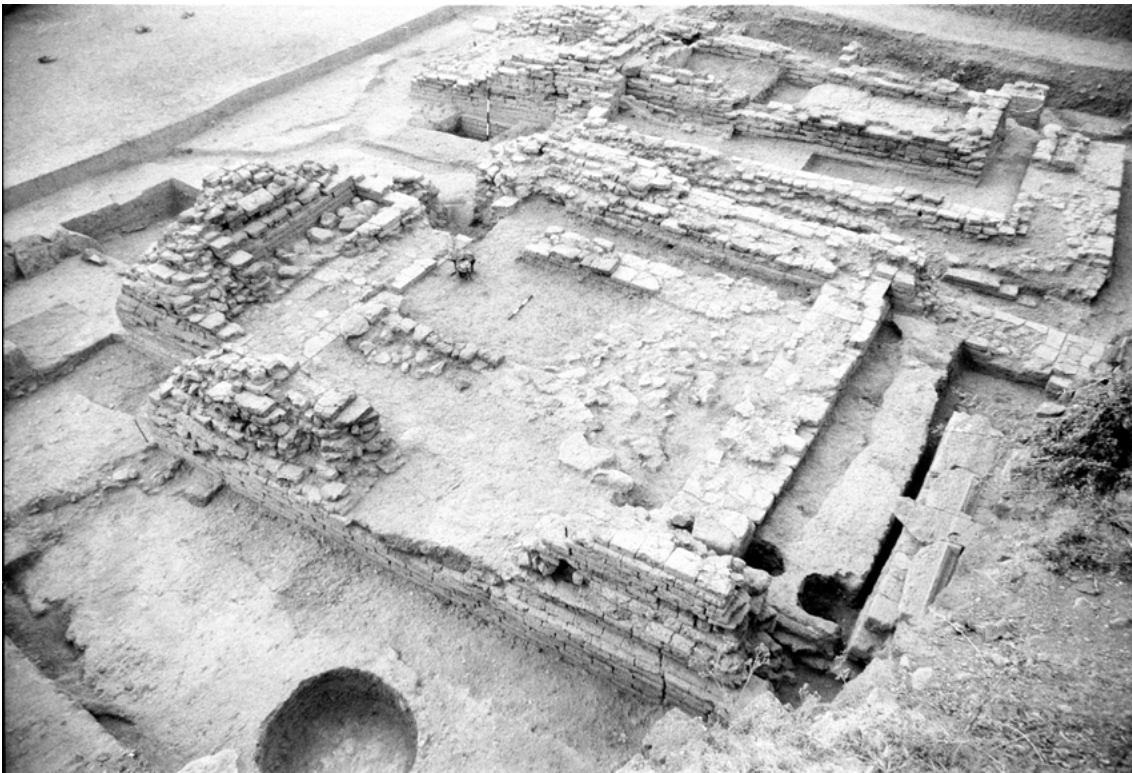
Fig. 4.29: General view of the South Temple from the southeast during excavation.

The South Temple consists of a rectangular *garbhagriha* with a rectangular *mandapa* attached to its eastern side (Figs 4.29 and 4.30). The *mandapa* was once subdivided by a north-south wall towards its eastern end, and the fragmentary remains of further internal walls are also preserved. The maximum dimensions of the whole structure are 9.4 m east-west and 6.25 m north-south (Fig. 4.31). As with the North Temple, this temple is not oriented precisely east-west. The main axis is oriented just under 4° south of magnetic west (266° measured with a prismatic compass in February 1998), which is about 1° different from the orientation of the North Temple. The reason for this difference is not clear. The South Temple is located immediately to the south of the North Temple, being separated by a minimum distance of less than 1 m from the southern wall of the North Temple.
