Derek Kennet

Chapter 4

The Brick Temples in Trench A

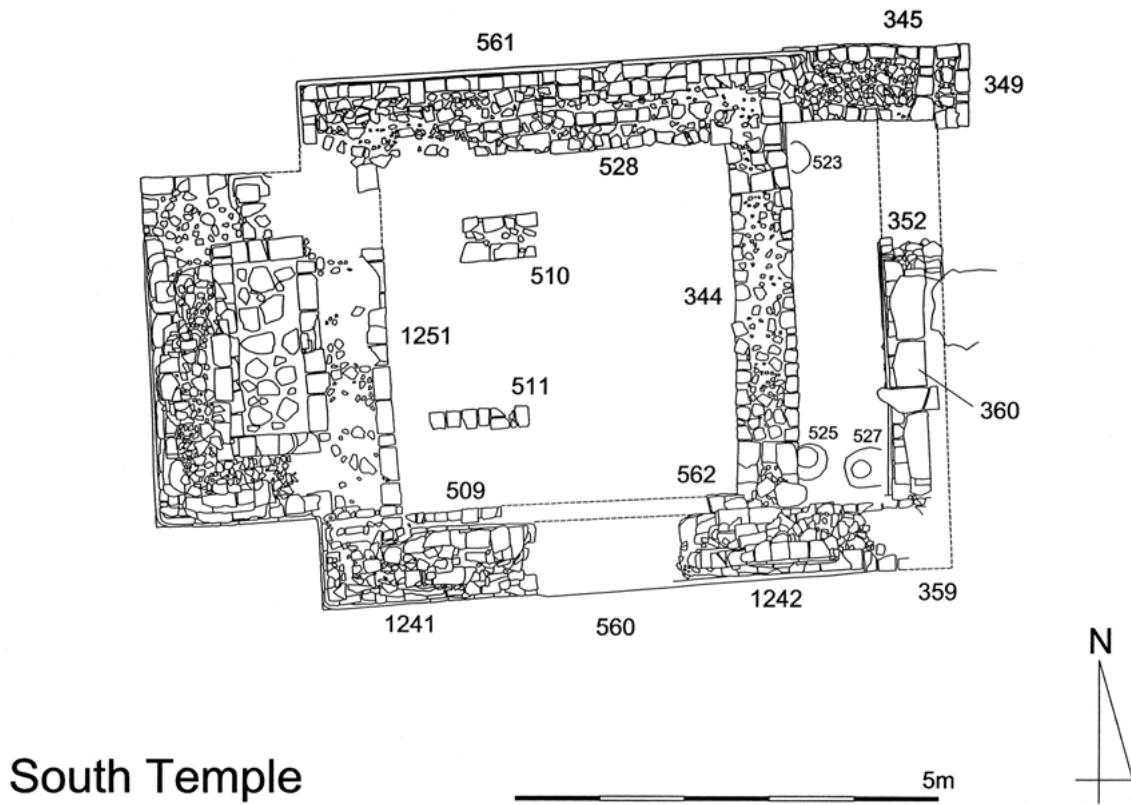
Fig. 4.30: Plan of the South Temple showing the location of the main walls.

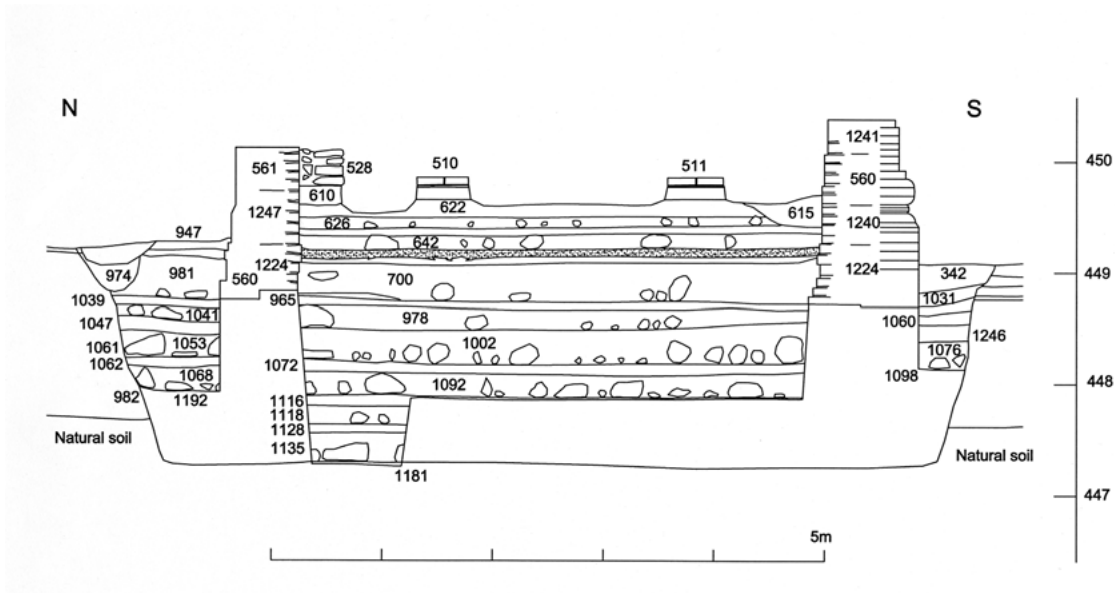
Fig. 4.33: West-facing composite section across the South Temple showing foundations.

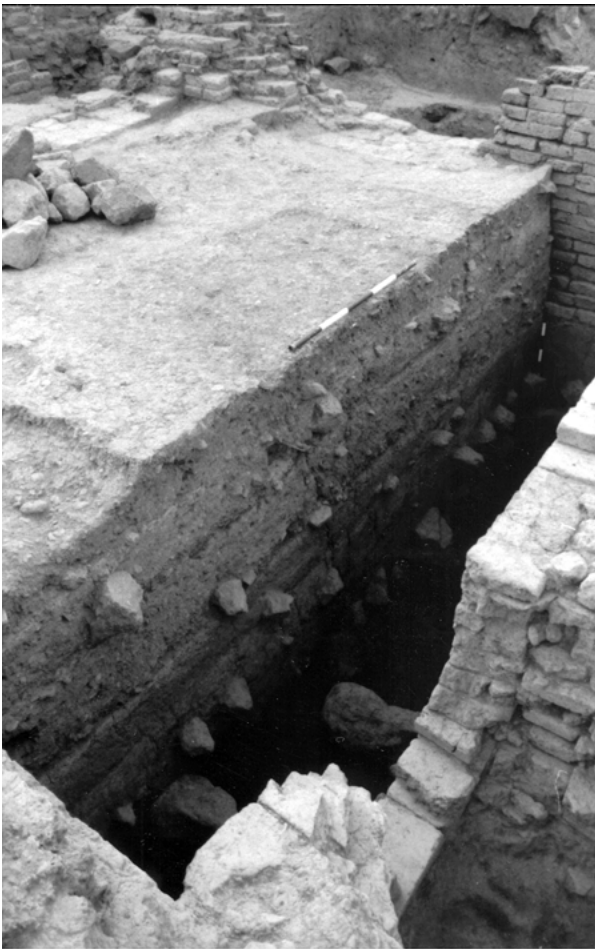
Fig. 4.34: View of the eastern section of Test Pit 5 across the interior of the South Temple looking south-east showing the successive foundation fills.

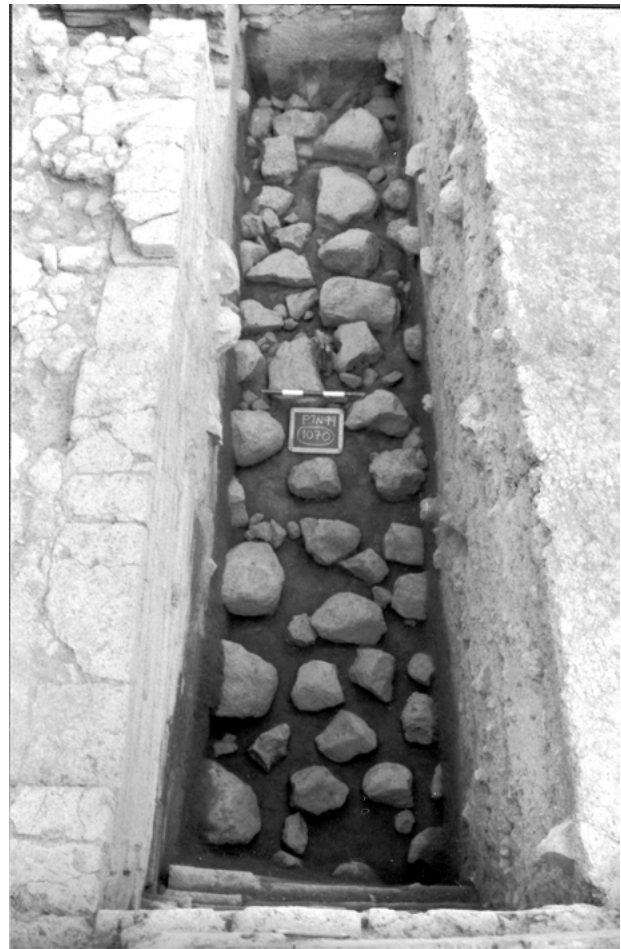
Fig. 4.35: Interior of the South Temple during excavation of Test Pit 5 showing a level of foundation fill consisting of small boulders.

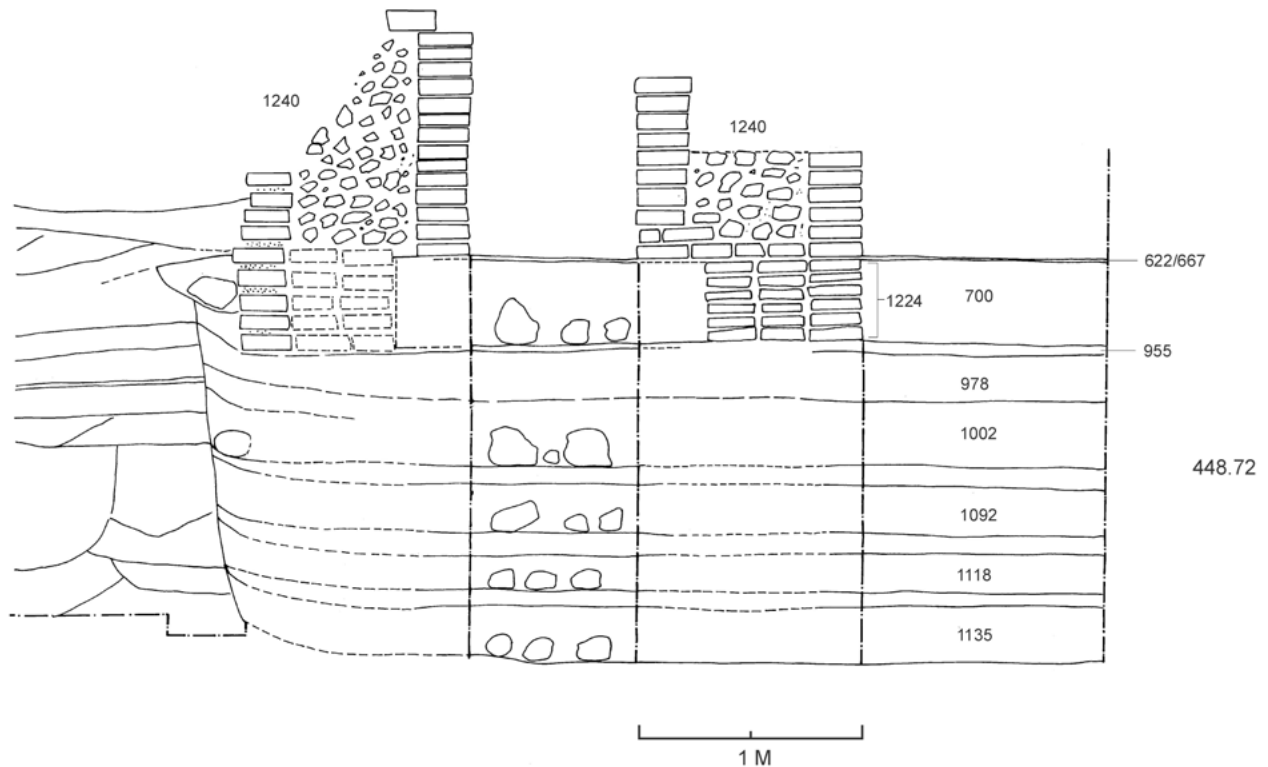
Fig. 4.36: Composite east-west section through the west end of the South Temple looking north.

As has been mentioned above, the Phase II walls around the *garbhagriha* are as much as 35 cm thicker than the Phase I walls (Fig. 4.36). This caused the space within the *garbhagriha* to be considerably reduced during Phase II. In Phase I, there had also been a wide opening between the *garbhagriha* and the *mandapa*, but this opening may have been narrowed during Phase II by the construction of wall 1251, which probably supported the walls on either side of a doorway, but there is no trace of the doorway so it is impossible to know how wide the opening was during this phase.

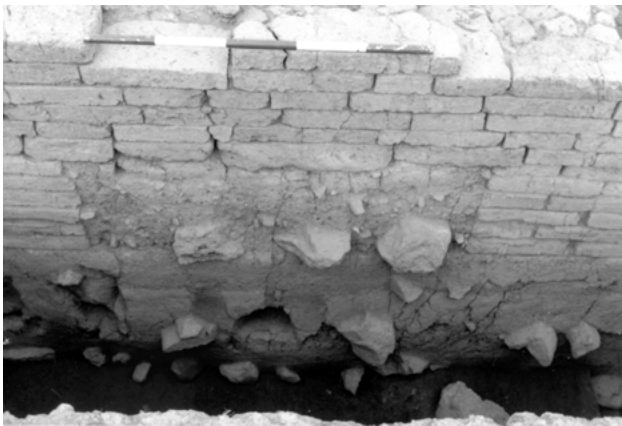
Fig. 4.37: The wall between the *mandapa* and the *garbhagriha* in the South Temple looking west during the excavation of Test Pit 5. The Phase I gap in this wall can be clearly seen below the Phase II wall.

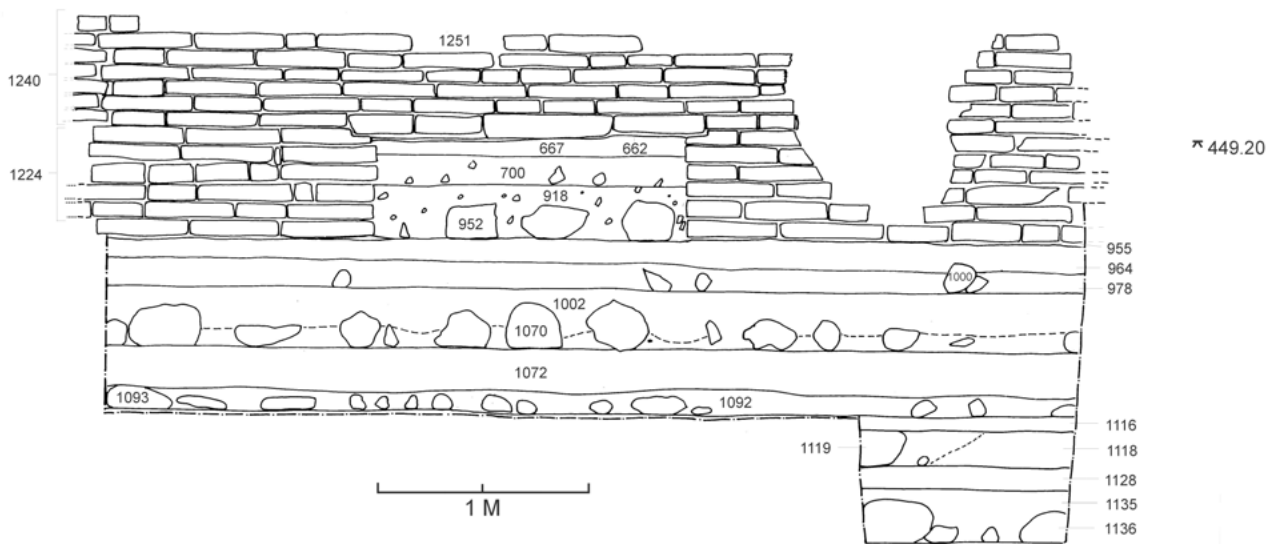
Fig. 4.38: Western section of Test Pit 5 across the South Temple in front of the wall between the *garbhagriha* and the *mandapa*.

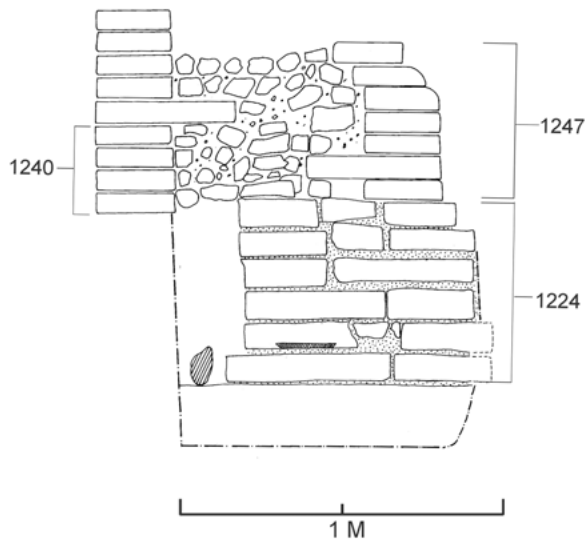
Fig. 4.39: Cross-section of walls 1247 and 1224 South Temple.

Upon excavation, it became clear that the first four brick courses above foundation wall 1240 are built of a different masonry to the higher superstructure of the temple (Fig. 4.39). The lowest of these is a levelling course, using split or wedge-shaped bricks to create a level platform out of the Phase I wall. After the construction of the Phase II walls, the interior was raised using another sequence of silt/stone foundation layers similar to those described above, which was then capped by a floor, some 20 cm higher than the Phase I floor.

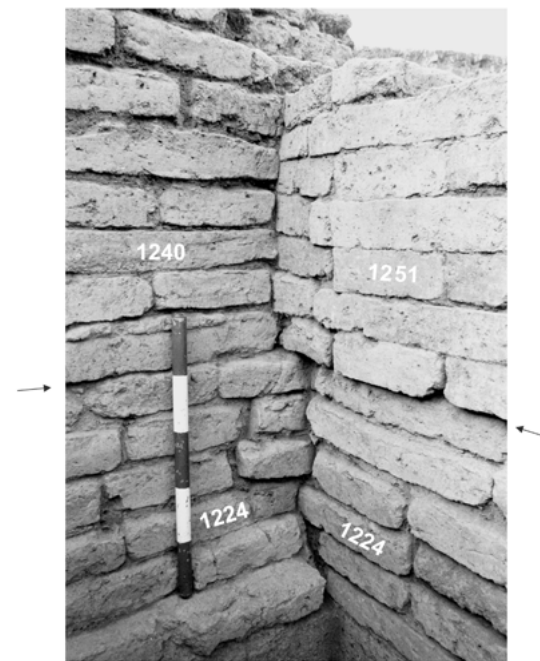
Fig. 4.40: View of the corner formed by walls 1240/1251 and 1224 in the southwest corner of Test Pit 5 looking southwest. The arrows show the boundaries between the upper and lower walls. The inter-bonding between walls 1240 and 1251 is clearly visible just to the right of the corner and the difference in the quality of the brickwork of the two walls is also clear.

Walls 1240/1247 and 1251 are crudely inter-bonded (Fig. 4.40), suggesting that the Phase II structure was built in stages, but it is difficult to establish exactly what the sequence was and why it should have been built in this way.

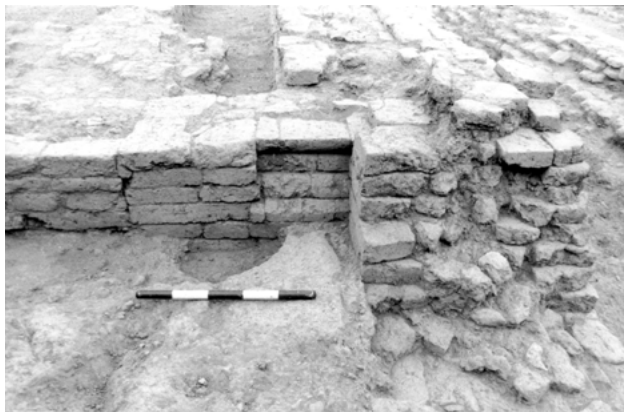
Fig. 4.41: Remains of mouldings in wall 1240 at the eastern end of the South Temple looking west.

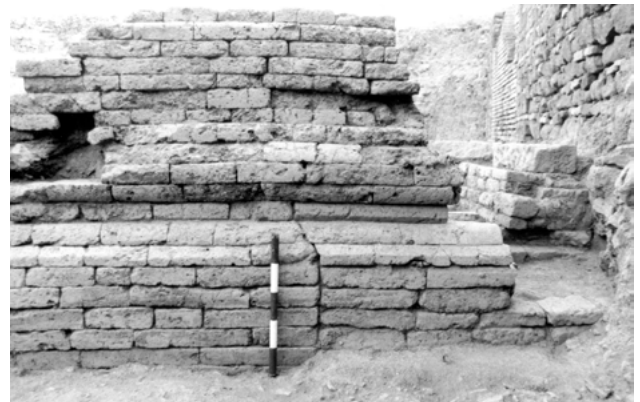
Fig. 4.42: View showing the eastern end of the south wall of the South Temple looking north (see Fig. 4.46 for a key to wall numbers).

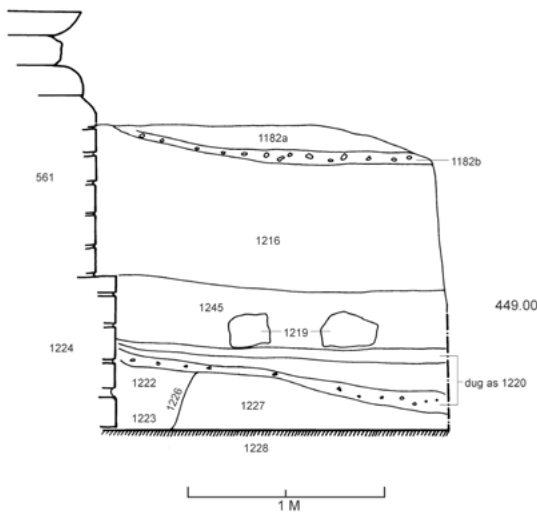
Fig. 4.43: South-facing section of Test Pit 8 showing the sequence of floors that abut the eastern face of the Phase I – III walls of the South Temple.

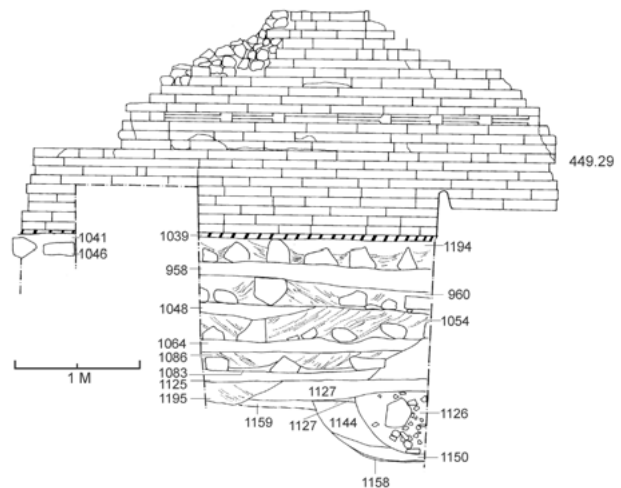
Fig. 4.44: Elevation of the western wall of the South Temple above the eastern section of Test Pit 1 showing the fills of the temple foundations.

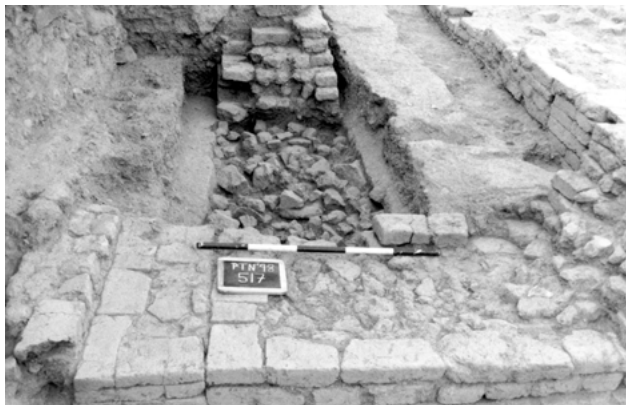
Fig. 4.45: The robbed-out wall 352 at the east end of the South Temple looking south.

have been visible within the temple. A small section of brick-bat flooring (353) is preserved to the eastern side of wall 352, and this may indicate the floor level of Phase IV, although it may also be somewhat later. Wall 352 was much later robbed out along its northern half, revealing details of construction and foundation (Fig. 4.45).

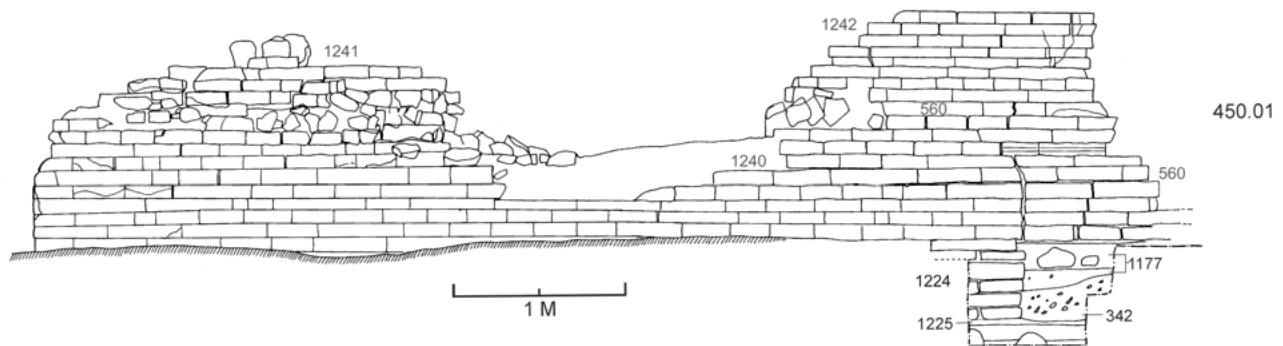
Fig. 4.46: Elevation of the southern face of the southern wall of the South Temple (wall 560).

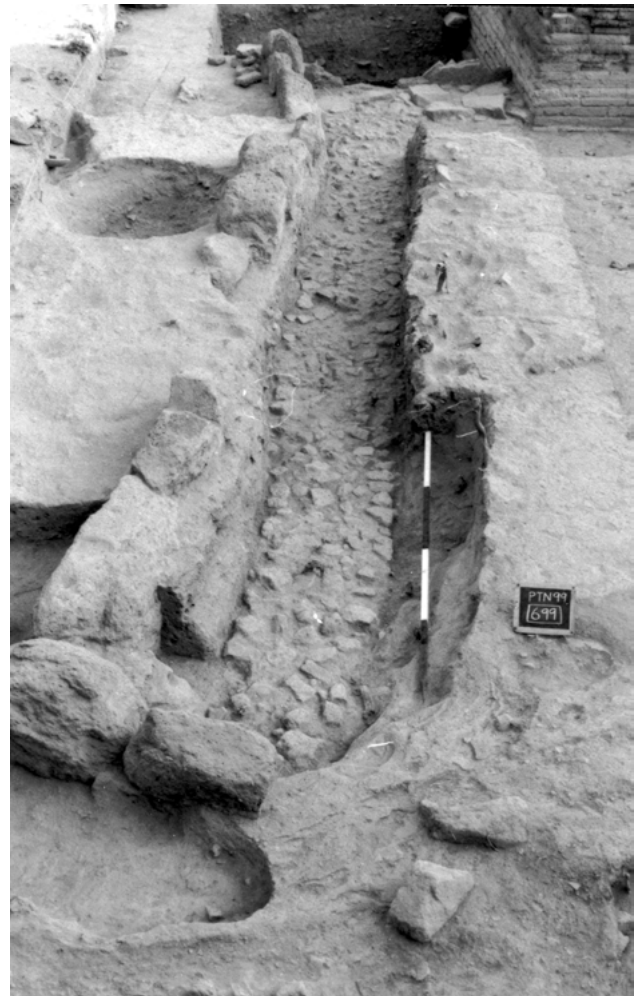
Fig. 4.47: Foundations of the Early Medieval perimeter wall 699 in the South Area of Trench A looking north. The stones of wall 691 are visible immediately to the west. At the top of the photograph, the foundations of 699 turn to butt the south-west corner of the South Temple.

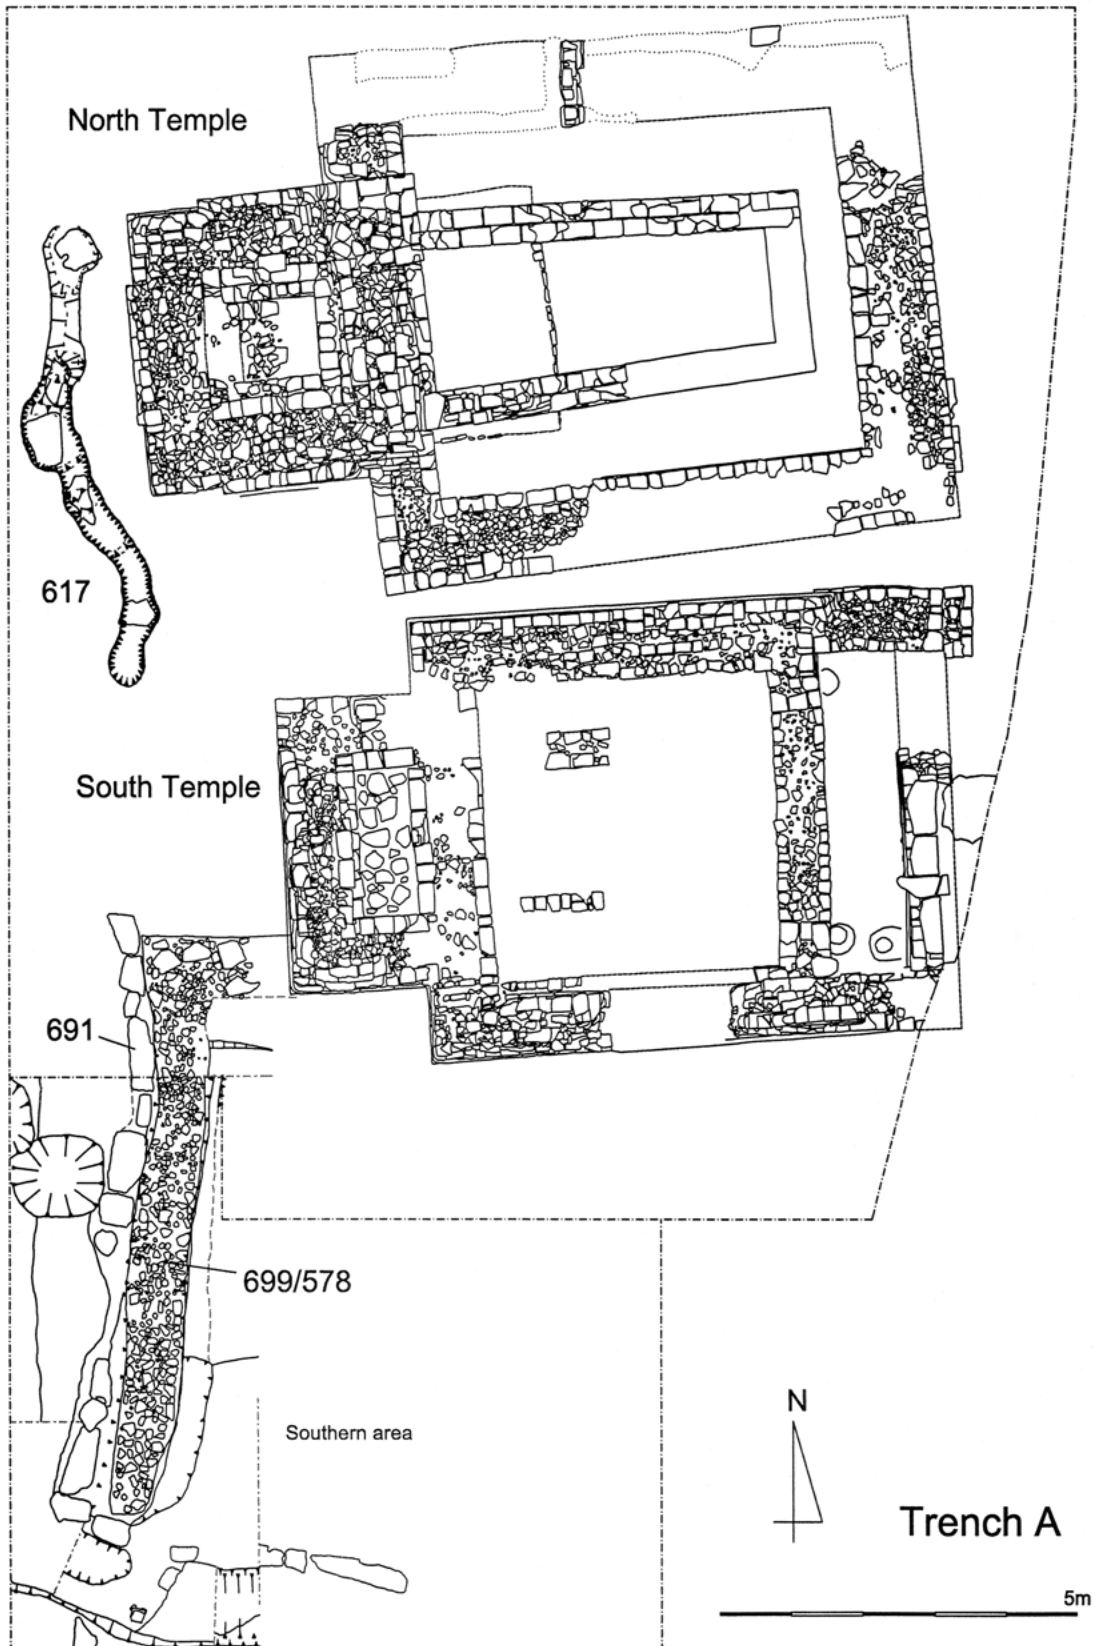
Fig. 4.48: Trench A showing the remains of the possible late enclosure walls 578/699 and 691 and associated features to the south of the South Temple and feature 617 to the west of the North Temple.

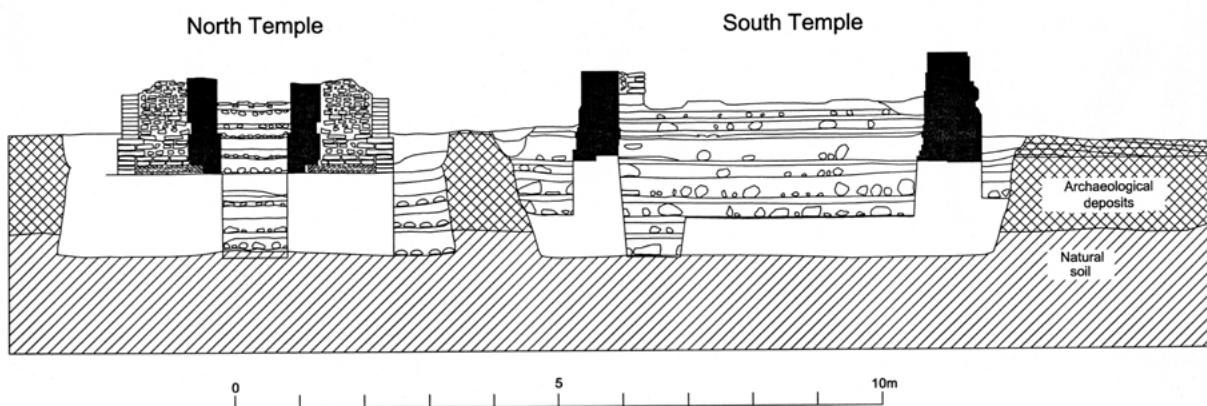
Fig. 4.49: A composite section through the two temples and their foundations.

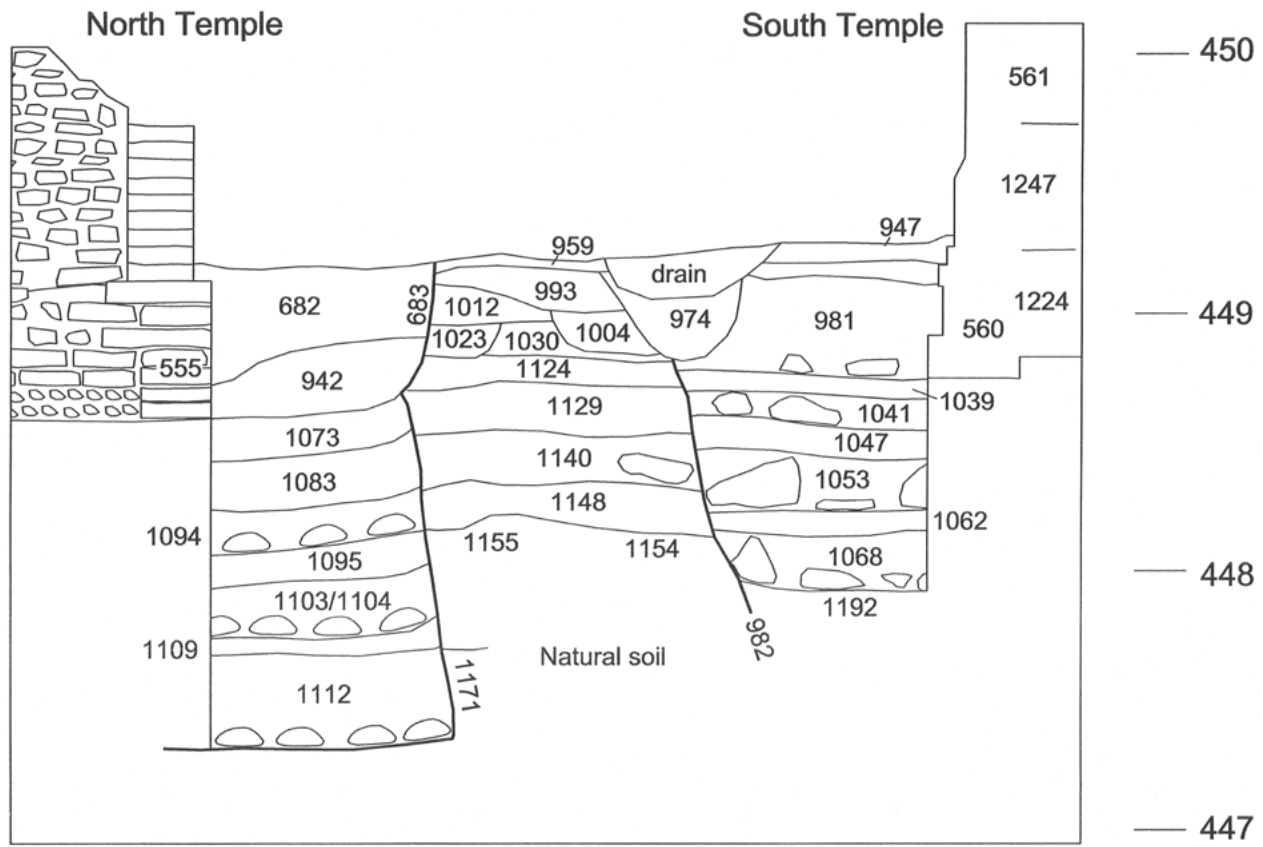
Fig. 4.50: West-facing section of Test Pit 3 showing the foundation cuts for both buildings.

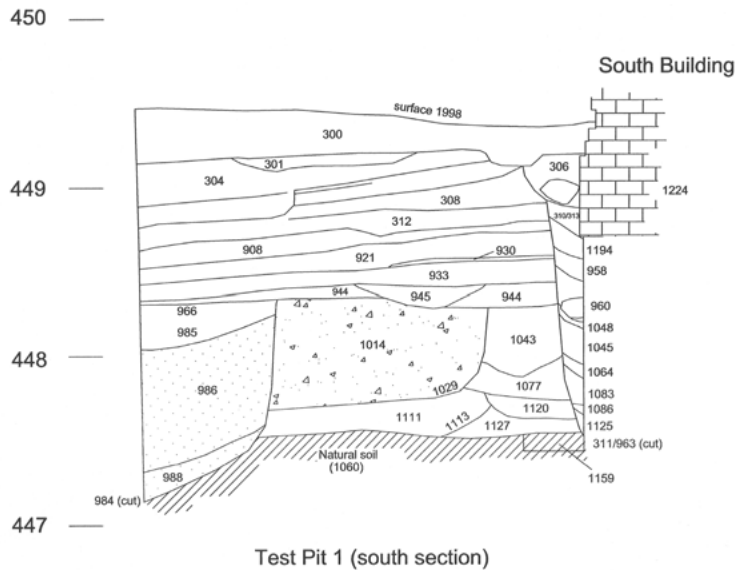
Fig. 4.51: South-facing section of Test Pit 1, Trench A, showing the foundation cut for the South Temple.

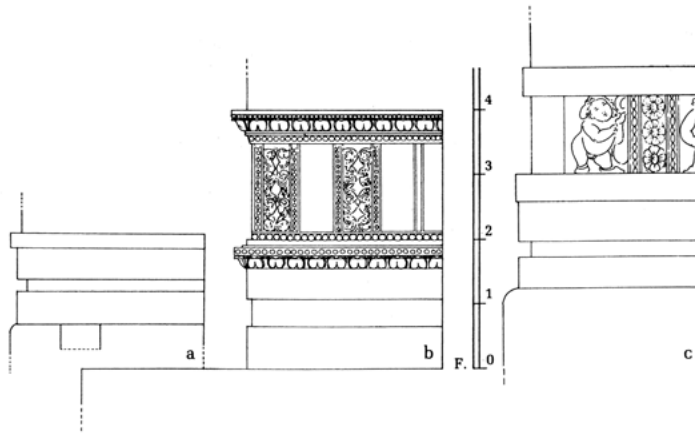
Fig. 4.52: Plinth mouldings from Ramtek: (a) Rudra-Narasimha temple; (b) Kevla-Narasimha temple; (c) Bhogarama temple (after Meister *et al.* 1988: fig. 40).

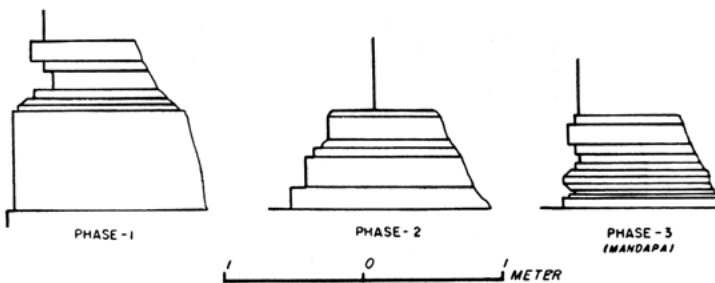
Fig. 4.53: Plinth mouldings on the main temple at Chejerla (from Sarma 1982: fig. 18).

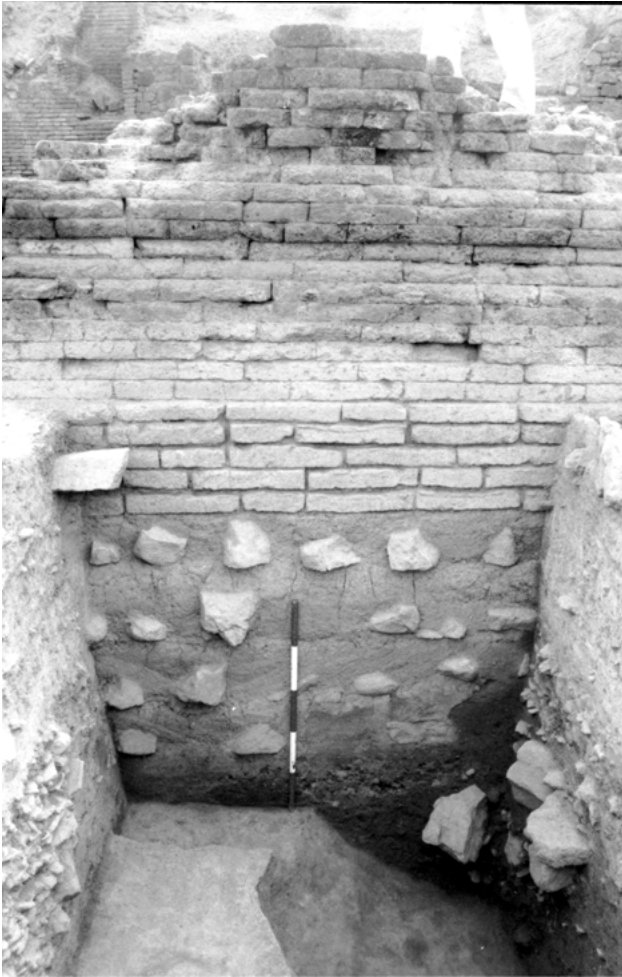
Fig. 4.54: Eastern section of Test Pit 1 showing the foundation fills under the west end of the South Temple.

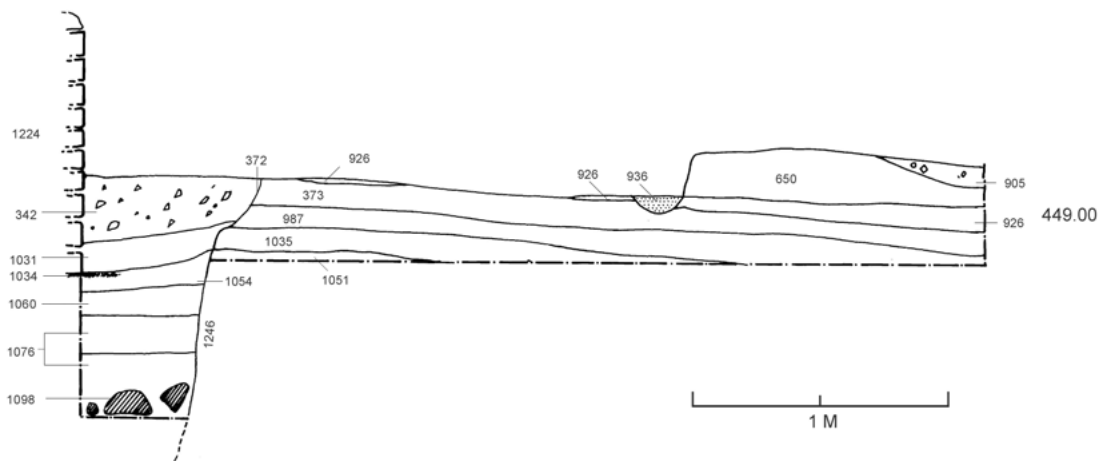
Fig. 4.55: South-facing section, Test Pit 6.

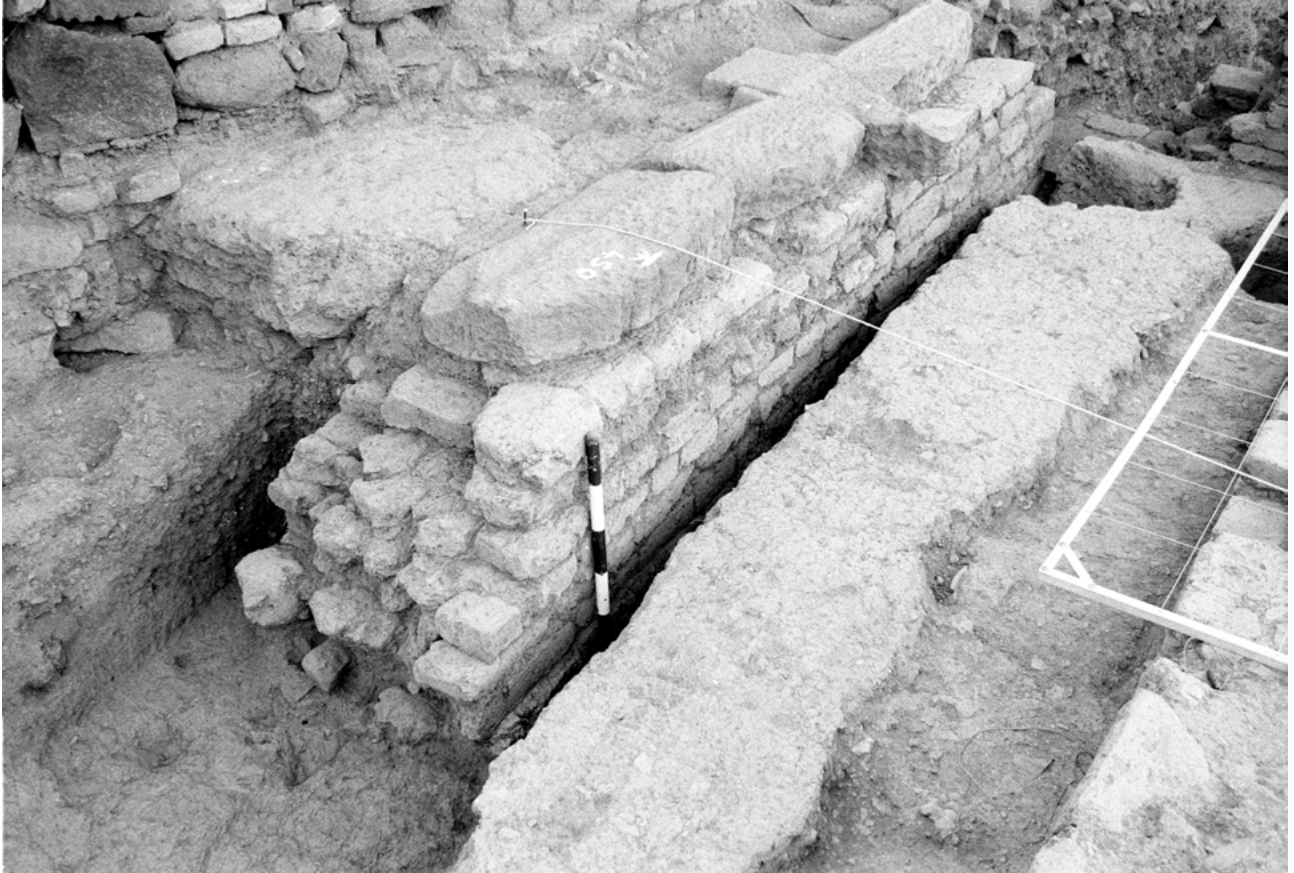
Fig. 4.56: View of wall 360, built from re-used stone architectural fragments above wall 352 at the east end of the South Temple from the north-west.

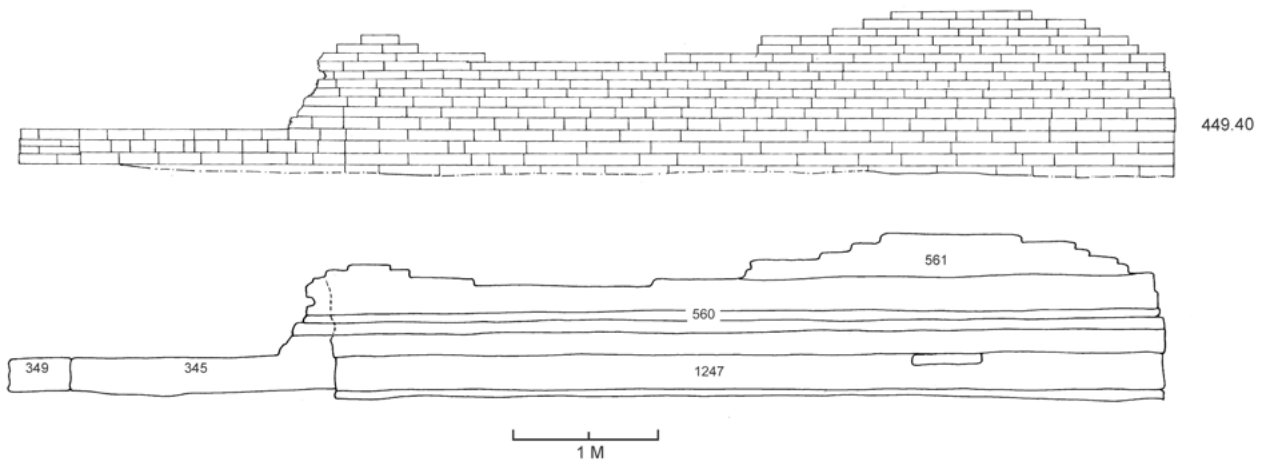
Fig. 4.57: Drawing of the north face of the north wall of the South Temple with an interpretive overlay.
