EFFECT OF HIGH CONCENTRATIONS OF CHLORINE AND SULPHIDE ON STAINLESS ALLOYS IN SEAWATER

Damien Féron

Bengt Wallén

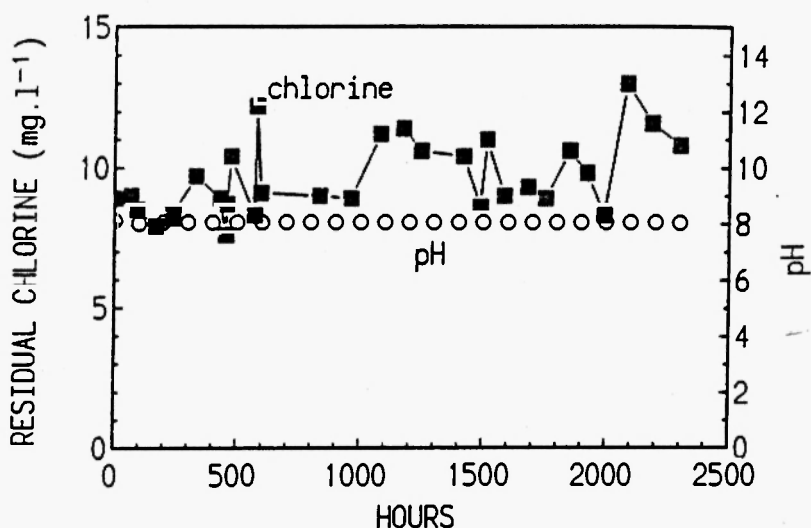
Fig. 2: pH and residual chlorine evolution

The measurements related to the chemistry of the two tests (i.e. pH and sulphide or chlorine concentrations) are also reported in Table 3, and their evolution is shown in Figures 2 and 3. The mean redox and free corrosion potentials are also reported in Table 3.

3.2.1. Chlorinated Seawater. Chemical parameters were fairly constant during the chlorination test, as shown in Figure 2. The pH of the chlorinated seawater was maintained between 8.0 and 8.1. The residual chlorine concentration was the more fluctuating parameter, with values between 7.6 and 13 mg.l⁻¹, the mean value being 9.2 mg.l⁻¹ in the 5 m³ tank. At the beginning of the test, residual chlorine was also analysed at the outlet of the titanium vat: with a residual chlorine concentration of 10.8 mg.l⁻¹ in the 5 m³ tank, i.e. at the inlet of the titanium vat, the chlorine concentration at the outlet of the titanium vat was 9.2 mg.l⁻¹. This shows that there was a decrease of residual chlorine concentration during the stay of the chlorinated seawater in the titanium vat (approximately 10 hours at 45°C), but this decrease was limited to about 15%.

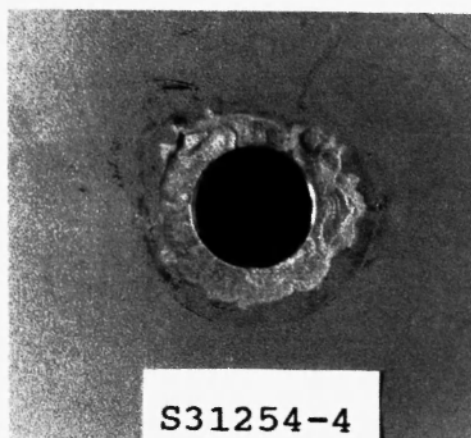
Fig. 8: Crevice corrosion on S31254 superaustenitic 6 Mo steel

The observations made on the coupons and electrodes are summarized in Table 4 and illustrated by photographs shown in Figures 7 to 13. Besides crevice corrosion under the gaskets, all alloys except S32654 were attacked by other types of corrosion.

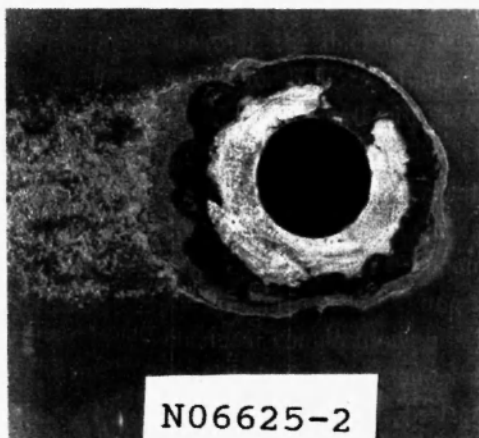
Fig. 9: Crevice corrosion on
N06625 nickel base alloy

Both nickel base alloys exhibit a very distinct corrosion circle around and exactly at the mouth of the aramid crevice (Figures 9 and 10). This type of corrosion existed on all nickel base specimens. A profilogram showing this type of attack is presented in Figure 13. As can be seen in Figure 9, areas covered by corrosion products (from the crevice) are etched too on N06625. Quite unexpectedly, a few pits were observed on N10276 specimens in places where rust spots could be seen after the exposure. A section of such a pit is shown in Figure 14.

crevice corrosion under the gaskets. These results are not unexpected, however. Earlier investigations have shown that, under similar conditions, crevice corrosion is to be expected on S32750 and S31254 if the temperature or the chlorine concentration exceeds certain limits: thus, at 45°C, 2 mg.l⁻¹ chlorine will cause crevice corrosion on both these alloys /1,2/. As shown in other tests, N10276 is not immune to crevice corrosion in natural, unchlorinated seawater at ambient temperature /4/ and etching has been reported on N06625 in seawater containing 4 mg/l⁻¹ of chlorine at ambient temperature /3/. It could be seen that on the nickel base alloys, but not on the stainless steels, crevice corrosion occurred not only inside the crevice, but also at the mouth of the aramid crevices (Figures 9, 10 and 13).

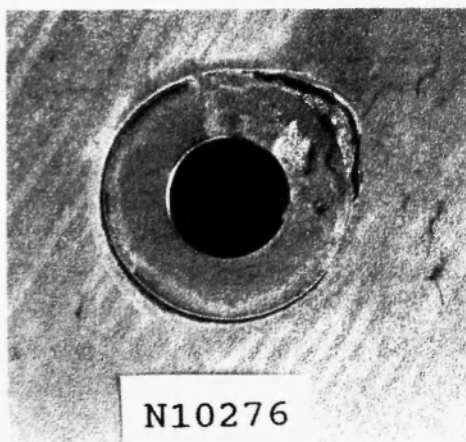
Fig. 10: Crevice corrosion on
N10276 nickel base alloy

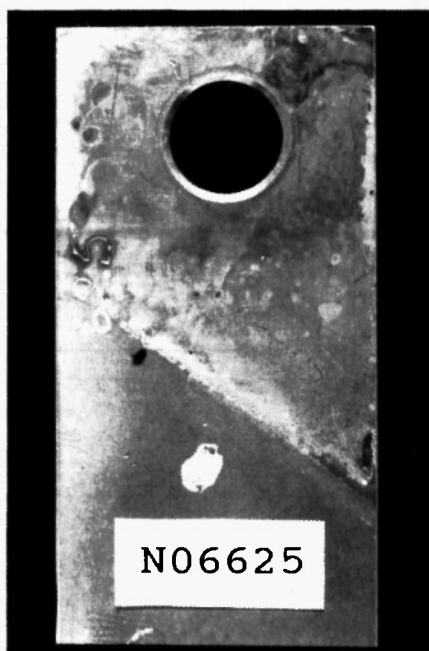
Fig. 11: Vapor phase corrosion on N06625 nickel base alloy

In the gas phase above the water level, all alloys except S32654 and N10276 were slightly etched at the mounting holes of the electrodes. The gas phase attack was more severe on N0-6625 electrode (Figure 11): the whole area above the water line was etched but the attack was most pronounced at the water level.

The gas phase corrosion observed on S31254, S32750 and N06625 electrodes might have been caused by chlorine gas evaporating from the water and forming a highly corrosive condensate. This type of corrosion is common in chlorine stage filter washers in pulp bleaching plants /5/.
