Study of Thermal Fatigue of H13 Die Steel with Various Surface Treatments

*V.V.Ivanov, **I.R.Paine and ***P.J.Revnyuk

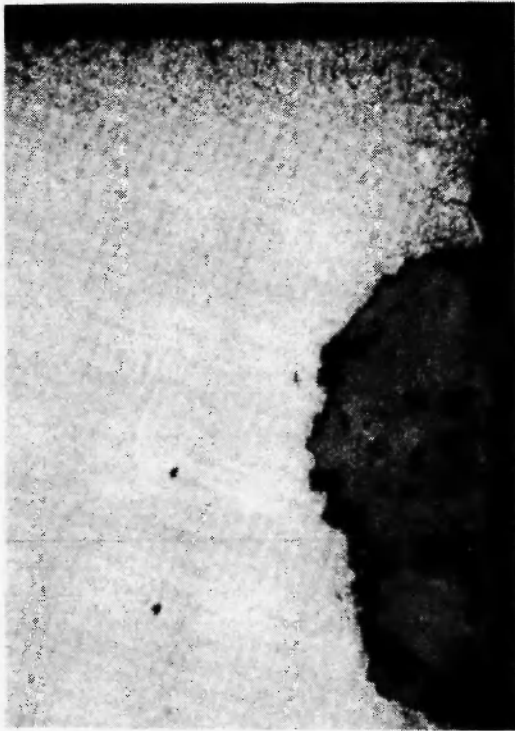
Fig. 3: Pit-like defect of the H4 specimen, 25000 cycles, 2.5% nital, 200×.

There is a feature, which is common only for H-type specimens – it is the presence of pit-like defects (Figures 3 and 4). They are filled in with two different substances of grey and white appearance in the picture. The EDX analyses have shown the presence of Fe, Cr, Si, V, and Mn in the grey one. The XRD results were not very convincing showing complex oxides as well as intermetallic compounds, but taking into consideration the microhardness values of (550 - 750) H_v , it is quite reasonable to conclude that the grey substance mostly consists of the complex spinel-type oxides. The EDX analyses of the white substance have shown the

The dark spots seen in Figures 3 and 4 are voids that resulted from the steel manufacturing process. After machining, voids can be exposed on the surface. These sites are more susceptible to thermal fatigue. The situation exacerbates when flaws fill up with oxides, casting alloy or intermetallics, which act as a wedge during the cycling, expanding the cavities. The size of surface defects for the given conditions becomes a

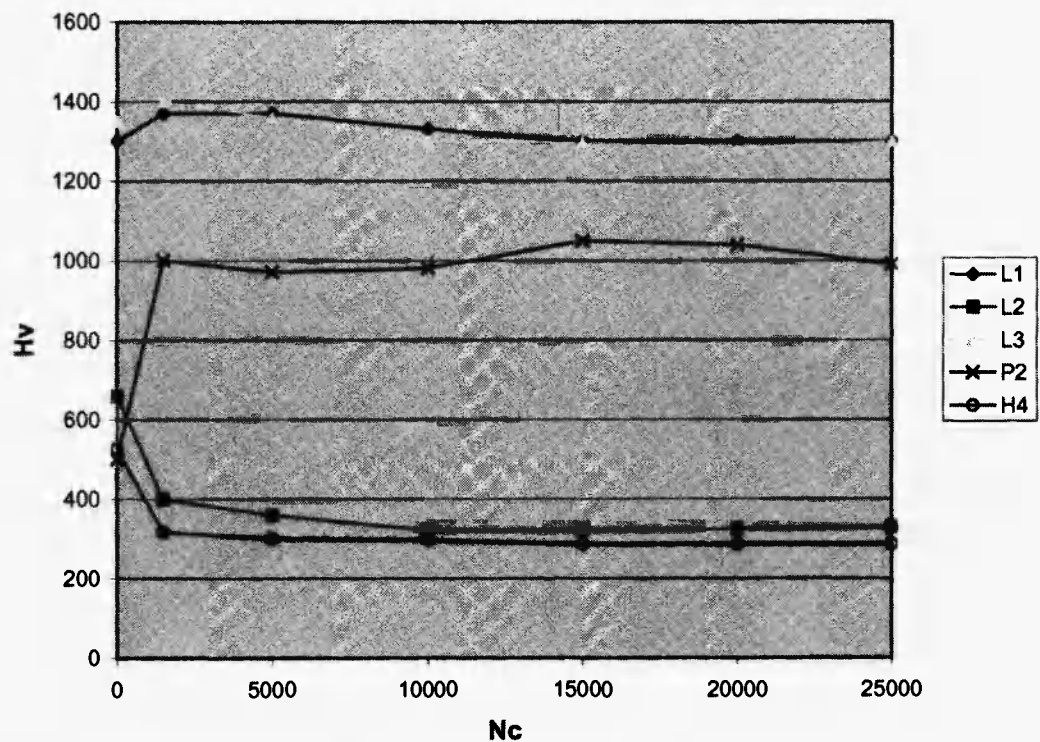
Fig. 17: Case microhardness values (H_v) versus number of cycles (N_c) of the H-, L1-, L2-, L3- and P2 specimens.

The changes in the coating microhardness values of the coated samples as a function of the number of cycles are shown in Figure 17 (uncoated H4 and L2 are presented for comparison). The substantial increase of the hardness for the P2 coating during the first 1500 cycles can be explained as a result of phase

transformations, which include the secondary hardening (precipitation of various secondary carbides or the like).
