The Effect of Surface Treatments on Thermal Fatigue of H13 Die Steel.

*V.V.Ivanov, ** W.G.Ferguson and *A.F.Trubuhovich

* *Glucina Metals (A Division of Pro Topline Ltd.), New Zealand*

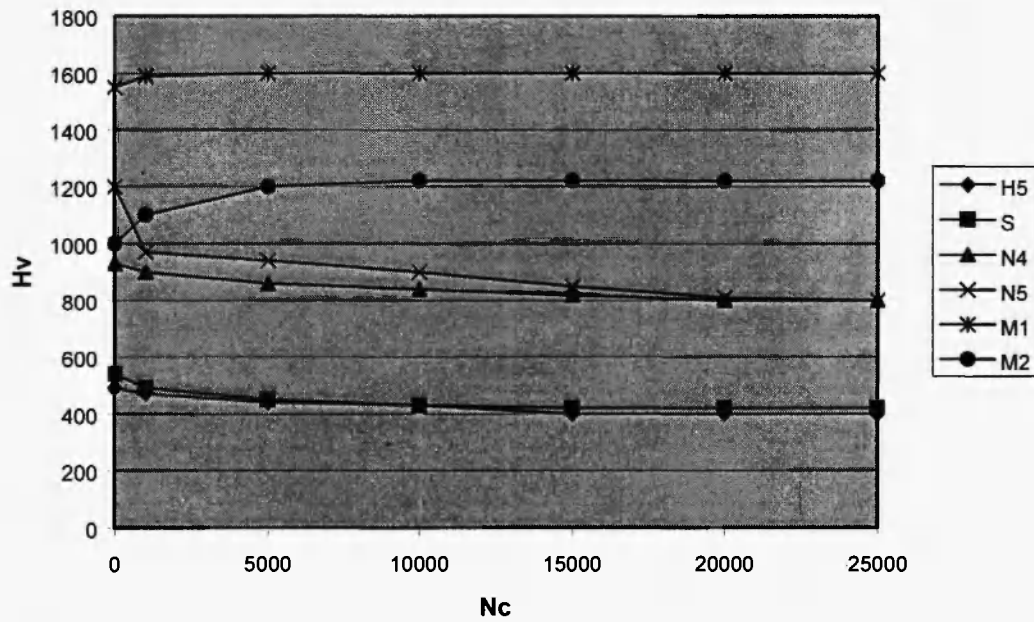
The surface hardness values of the H5 specimen gradually reduce from (470 – 480) H_v at the beginning to (400 – 420) H_v at the end of the test (Figure 4).

Fig. 4: Case microhardness values (H_v) versus number of cycles (N_c) of the tested specimens.

The changes of the case micro-hardness during the thermo-cycling are shown in Figure 4. The micro-hardness of the N4 specimen gradually drops from 930 H_v (initial) to 800 H_v at 25000 cycles. The N5 sample has higher initial micro-hardness (1200 H_v), but it decreases rapidly during the first 1000 cycles (970 H_v) and then slowly reaches 800 H_v at 25000 cycles. Probably because carbo-nitride phases are less inclined to coagulation during the heating than nitrides, the N4 specimen shows better tempering resistance than N5.

The initial subsurface micro-hardness of the S-sample, and that following a certain amount of thermo-cycling is shown in Figure 4. At the first stage of cycling (1000 cycles), the hardness of the S-specimen dropped faster (from 540 to 490 H_v) than that of H5 (from 490 to 470 H_v), but then it maintains the positive difference of 10-20 units up to the 25000 cycles.

The initial micro-hardness of the M1 coating was about $1550 H_v$, then slightly increased during the first stages of cycling (up to $1600 H_v$) and maintained this level up to the end of the test (Figure 4).

The pattern of the coating's micro-hardness change is pretty much similar to that for M1; only the level of values is lower – from 1000 to $1220 H_v$ (Figure 4). The hardness of the interfacial layer, adjacent to the chromium carbide coating, was between $450 - 700 H_v$ and was retained at this level up to the end of the test. Such a transition between the substrate and the coating seems to be much more suitable than that in the M1 specimen.

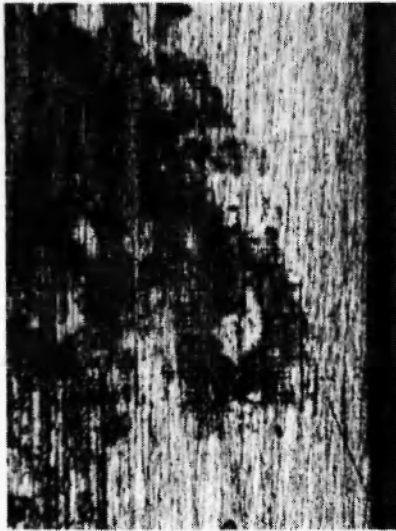
Figure 5 displays the regular transversal cracks, which originate in oxide layer (grey). Eventually, some of them can initiate cracks in the die metal when the tensile stress exceeds the elastic limit.

Fig. 5: Edge of the N4 specimen, 25000 cycles, 50 \times ; unfinished grinding process; remains of oxides (grey) with transversal cracks, which do not propagate into steel (white).

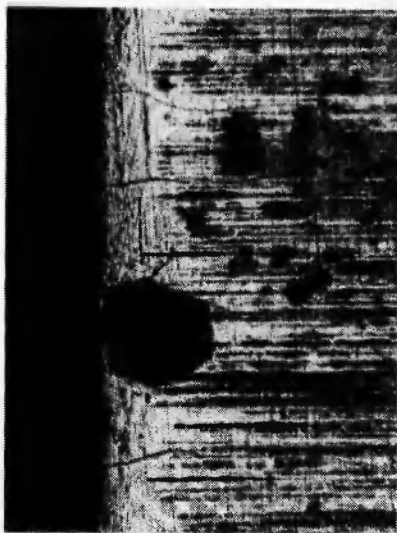
Fig. 13: M1 specimen after 25000 cycles, 50x.

Fig. 14: M2 specimen after 25000 cycles, 50x.

The surface condition of the M1 and M2 coatings after 25000 cycles are displayed in Figures 13 and 14. The M1 coating has transversal cracks, pits of various size and areas detached from the substrate. The M2 coating shows pits, which are beginning to combine in transversal lines, no cracks and no significant damages. However, no substrate cracks were found in either the M1 or M2 specimens.
