## Research Article

# Effect of concrete and reinforcement continuity on repairing mid-span zone in simply supported one-way slab

**Abstract:** The flexural strength of slabs may be reduced due to accidents and environmental effects. This study focuses on the rehabilitation of the one-way reinforced concrete slab. Experimental works include five simply supported one-way reinforced concrete slabs with width, depth, and length of 400, 120, and 2200 mm, respectively. Different configurations of steel continuity between old and new concrete have been tested. Moreover, in the control specimen (steel is continued overall, the specimen and concrete are cast in one stage over the entire slab). In the other four specimens, the concrete is cast in two stages, the left and right parts representing the old concrete are cast first, and the middle part representing a new concrete is cast after that. In these four specimens, new steel is connected to old one by different configuration (original steel remain to continue, new steel connected to old one by weld, new steel connected to old one by making 90° hooks, and new steel bars are put inside bores using epoxy). After testing, the welding meth

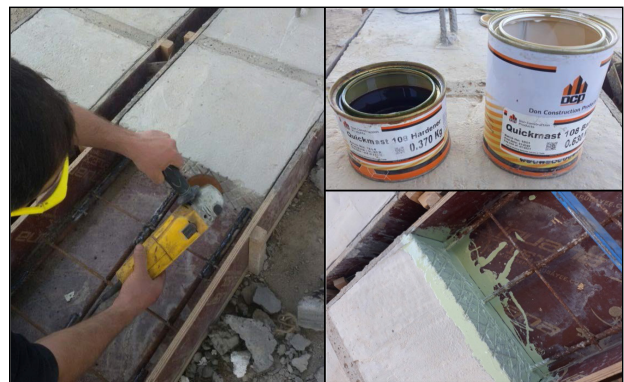
Figure 8: Preparing old concrete surface.

In the two stages of casting and after 24 hours, the specimens are marked and covered by wetted gunny bags until 28 days. A scarifying device using a rotating disc wheel is used for cleaning and roughing the old concrete surface before using a quick mast from DCP Company (see Figure 8), which would be put before 30 minutes from casting a new concrete (second stage of casting).

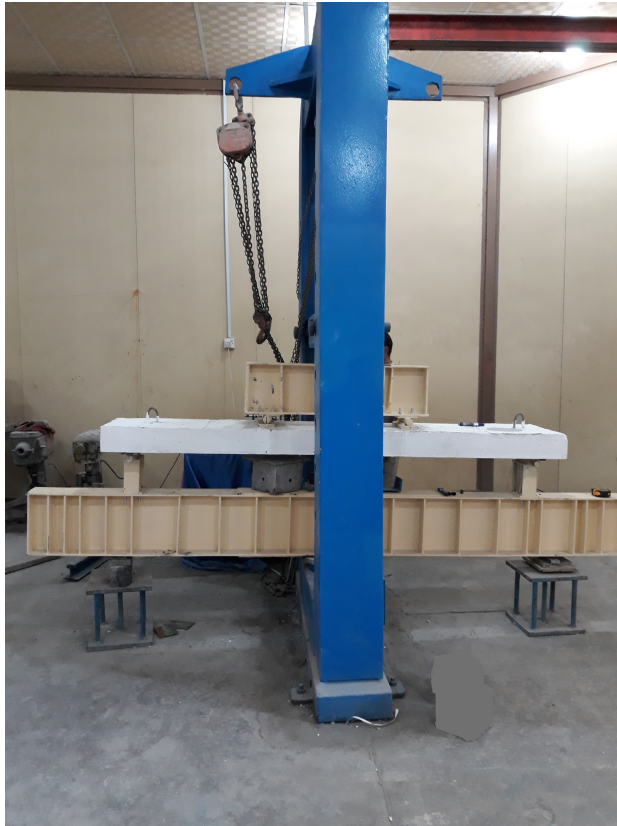
A load of two points is applied for all specimens. One dial gage is placed at mid-span under the slab to record deflection when the load is applied up to failure (see Figures 9 and 10).

Figure 10: Flexure test machine.

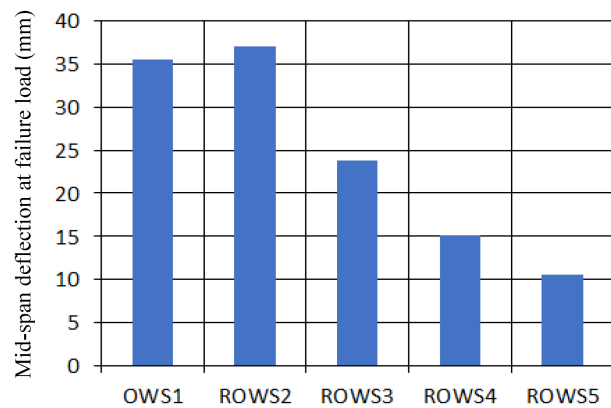
**Figure 13:** Mid-span deflection at failure loads for all specimens.

For all specimens, the curves of load-deflection are shown in Figure 11. Also, the relationship between the external applied load and deflection at mid-span is shown. The first cracking load, failure load, mid-span deflection at failure load, and failure type of all specimens are shown in Table 1 and Figures 12 and 13.
