Research Article

Rehabilitation of reinforced concrete deep beams by near-surface-mounted steel reinforcement

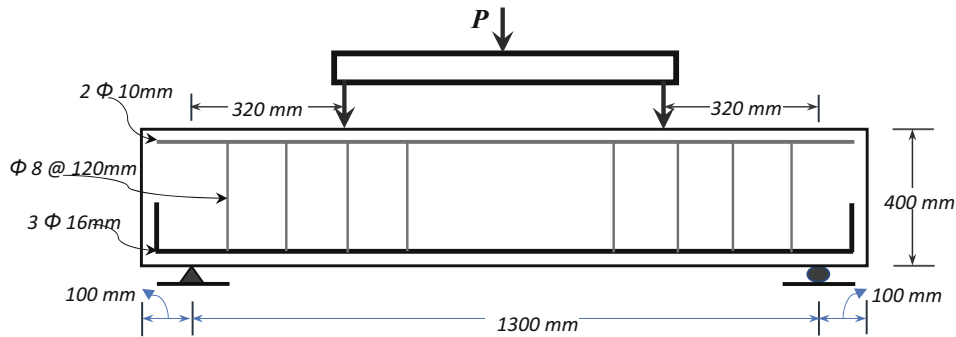
Figure 1: Dimensions and reinforcement details of tested beams (all dimensions in mm).

33.4 MPa at 28 days was used. In reinforced concrete deep beams, three different diameters of deformed steel bar reinforcements (16, 10, and 8 mm in diameter) were used. Three steel bars (16 mm in diameter) bent 90° at either end make up the flexural reinforcement of each beam. As internal compression reinforcement, two deformed steel bars of 10 mm diameter were used. Finally, eight steel bars with an 8 mm diameter were spread along the length of the deep beams as shear reinforcement. Figure 1 shows the dimensions and reinforcing information of the test specimens.

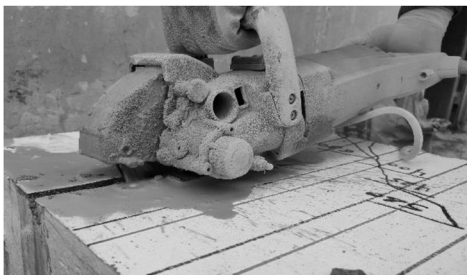
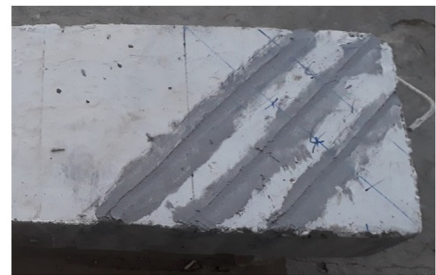
Figure 2: NSM repairing steps.

rehabilitation procedure, the NSM technique is applied by cutting the concrete cover in several directions at the side of the beam by a special cutter. The grooves were cleaned of any loose material, compressed air, and compressed water in some cases to guarantee proper bonding between the epoxy and the concrete. Then, after the epoxy had been partially applied, the steel bar was put into the groove and gently pressed. Hence, the epoxy was compelled to flow around the steel bar. The steps are shown in Figure 2.

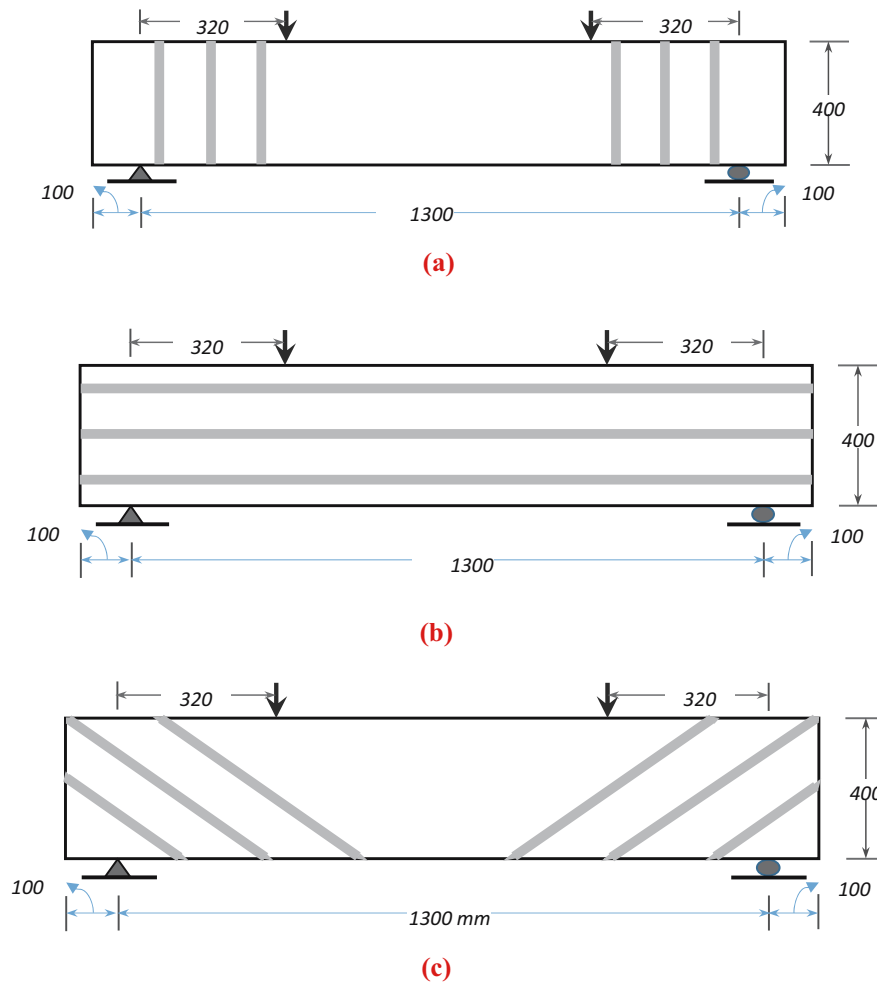
Figure 3: Vertical, horizontal, and inclined configuration of the repairing NSM steel bars: (a) vertical, (b) longitudinal, and (c) inclined.

Figure 3 illustrates the three configurations of repairing using the NSM technique for tested beams. Vertical, inclined, and longitudinal are the drilled near surface grooves. For all beams, three grooves were drilled at each face except the beam (DB-I-0.75-1 face), in which the repairing was at one face only. The retrofitted beams were cured at ambient temperature for 7 days for curing of epoxy adhesive.

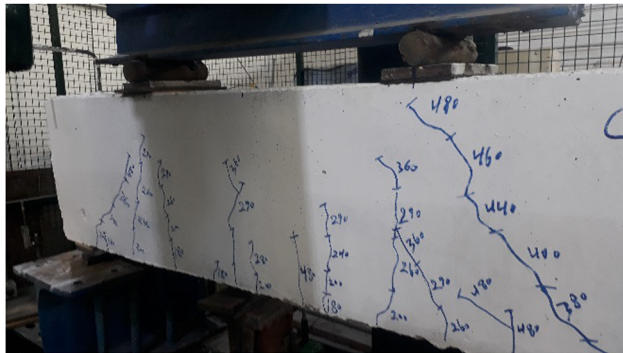
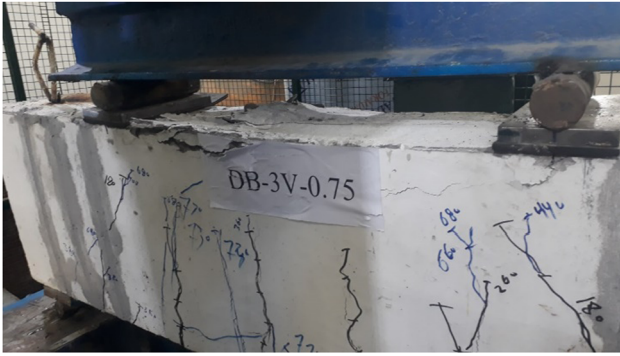
Figure 5: Specimens DB-V-0.75 during testing.

This deep beam was pre-cracked until the load reached an approximate value of 540 kN (i.e., 75% of the control

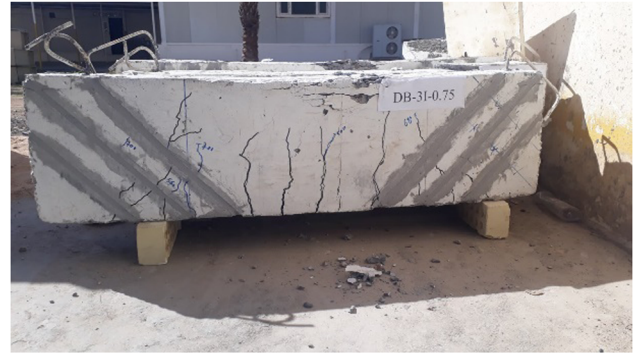
Figure 7: Specimen DB-I-0.75 after testing.

With reloading, hairline flexural cracks extended upward while the hairline web cracks started to extend diagonally. Expansion and elongation were noticed for both cracks until the beam's failure was reached. The failure occurred in the crushing of the concrete of the top fiber at the flexural zone but with an ultimate load of 750 kN. Figures 7 and 8 show the cracks' elongation and load-deflection curves compared to the control beam.

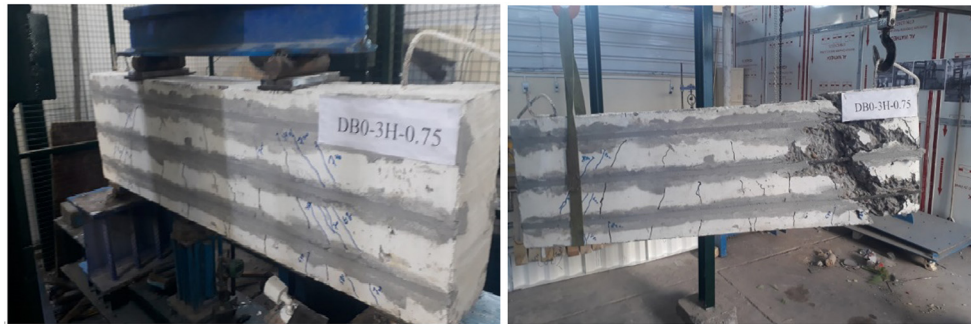
Figure 9: Specimen DB-H-0.75.

at both faces. The hairline cracks that developed before repairing, as a result of loading the beam to 75% of the capacity of the control beam, were clear at both the flexural and flexural-shear zone. After reloading, the extension and elongation occurred to only the hairline cracks at the flexural-shear zone. In contrast, flexural cracks remained without changing due to the mounted reinforcement. Figure 9 shows the behavior of the beam before and after the reloading.

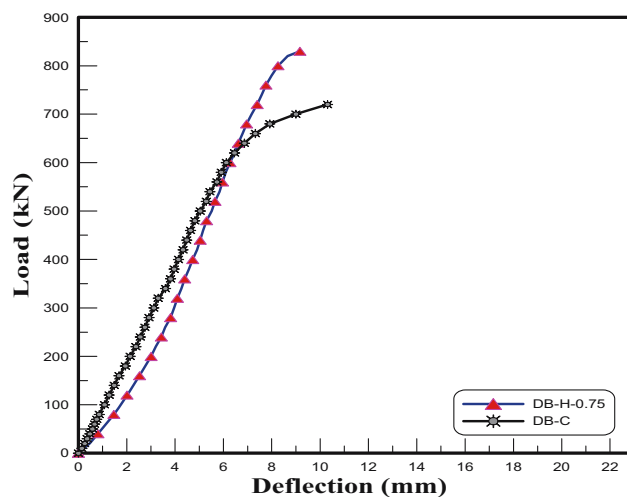
Figure 10: Load-deflection of specimen DB-H-0.75.

The failure occurred by crushing a massive amount of concrete diagonally in the flexural-shear zone. The ultimate load of the beam was 830 kN. Figure 10 shows the load-deflection curve of the beam compared with the control beam. This technique achieved a 16% increase in capacity.

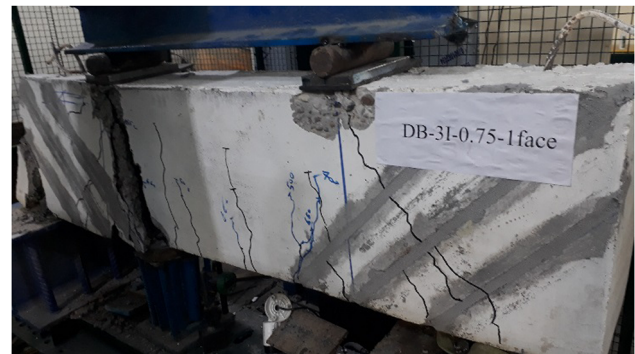
Figure 11: Specimen DB-I-0.75-1 face.

This beam is similar to beam DB-I-0.75, except that its rehabilitation was conducted to one face of the beam. As a result, this beam's capacity was roughly equivalent to that of the control beam. The failure occurred due to the concrete crushing under the point load (Figure 11). Figure 12 shows the load-deflection curve compared with the behavior of the control beam.

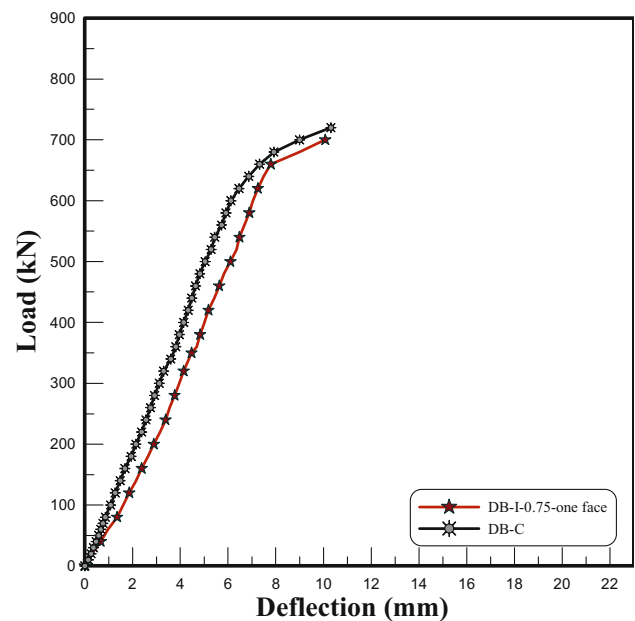
Figure 12: Load-deflection of the specimen DB-I-0.75 face.

It may be concluded that this procedure does not contribute to an increase in the load capacity, so its capacity reached 700 kN.

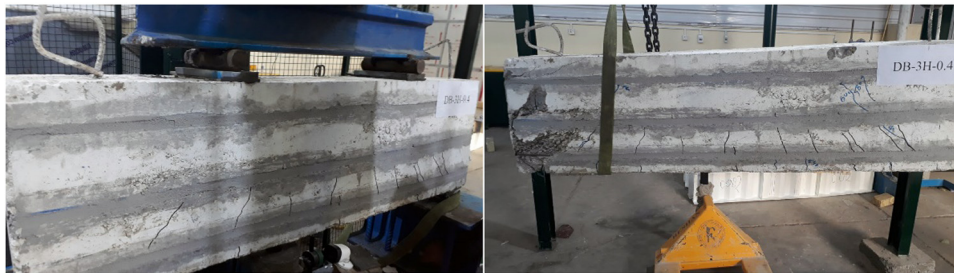
Figure 13: Specimen DB-H-0.4.

This beam is similar to beam DB-H-0.75, except that its repair was done after loading to 40% of the capacity of the control beam. At 180 kN, the first vertical hair flexural crack appeared, followed by web cracks at the shear zone. The number of cracks has increased with increasing load.

The web shear cracks extended diagonally. Finally, the beam capacity reached 860 kN, resulting in more elongations and extension of flexural-shear cracks. This behavior was similar to that of beam DB-H-0.75, but with higher capacity. The

increase in the capacity was 19% of the capacity of the control beam (Figure 1 of the control beam and Figure 13). Figure 14 shows the beam's load-deflection curves.

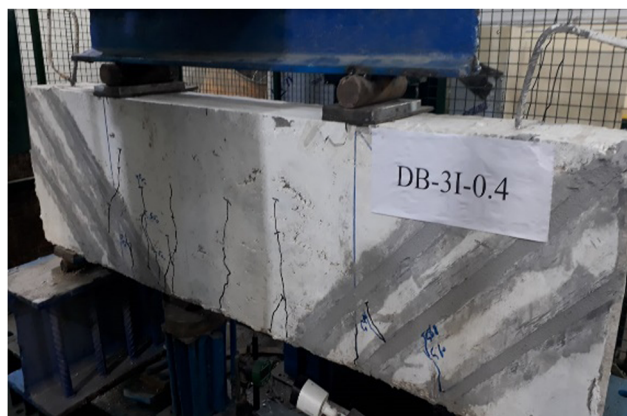
Figure 15: Specimen DB-I-0.4.

After loading this beam to 40% of the capacity of the control beam, the rehabilitation of this beam started (Figure 15). With reloading, flexural and web cracks developed and extended upward and diagonally until failure, which resulted from the concrete crushing at the flexural zone. The beam failed at 770 kN with an increase in capacity by 7%. Figure 16 depicts the load-deflection curve of this specimen.

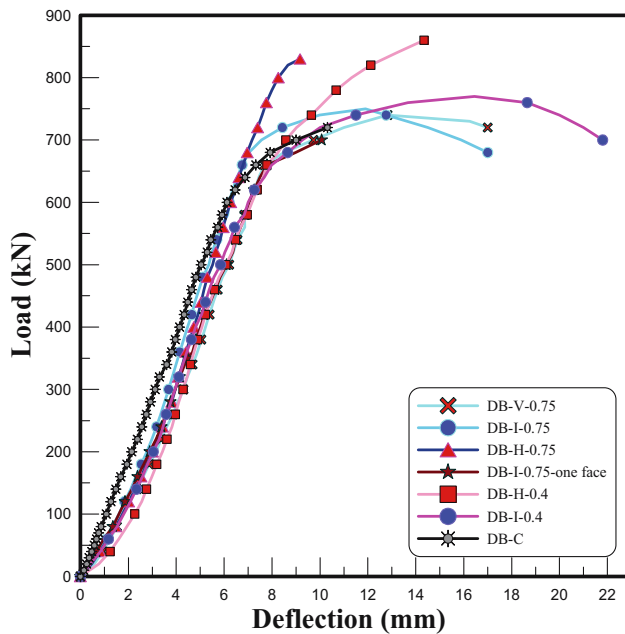
Figure 17: Load-deflection curves of all tested beams.

Figure 17 shows the load-deflection curves of all tested beams. The best increase in the flexural capacity compared with the capacity of the control beam was achieved by DB-H-0.4 and DB-H-0.75. For both beams, the NSM technique was accomplished by installing three rebars in horizontally drilled grooves at both faces of the beams. The increase in capacity may arise due to the following reasons.

- 1- For both these beams, it was noticed during the test that the flexural cracks developed in the pure moment zone before planting the bars remained as they were after the planting without any change despite the increased applied load. This indicates that these mounted bars significantly stopped cracks from elongating and expanding. Moreover,

- 2- Unlike the rest of the beams, the failure occurred by crushing the concrete diagonally at the shear zone. The mounted steel bars played a role in resisting the flexural stresses and only the shear stresses, which were responsible for failure. Contrary to all other beams that were strengthened using the I and V embedded bars in the shear zone, the failure (crushing of the top fiber of concrete) occurred in the pure bending zone. It may be concluded that the near-surface rebars extended along the beam significantly increased the flexural capacity.
