Research Article

Experimental investigation of RC beams strengthened with externally bonded BFRP composites

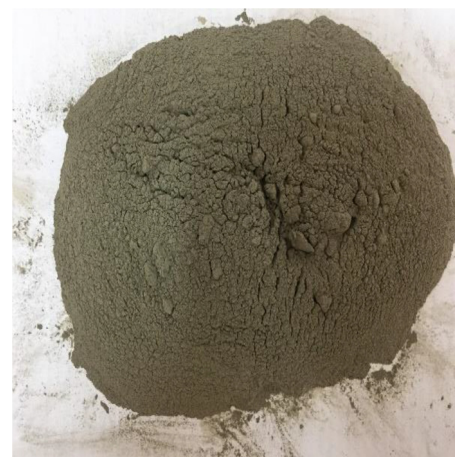
Figure 1: FA picture that was employed in the fixing RC.

Class F. FA was utilized for fixing the RC specimens, as shown in Figure 1. Furthermore, FA is a very beneficial material, which has a spherical microstructure and affords high flow ability. It was delivered by warm air control Ceyhan Sugözü Turkish herb [26].

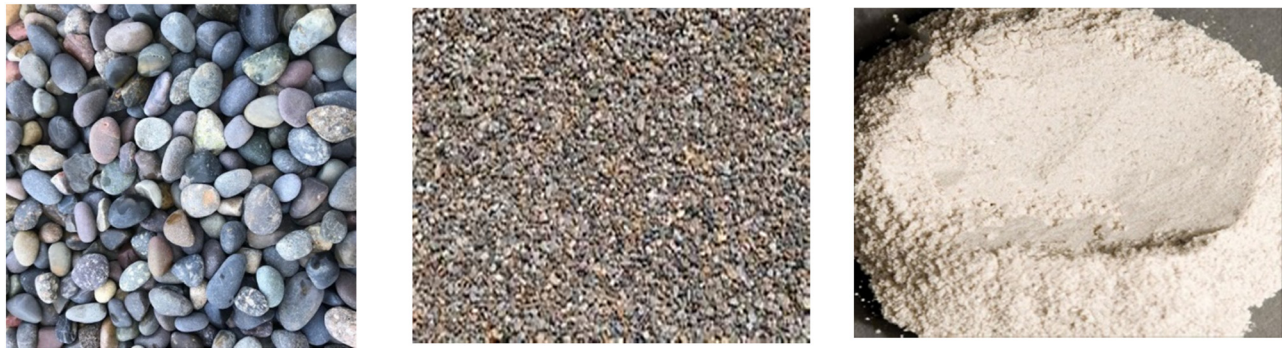
Figure 2: Aggregates used in the mix design. (a) Coarse aggregate. (b) Fine aggregate. (C) Fine crushed stone.

The local coarse aggregate was used with a nominal size of 10 mm, while the river sand and fine crushed stone were used as the fine aggregate with a maximum size and specific gravity of 2.6. Figure 2 shows the aggregate used in the mix design of all samples, while Figure 3 shows the volumetric pitches of the rough and fine collections.

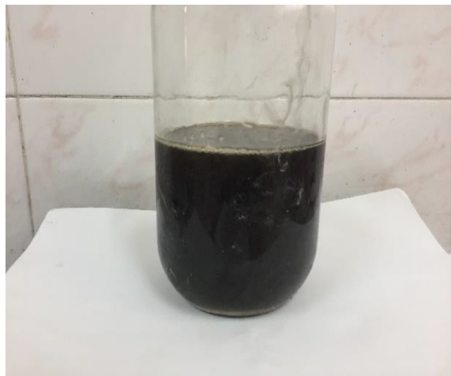
Figure 4: Superplasticizer used in our study.

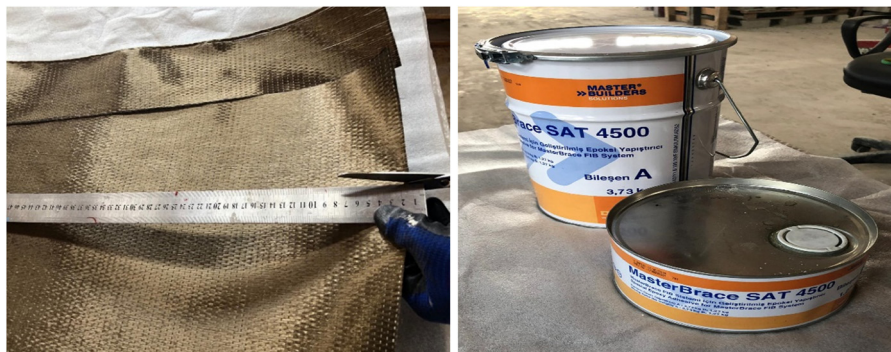
**Figure 5:** Epoxy resin used for bonding and BFRP sheets.

the BFRP fabric on the exterior concrete side. According to the company, the epoxy resin had a compressive strength greater than 60 MPa, a bending strength greater than 50 MPa, and a bond strength greater than 3 MPa. The necessary amount of epoxy (A + B) is added in a 3:1 ratio. Figure 5 displays epoxy resin that connects to BFRP sheets. The procedural text determined upon the presentation of the bonding agent to the ray

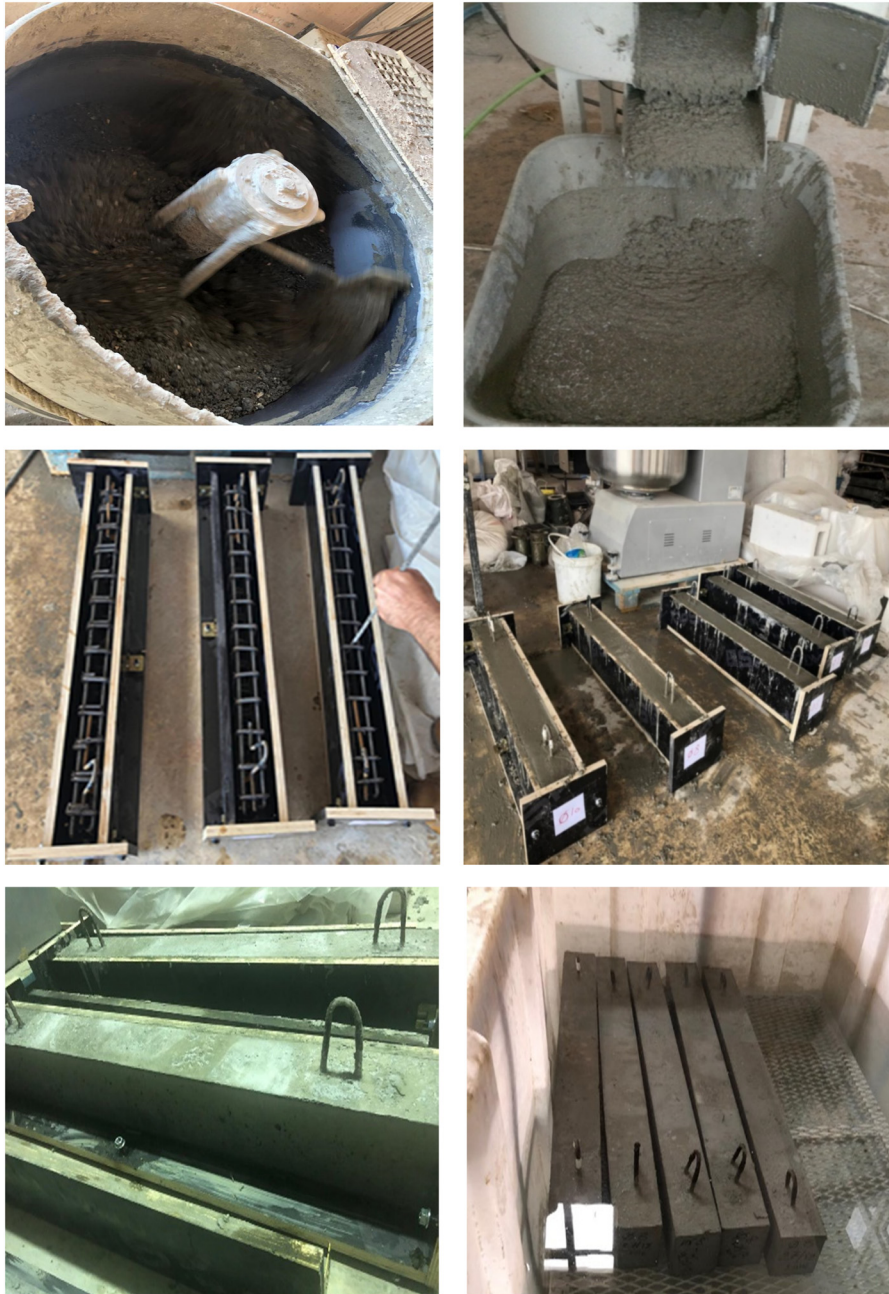
Figure 7: Steps casting and curing.

Table 3 shows the weighted quantities of required materials needed for the two batches. First, the fine and coarse aggregates were mixed in dry conditions for 2 min. Then, the binder materials containing cement, FA, and crushed sand were added with half the amount of the water and mixed for 1 min. Finally, the remaining water and superplasticizers were pre-mixed and poured into the mixture with another 2 min of mixing to consist of the mixture contents. After the mixing procedure was complete, the concrete was poured into the molds immediately without compaction. The steps of casting and curing are illustrated in Figure 7. The beams are covered and left for 24 h in the casting room. After completion of concrete casting, all tested beams were cured in a water tank at laboratory temperature for 28 days. Before starting the test procedure, the compressive strength test was made for six cylinders (100 mm × 200 mm).

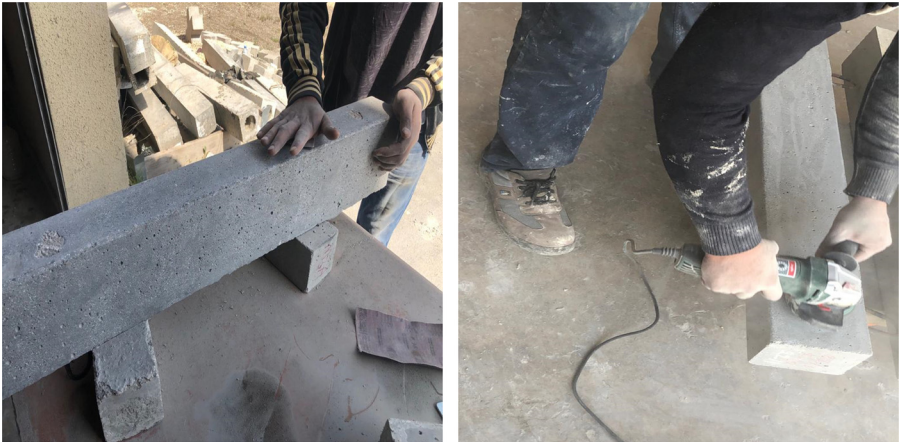
Figure 8: Configuration steps of the preparation surface RC beams to increase the adherence of BFRP by epoxy.

As shown in Figure 8, a concrete mincer with a rotating disk was served to form the concrete surface by expelling a laitance layer and concrete crumpling. Beams' lower sides were rotated with a radius of about 0.5 in. [29] to evade the concentration stress, which led to premature rupture of the BFRP sheets in accordance with ACI 440.2R [30].

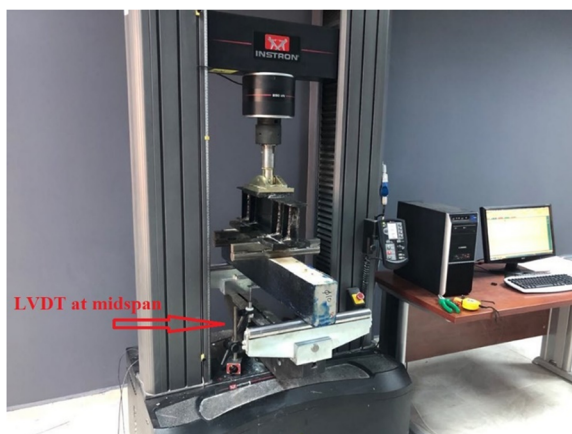
Figure 17: The flexure test setup.

RC beams, both with and without BFRP fabrics, every single sample, were investigated under a static two-point load. For the assessment process, an INSTRON testing machine, as demonstrated in Figure 8, was utilized, which includes a hydraulic with a load size of 250 kN with a

closed-loop servo-hydraulic testing system digital controller (Figure 17).

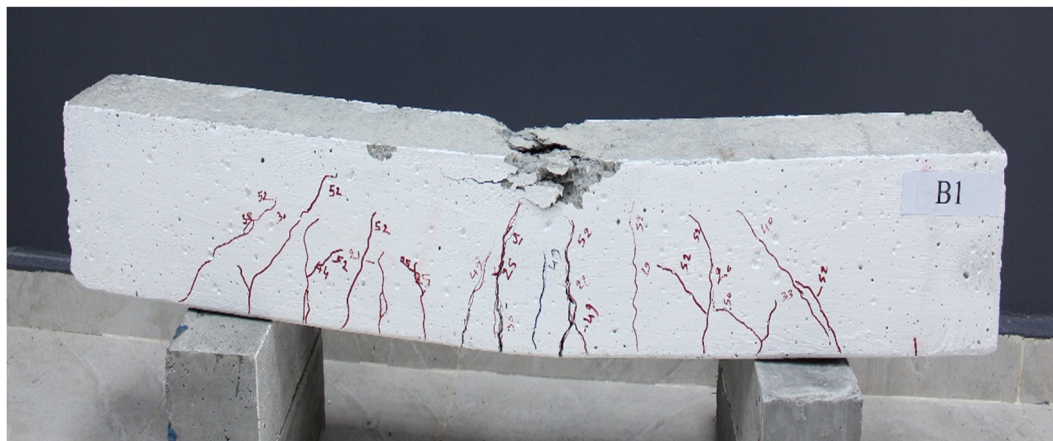
**Figure 19:** Crack pattern for beam B1.

Beam B1 control specimen has been loaded in a four-point bend test setup as described previously. The beams have been loaded with equal force on the two load points until the beams are deformed. The damage in the beams

started with bending cracks in the central region of the beam, as shown in Figure 19. The first crack was observed at 19 kN. As load reached 52 kN, more cracks were observed. Almost all cracks were vertical. Near top and bottom edge sub-cracks were generated connecting to the main crack. The first crack generated was between the left point load and the beam center. The second crack was just inside the right point load. The third and fourth cracks generated were between the center point of the beam and the right point load. The fifth crack was just outside of the right point load. The sixth crack was between the third and fourth cracks. Major cracking was observed at 53.1 kN, and the beam stopped taking load after this point.
