Research Article

Marcin Szyszka*

Structural evaluation of historical masonry walls utilizing non-destructive techniques – Comprehensive analysis

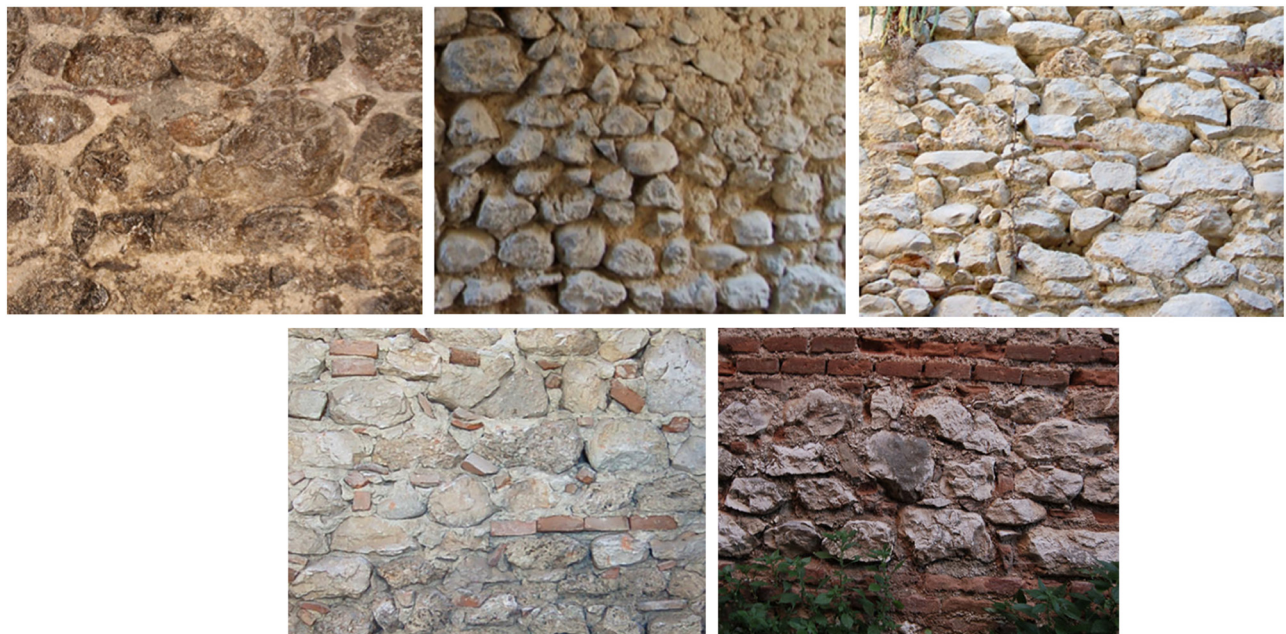
Figure 4: Example of masonry types in L'Aquila (Central Italy) (after Rovero *et al.* [40]).

Figure 4 shows the scale of variety in possible textures. This figure represents the typology of texture identified

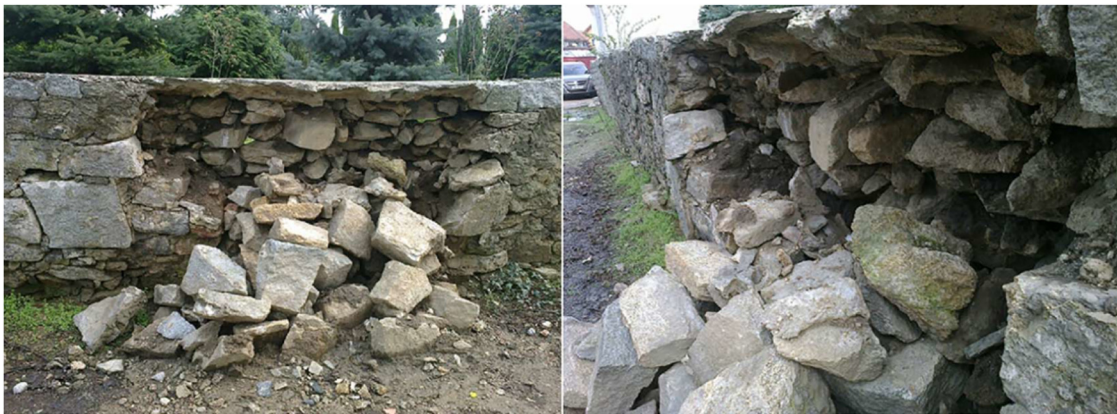
Figure 6: Free-standing two-layered wall in rural Poland, damaged through the separation of layers (source: own).

by insufficient cross-sectional interlocking [43–46]. Most of the failures are related to seismic actions. However, deterioration of connections over time, along with geometric eccentricity, also may be destructive. Such a case is shown in Figure 6, a two-layered irregular stone wall.

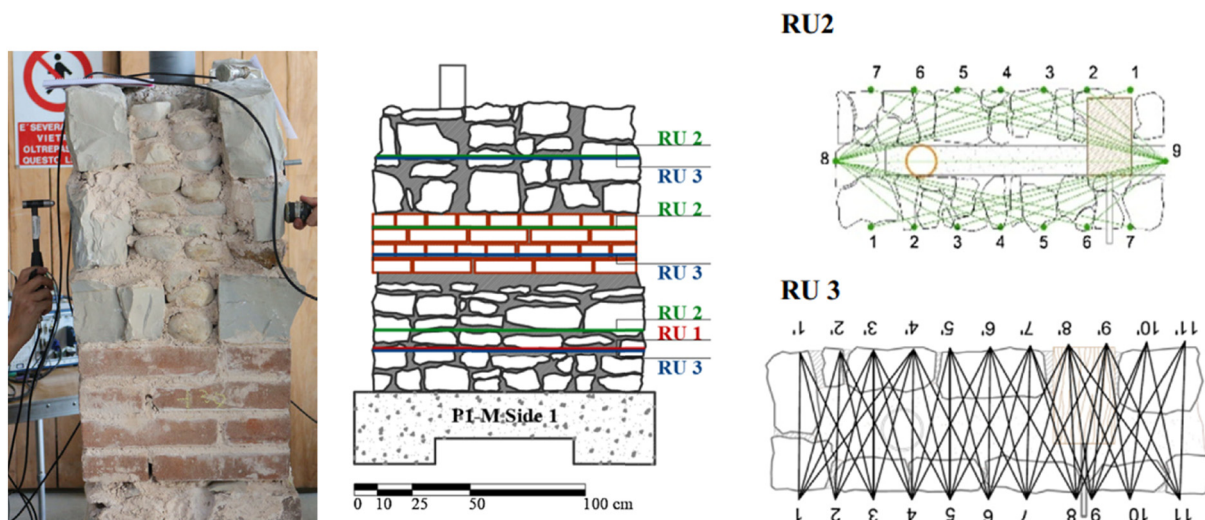
Figure 13: Exemplary specimen, tested cross-sections, and horizontal sonic tomography (Source: Valluzzi *et al.* [82]).

heterogeneity of masonry cross-sections was obtained through sonic methods in the case of the Cathedral of Noto. The research had a practical aspect, as it served to verify the state of damage and to indicate the possible renovation techniques in the reconstruction project (Figure 13) [83,84].

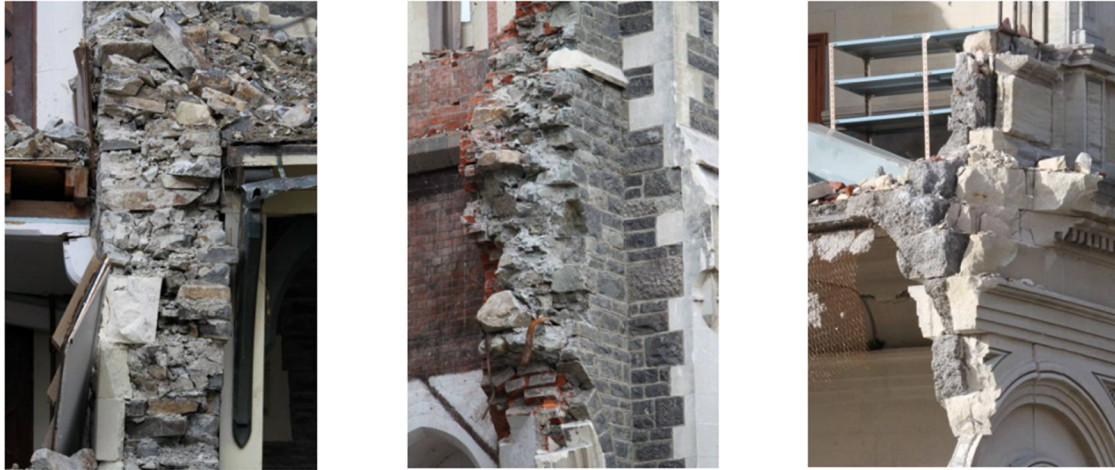
Figure 15: Stone masonry cross sections in New Zealand. From left to right: dressed stone in outer leaves and rubble fill, stone facing and brickwork backing, stone facing and concrete core (Source: NZSEE [98]).

The document also underlines the importance of the wall cross-section, indicating to identify any connections between wythes, determine the material of the core, and locate voids and cavities. It is stated that all these features contribute to determining the wall’s structural properties. However, no indications are given on how to quantify the contribution of these parameters (Figure 15).
