Research Article

Application of the terrestrial laser scanner in the monitoring of earth structures

Keywords: laser scanning, slope stability, earth structures

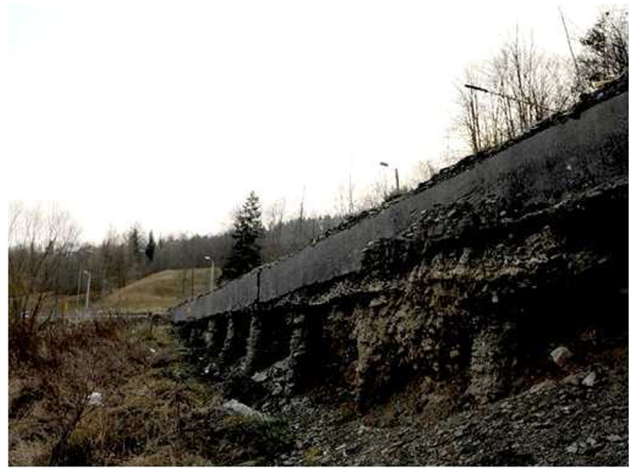
Figure 1: The overview of the road embankment located along the slope.

which includes clay shales, shales and fine-grained sandstones. Layer III is also located in the entire area below layer II. Figure 1 presents the overview of the road embankment located along the slope. One may notice significant deformations of the topsoil and visible damage of the road subgrade.

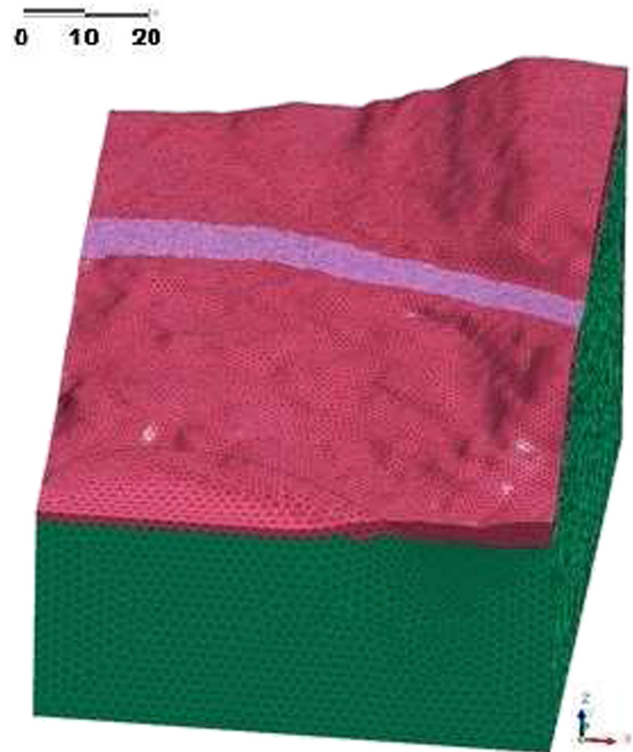
Figure 4: 3-D model of the terrain implemented into the FEM package MIDAS GTS NX.

TLS monitoring was carried out in late autumn and early spring. Based on a cloud of points measured, a 3D terrain surface was generated from the approximation of the point cloud using the finite elements technique. Following this, the spatial analysis of the road embankment was then made using the FEM package MIDAS GTS NX [28]. The numerical model was built taking into account the relief of the terrain surface obtained on the basis of TLS. The soil surface and the spatial arrangement of geotechnical layers, as well as the ground-water table, were modelled using data from geotechnical profiles taken from four different boreholes. The approximation of geotechnical layers was carried out with the assumption of a linear change along the boreholes. The numerical model utilised 13,95,941 hexahedral finite elements creating 2,44,102 nodes and 7,32,306 degrees of freedom (Figure 4). The number of equations was equal to 7,16,030. The boundary conditions were sliding joints with respect to the vertical axis, with blocking

displacements in the horizontal direction, for the planes xz and yz . The bottom of the model was fixed along the x , y and z axes. The values of the effective internal friction angle φ' and cohesion c' , soil unit weight γ' and the liquidity index I_L were adopted according to the existing documentation, while the Young moduli E_0 and Poisson ratio ν were adopted in accordance with the locally occurring parameters [26]. The clay layer was modelled as an elasto-plastic Coulomb–Mohr soil model. Both the shale layer and the road were modelled as isotropic elastic constitutive material. Table 1 presents the parameters used in further analysis.

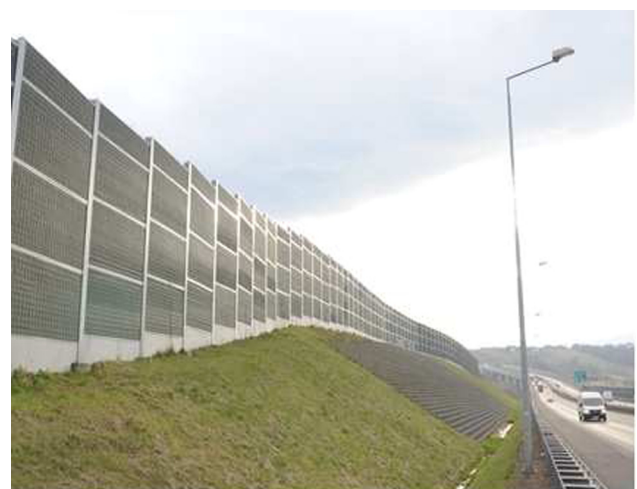
Figure 8: Overview of the slope with retaining structure and the noise barriers [33].

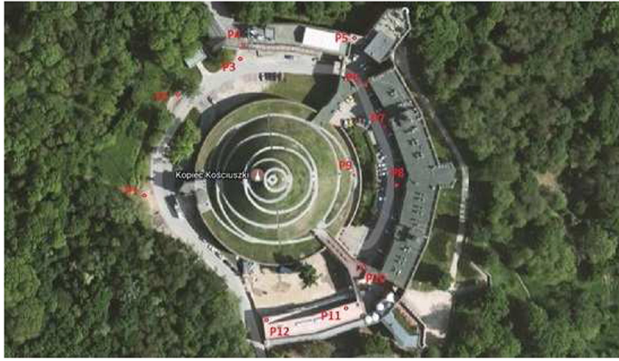
Figure 13: The aerial view of the mound with points of the TLS location.

presents the overview of the mound with several points of the TLS location marked. The measurements were performed over a year apart. Figure 14 presents the surface of the mound represented by the cloud of points. By overlapping two clouds of points representing the same surface, it was possible to create a differential model, which showed that almost the whole mound had deformed over the year between the measurements.

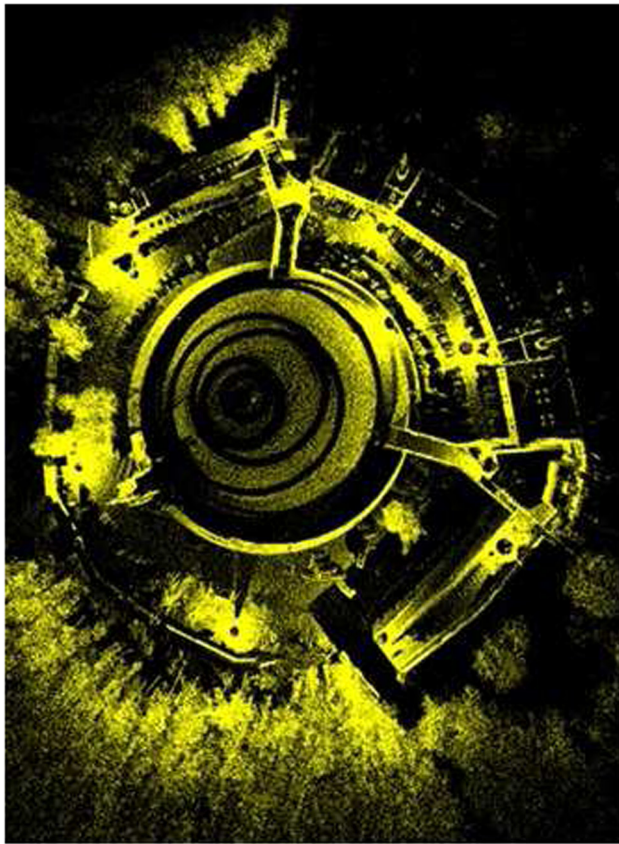
Figure 14: The surface of the mound represented by the cloud of points.
