Research Article

Disintegration characteristics in granite residual soil and their relationship with the collapsing gully in South China

Keywords: disintegration, granite residual soil, collapsing gully, NMR

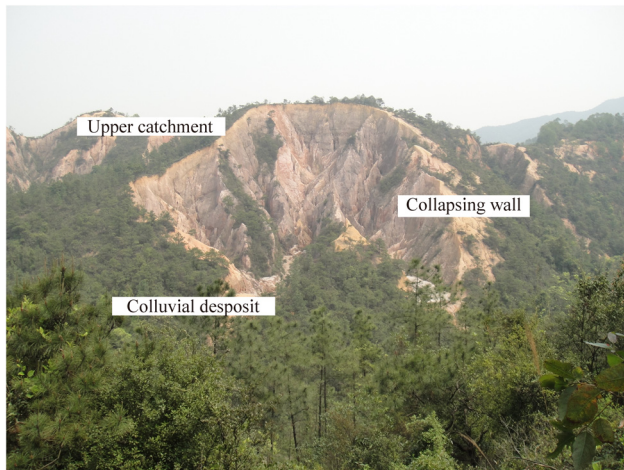
Figure 1: A typical collapsing gully in the hilly granitic region, consisting of (1) upper catchment, (2) collapsing wall, and (3) colluvial deposit.

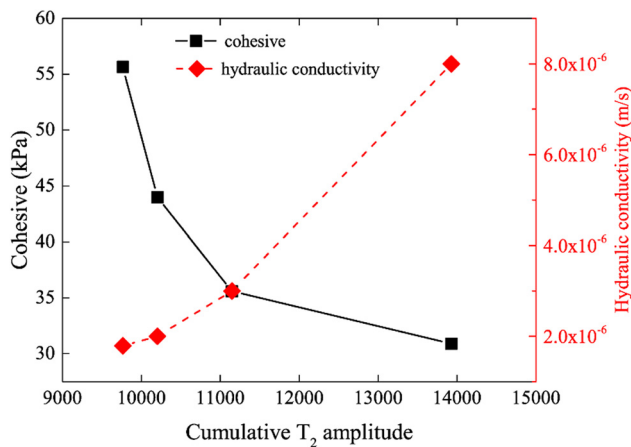
Figure 9: The relationship between cohesive and hydraulic conductivity with cumulative T_2 amplitude.

The internal pore content of the material was indirectly reflected by the cumulative T_2 amplitude. The relationship among cohesion, hydraulic conductivity coefficient, and cumulative T_2 amplitude is shown in Figure 9. It can be seen that the cohesive force and the cumulative T_2 amplitude value were inversely proportional to the decaying relationship while the hydraulic conductivity coefficient and the cumulative T_2 amplitude value were proportionally increasing. With the increase in cumulative T_2 amplitude, the cohesive force gradually decreased and the rate of decrease gradually decreased. The decay rate of the curve indicated that the sensitivity of the material cohesion to the change in the pore content was different. The cohesion of the material rapidly decreased when the pore content of the sample increased. Meanwhile, the change in cohesion was not so significant as the pore content continued to increase. The hydraulic conductivity coefficient increased as the

cumulative T_2 amplitude value increased, and the growth rate gradually increased. Especially, the hydraulic conductivity coefficient increases nearly six times when the water content was 0.6%, which provided better conditions for later water infiltration and accelerated disintegration or collapse.
