Research Article

Effect of groundwater fluctuation, construction, and retaining system on slope stability of Avas Hill in Hungary

https://doi.org/10.1515/geo-2020-0294 received July 12, 2021; accepted September 08, 2021

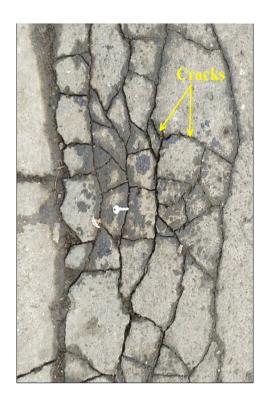
Figure 9: Tensional cracks in the asphalt coverage of the study area.

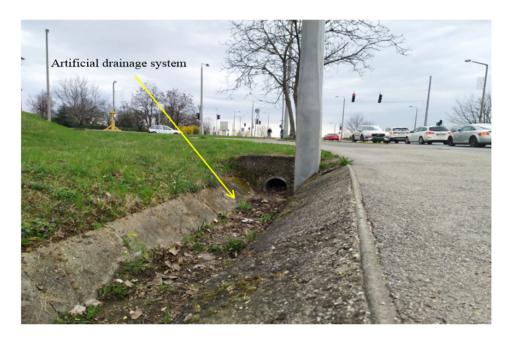
Figure 10: Drainage ditch (artificial systems) to diminish slope water infiltration.

attributed to the artificial drainage systems (e.g., drainage ditches), which were constructed to reduce the infiltration of slope water into the ground (Figure 10).
