S. Rajakumar*, V. Balasubramanian and M. Balakrishnan

Friction surfacing for enhanced surface protection of marine engineering components: erosion-corrosion study

DOI 10.1515/jmbm-2016-0013

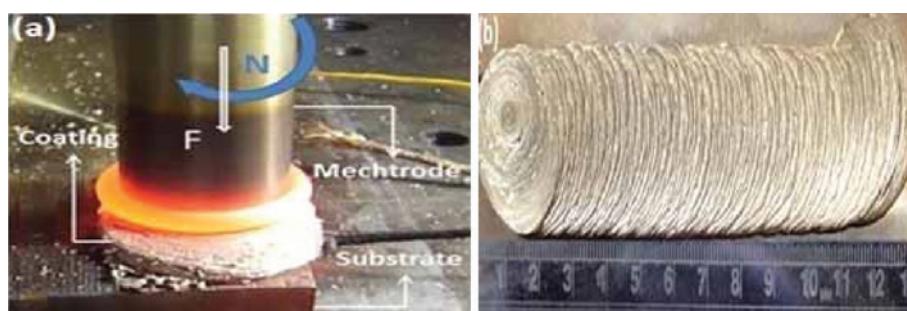
Figure 1: Friction surfaced sample.
(A) Deposition stage, (B) coating.

tools, Coimbatore, Tamilnadu, India) was used to perform the surfacing. The parameters used for surfacing are 200 mm/min traverse speed, 60 mm/min plunge speed and rotational speed of the studs of 2500 rpm rotational speed of the studs. Single layer surfacing deposit was considered in this study. The coating produced by the FS sample of deposition stage and coating is shown in Figure 1A and B.

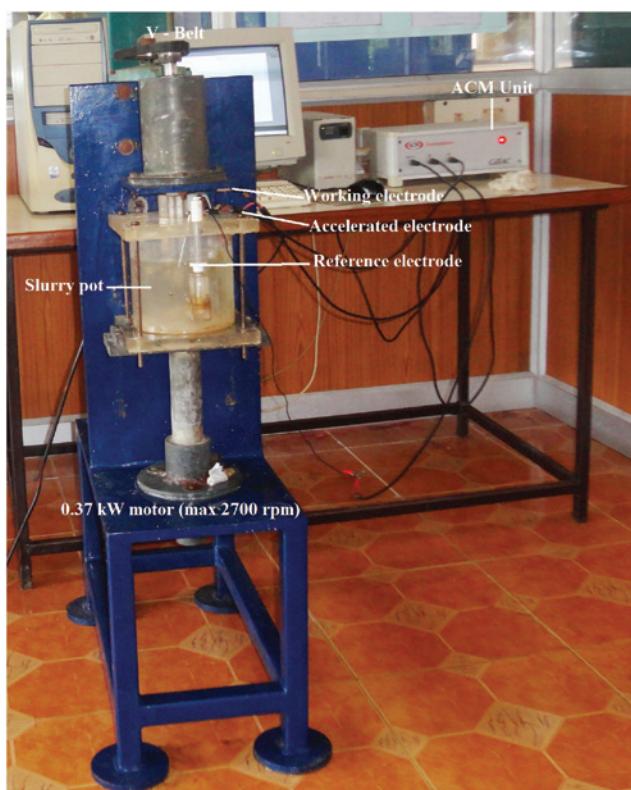
Figure 2: Erosion corrosion test rig.

Figure 2 represents the specially designed test rig to conduct slurry erosion tests. Slurry erosion corrosion test equipment is built in-house with AC-Gill Photentiostat supplied by Wear and Friction Tech, Chennai, India. This machine is capable of controlling the parameters like impact velocity (v), angle of impingement (h), mass flux rate (m), particle size (S) and distribution (d), and standoff distance between the nozzle outlet and target surface individually. Slurry erosion testing was conducted as per the ASTM G-73 standard procedure. Specimens were cut into a size of 10 mm diameter, 10 mm thick by using a wire cut electrical discharge machining (EDM) (Electronica-Pune, Maharashtra, India). Samples were polished with 2500-grid emery papers over the roughly finished surface. The samples prepared for slurry erosion-corrosion for substrate and friction surfaced samples are shown in Figure 3. Prior to testing, all the samples, surfaced as well as unsurfaced, were ground using emery papers up to 1500 grit size. Then, those were polished using 1- μ m alumina slurry paste on a disc polishing machine (Metatech-Industries, Pune, Maharashtra,

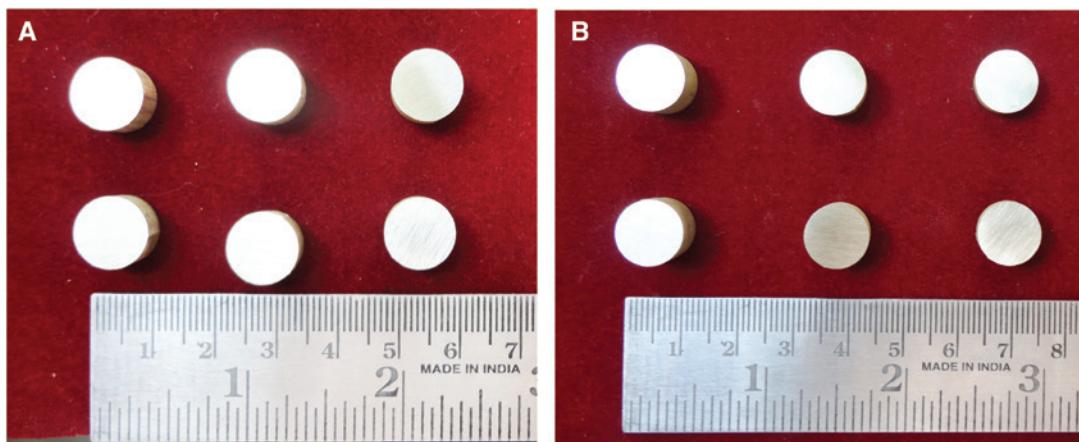
Figure 3: Erosion corrosion samples.
(A) Base metal, (B) friction surfaced samples.

The weight loss of the substrate and friction surfaced samples as a function of the impact angle in the presence of slurry was measured. It was noted that when the impact angle increased from 30° to 90°, the weight loss is decreased. Erosion rate is the difference between sample weights before the test with sample weights after the test. The corrosion rate was calculated from the formula (Eq. 1), and erosion and corrosion rates of base metal for 30° and 90° angle of impact is given in Tables 2 and 3. Figure 4A and B show the effect of impact angle on erosion-corrosion behavior of friction-surfaced NAB material. From

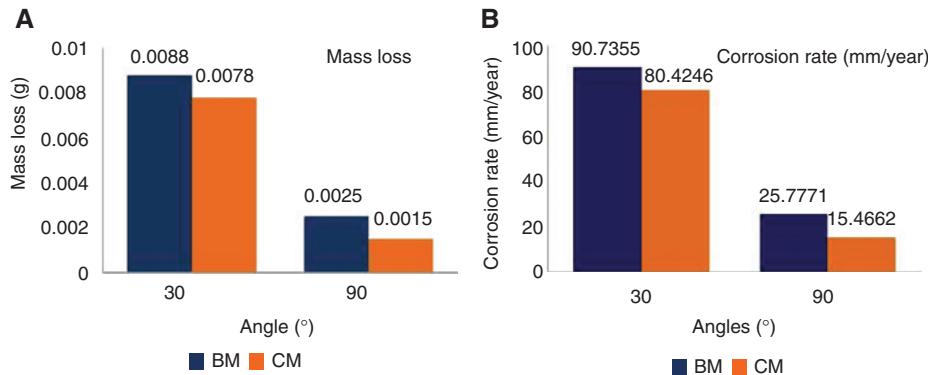
**Figure 4:** Bar chart shows the effect of impact angles in erosion rate (A) mass loss and (B) corrosion rate (CM-coated metal, BM-base metal).

Figure 4, it is observed that in both charts the erosion and corrosion rate decreases at 90°, compared with 30°. For the base metal, the corrosion and erosion rate is higher than the coated samples (Figure 4B).

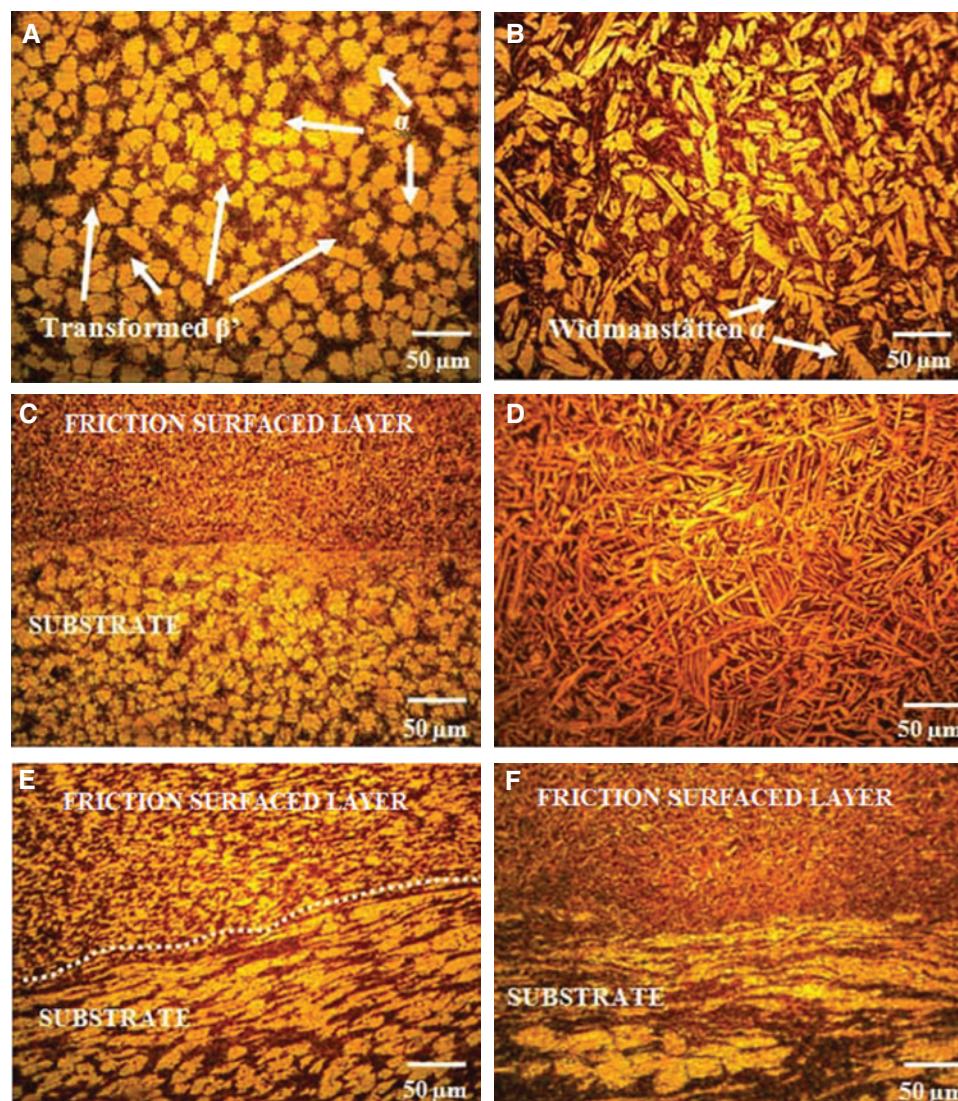
Figure 5: Optical microstructures of substrate, mechtrode and friction surfaced interfaces.
 (A) Base material-cast NAB, (B) mechtrode-extruded NAB, (C) interface-friction surfacing and substrate, (D) unmixed friction surfacing, (E) interface-friction surfacing and substrate, (F) interface-friction surfacing and substrate (α grains and β phase).

Figure 5A–F shows the optical micrographs of the substrate (cast NAB), mechtrode (extruded NAB) and friction surfaced zone. The cast NAB material has (Figure 5A) (i) α -phase, (ii) β' -phase formed during solidification alter to the FCC primary α -phase, (iii) globular kappa κ_{ii} (Fe_3Al) (medium gray), (iv) fine κ_{iv} precipitates which are also nominally Fe_3Al and (v) eutectoid mixture of β transformed $\rightarrow \alpha + \kappa_{iii}$ phase of proeutectoid κ_{iii} (NiAl) globular morphology (dark gray).

Tool (mechtröde) material shows a Widmanstätten pattern of microstructure (Figure 5B). The microstructure

consists of lamellar/few globular α -grains in addition to some flakes of α -grains, surrounded by quenched β -phase. Close to the surface of the layer, the phase is of lamellar shape. The friction surfaced interface microstructure reveals the good bonding of these layers. Figure 5C shows elongated α -grains mixed together with dark etching β -transformed products. This is due to the severe plastic deformation of the stir zone and experiencing a higher temperature than 800°C leading to the eutectoid reversion in to β -structure. In the unmixed friction surfaced region (Figure 5D), the microstructure clearly unveils the existence of α -grains (white needles) is smaller than that in the as-cast condition, which is actually very fine as compared to Figure 5B. This fine microstructure is due to the hot forging nature of the FS process [3, 25]. In interface locations, the microstructure comprises elongated α -grains and β -grains, but the size of α -grains is greater while the volume fraction of β -transformation products is lesser as observed in Figure 5E. In other locations (Figure 5F), both α -grains and β -transformation products are visible, but α -grains are highly deformed as compared to Figure 5E.

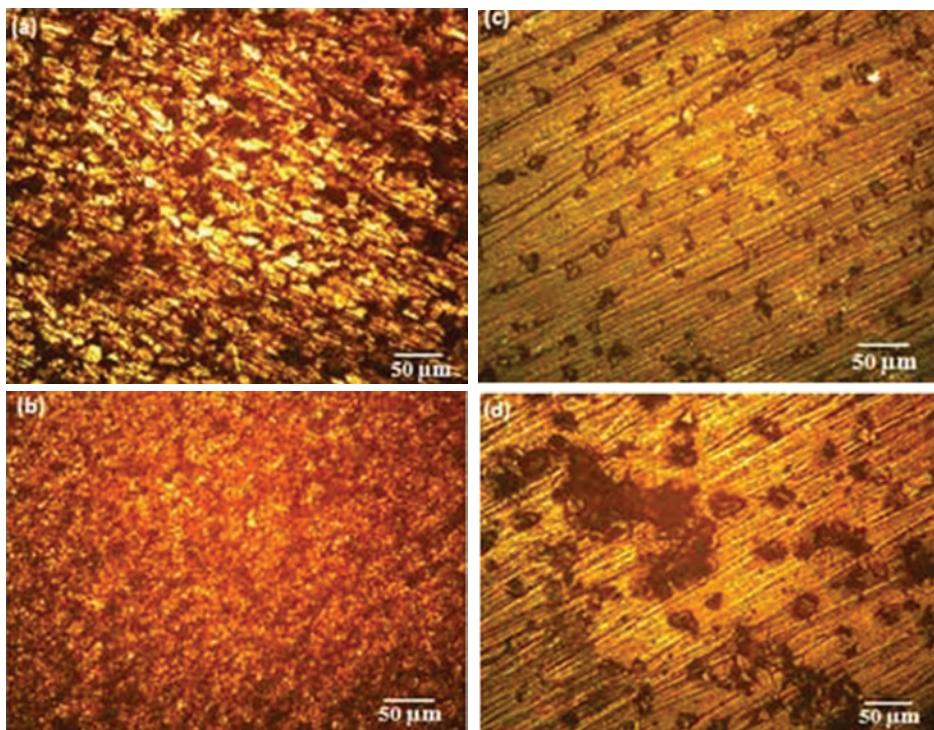
Figure 6: Optical microstructure of erosion corrosion.
 (A) Base metal at 30°, (B) base metal at 90°, (C) friction surfaced at 30°, (D) friction surfaced at 90°.

After the erosion-corrosion test, the damaged surfaces of the specimens were examined by optical microscopy as shown in Figure 6A–D. It is noted that due to the continuous impact of slurry on the samples, there was a presence of corrosion pits on the surface of the samples. It is observed that corrosion pits are more on the substrate than the deposit in both 30° (Figure 6A and B) and 90°

(Figure 6C and D). The number of corrosion pits is directly proportional to the weight loss. This is the main reason behind the weight loss of the samples after the test.

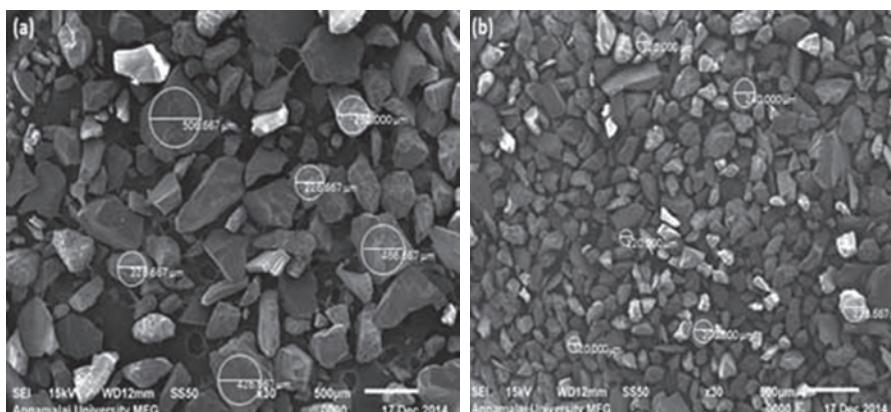
Figure 7: Scanning electron micrograph of silica sand.
 (A) Before erosion corrosion test, (B) after erosion corrosion test.

Figure 7A reveals the SEM of sand particles used in this study. The average silica sand before the test (size range of 220–500 μm) is shown in Figure 7A. It is noted that the size of the sand particles decreases from the nominal size range of 344 μm –177 μm (Figure 7B).

Due to the continuous impingement of sand particles during testing, the sand particle size reduces. Using a SEM, specimens tested at 30° and 90° were scanned on the surfaces at 250 \times magnifications, and micrographs are shown in Figure 8A–D. The base metal is heavily eroded (Figure 8A) when compared with the coated metal (Figure 8B). The corrosion products are formed all over the surface of the base material (both in 90° and 30°), whereas in coated sample, corrosion products are formed in selected areas only (Figure 8B and D). The rough surfaces are an indication of erosion. The white form or bright areas in the images shown in the figure represent the corrosion products. It is also noted that the

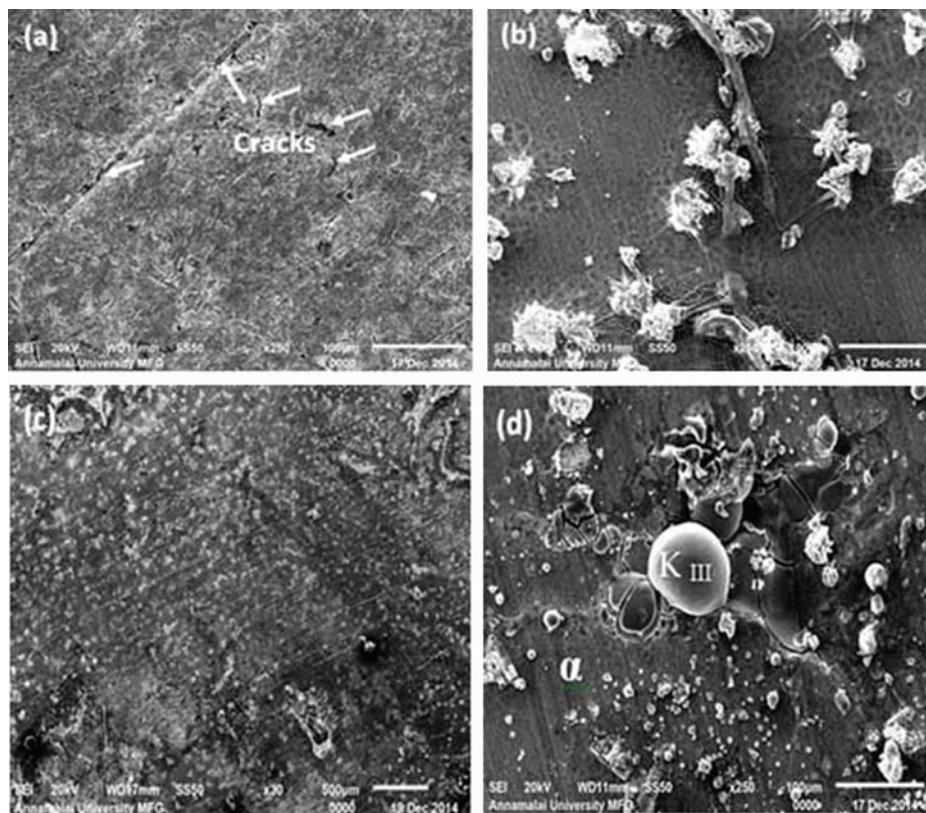
Figure 8: Effect of impact angle on erosion-corrosion morphology.

(A) Base metal at 30° , (B) coating at 30° , (C) base metal at 90° , (D) coating at 90° .

corrosion products are more in 90° substrate samples compared with 90° friction surfaced deposit samples as shown in Figure 8C and D.

The SEM study in Figure 8 shows that the NAB surface corrosion was initially confined to the eutectoid regions with a slight attack of the copper rich α -phase within the $\alpha+K_{III}$ eutectoid. While the eutectoid α -phase was preferentially attacked, the α -grains show very little attack; this is a form of selective phase corrosion [9, 28]. The accumulation of Cu_2O deposits at these locations will limit the diffusion (mass transport of species including copper ions, chloride and dissolved oxygen) toward and away from the NAB surface; thus, there is a potential for a microenvironment to develop beneath the deposit. If the pH of this microenvironment becomes acidic, e.g. below pH 4.0, the K_{III} phase becomes anodic to the α -phase and corrodes preferentially. From the experimental results, it is observed that the fine grain structure is more preferential to achieve high strength and less prone to erosion corrosion. The cast NAB base material samples are more eroded and forms more corrosion products than the friction surfaced samples.

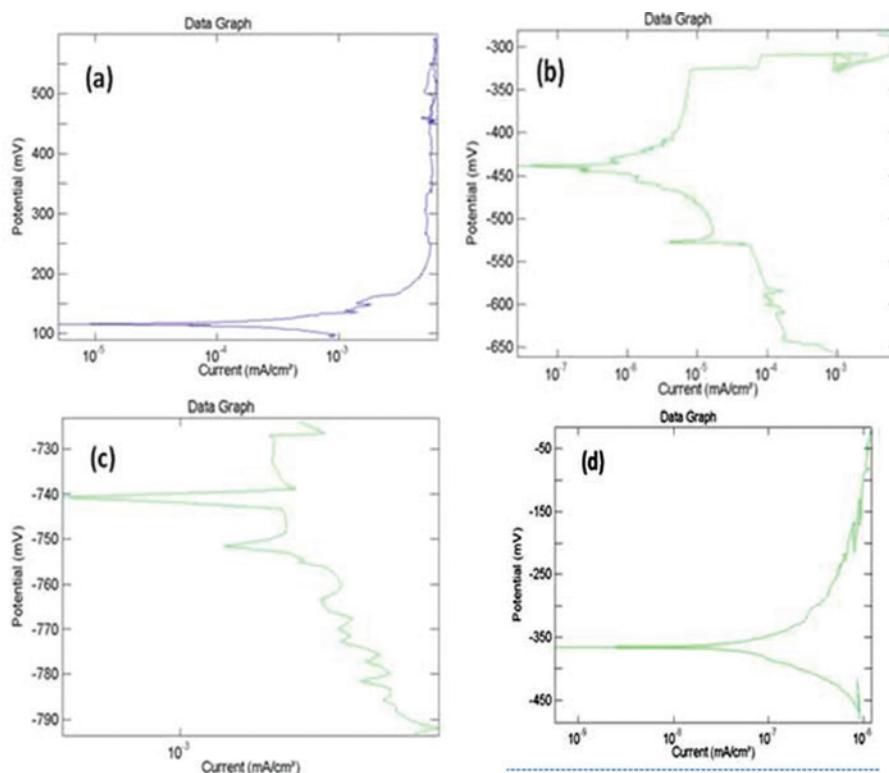
Figure 9: Polarization curve.

(A) 30° friction surfaced, (B) 30° base metal, (C) 90° friction surfaced, (D) 90° base metal.

Conjoint effect of erosion and corrosion behavior of friction surface and the base metal of NAB alloy is shown in

Figure 9A–D. From the pitting results, typical polarization curves are generated from impact angles of 30° and 90°, respectively. The respective I_{corr} value and rest potential are noted from the result generated by the software. It is noted that the corrosion rate is increased in 90° samples compared with 30° samples. The corrosion rate of coated samples decreases when compared with the base metal samples. The result generated by potentiostat is tabulated in Table 4.
