# Metrica – An application for collecting and navigating to geodetic control network points.

## Part II: Practical verification

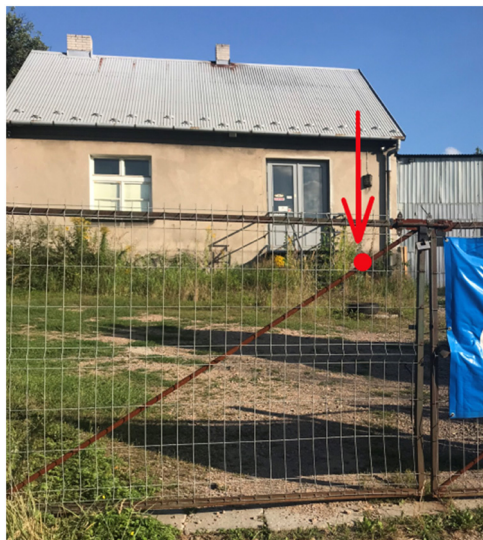
Figure 10: Photograph of building with inaccessible point.

The analysis of the point database was possible under the basic conditions: the point was accessible for inspection – criterion 2 and the point existed in the field – criterion 3. The given example demonstrates a point located on an unused building in a fenced area (Figure 10). Verification of information about the point and the possibility of its surveying are hindered because entering the area in the absence of the owner is not allowed.

Providing comments on hard-to-reach points makes it possible to plan surveys in the field more precisely, which greatly affects the economy of work – procedure A in the diagram (Figure 7, Part I).

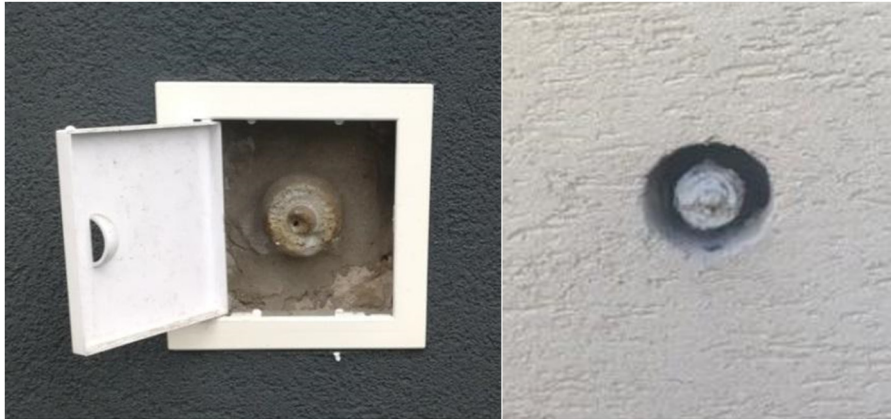
**Figure 13:** Points built-up in incorrect manner.

Currently, we often deal with survey markers in theoretically very good technical conditions that, after being built-up with insulation, become useless for levelling surveys. The reason lies in the ignorance of the owners who, wanting to protect them, are not aware of how surveyors use these points during surveys (Figure 13). Similar situations were encountered ten times during the control network analysis.

In the cases presented in the example for criterion 8, a surveyor using the application should post a photo and assign the point status as “not fit for surveys.” He or she may also provide information about the inability to perform surveys on the point, stating a specific reason for such a situation in the comments. In the application, the proposed scheme of conduct is point E from the scheme (Figure 7, Part I).

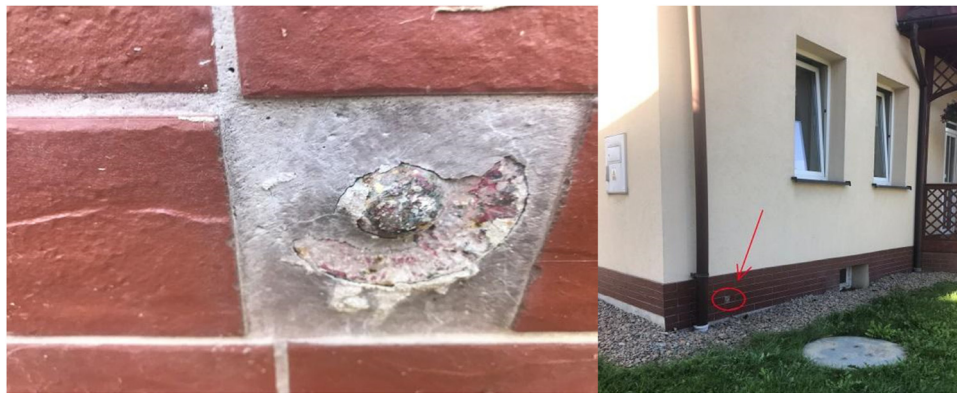
**Figure 14:** Photographs of the destroyed point – T point location zone.

example illustrated in the photograph (Figure 14), it can be seen that the survey marker has been destroyed. It is therefore not possible to perform a survey on this point.

In the case presented for criterion 9, the surveyor using the application should post a photo showing the actual point, give it the status of the point “not fit for surveys/destroyed” and include this information in the topographic description. In the comments to the point, it is possible to provide detailed information on the current situation. In the application, the proposed scheme of conduct is point E from the scheme (Figure 7, Part I).
