## Research Article

# Couple effects of multi-impact damage and CAI capability on NCF composites

**Abstract:** In this study, the mechanical properties of non-crimp fabric (NCF) composite laminates under low-velocity impact and compression after impact (CAI) tests were studied by Scanning electron microscopy (SEM) and Digital image correlation (DIC) techniques. The impact response under different impact times, impact angles, and impact distance is studied. Similarly, in CAI test, DIC technique is used to reveal the whole process of NCF composite compression failure, and SEM is used to reveal the microscopic failure form. The experimental results show that the impact damage process of NCF composites has strong directivity. The concrete manifestation is that the internal failure will extend along the paving direction at the failure layer. The peak load generated under 20 J impact energy is about 1/2 of that under 40 J impact energy. The impact distance is one of the important factors affecting the coupling effect of multiple impacts, and the impact angle has little effect on the internal damage extension. The proportion of internal damage area also supports the relevant view, that

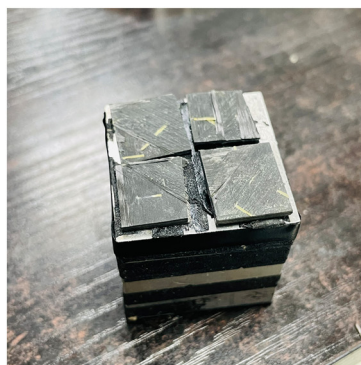
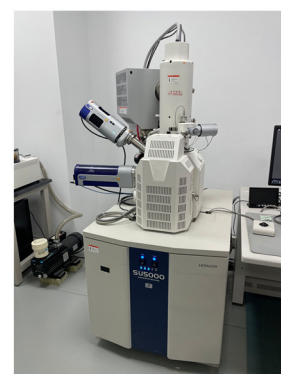
**Figure 6:** (a) SEM test piece and (b) SEM equipment.
