Bernhard Pichler\* and Wolfgang Kautek\*

# Surface investigations of bronze and brass statutory monuments in open-air exposure

**Keywords:** patina; copper; bronze; surface analyses; conservation

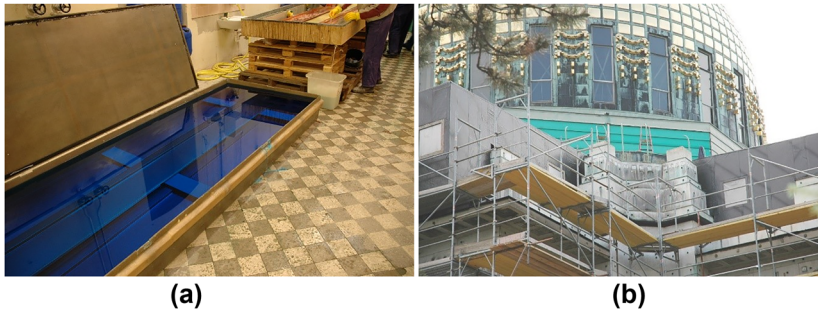
**Figure 1:** Artificial brochantite patination for the tambour sheeting of the Otto Wagner Church in Steinhof, Vienna, 2004. (a) Bath with submersed copper sheet, (b) tambour with new sheeting. © University of Applied Arts Vienna.

Therefore, green patina phases were synthesised, particularly the most stable type, brochantite,  $\text{Cu}_4(\text{OH})_6\text{SO}_4$ .<sup>1,23–28</sup> The synthesis by a solution-chemical technology of artificial brochantite patination layers was e.g. applied 2004 at the tambour sheeting (approx. 400 m<sup>2</sup>) of the Otto Wagner Church in Steinhof in Vienna (Figure 1).<sup>24,26</sup> Scanning electron microscopy (SEM) images of the surface textures of the typical reddish coloured cuprite and the greenish brochantite are shown in Figure 2.

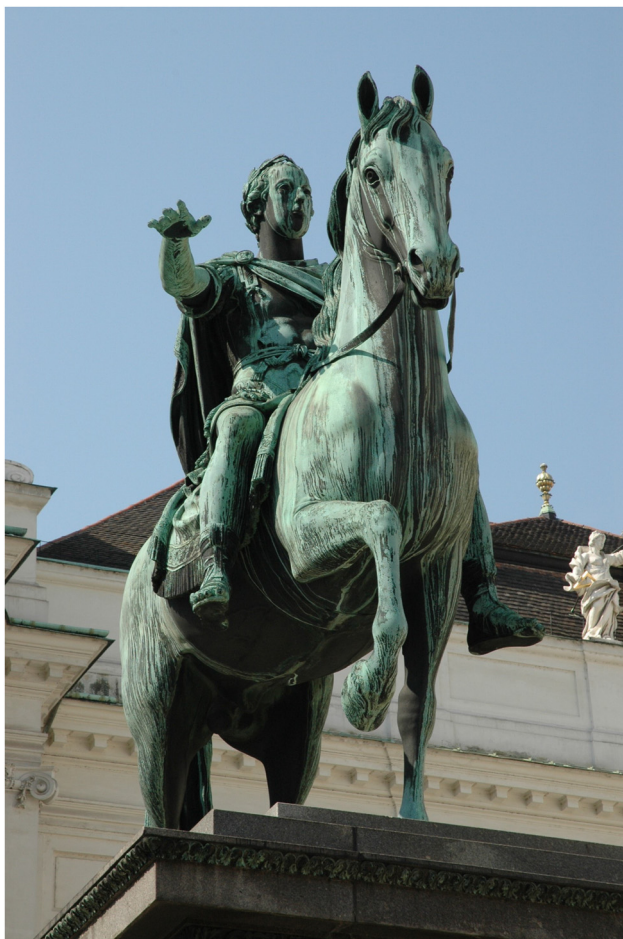
**Figure 5:** Emperor Joseph II. Memorial, Josefsplatz, Vienna. Unveiled 1807. © University of Applied Arts Vienna.

phenomenon is discussed below. The lower end of the horsetail of the Emperor Joseph II. Memorial exhibits a microstructure with grains of  $\alpha$ -solid solutions (Figure 4b). A metallographic colour etching of a sample from the right horse hock of the Peter the Great Monument also shows a dendritic alloy structure (Figure 4c).

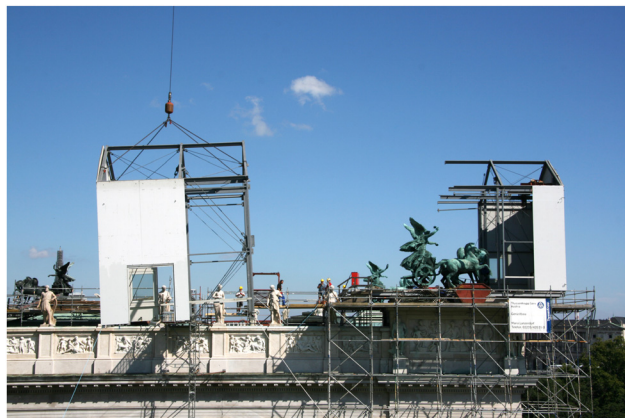
**Figure 7:** Construction of the housing on the roof of the Austrian parliament for the restoration of one of the Quadrigas. © Parlamentsdirektion, Michael Buchner, Picture ID: 2652377. Date of photograph: 22.08.2007.

Quadrigas finished in 1885 were restored on the roof of the Austrian parliament in the period 2007–2016.<sup>52</sup> Housings were established for this purpose (Figure 7). XRD data of patina formed on the right wing of a Nike figurine indicates basic copper sulphate, brochantite, as the major corrosion product together with quartz (Figure 8, left). XRD and EDX findings from a sample taken under a removed wheel hub of the left carriage wheel (Figure 8, right) indicate the presence of a chloride bronze patina,

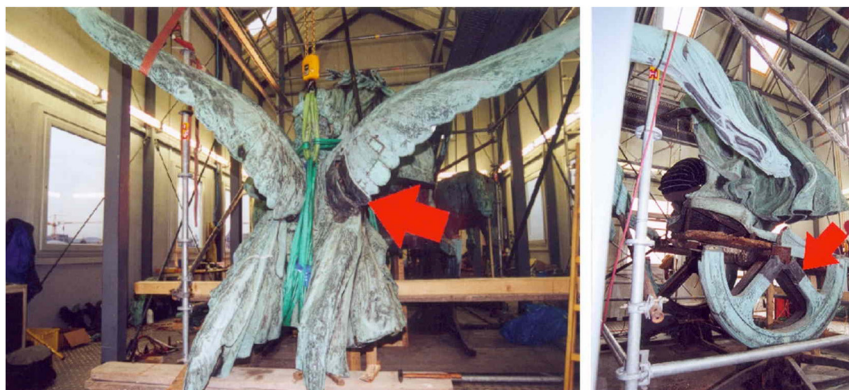
**Figure 8:** Quadriga (1885) on the northeast corner of the south wing of the Austrian parliament before conservation interventions. Left: Right wing of the Nike # Q21a. Right: Left chariot wheel # Q21b. © Atelier Mag. Elisabeth Krebs, Vienna.<sup>52</sup>

the basic copper chloride atacamite,  $\text{Cu}_2(\text{OH})_3\text{Cl}$ , a product that usually occurs in the marine environment. The source of the emitter that led to chloride corrosion products has not been resolved. Cl-containing air pollutants, in contrast to  $\text{NO}_2$ ,  $\text{SO}_2$ , and soot, were not routinely recorded in a dense network of measuring points in Vienna.<sup>29</sup> The basic copper sulphate, brochantite, represents the expected major component. Surface studies have shown that there can be a higher Sn content in the outer area of green areas compared to the outer black regions. It is assumed that in areas that are not regularly irrigated, the originally formed Sn-oxide is covered by deposits and corrosion products, whereas in areas that are constantly exposed to rain, surfaces are cleaned and brochantite or atacamite mainly remain.

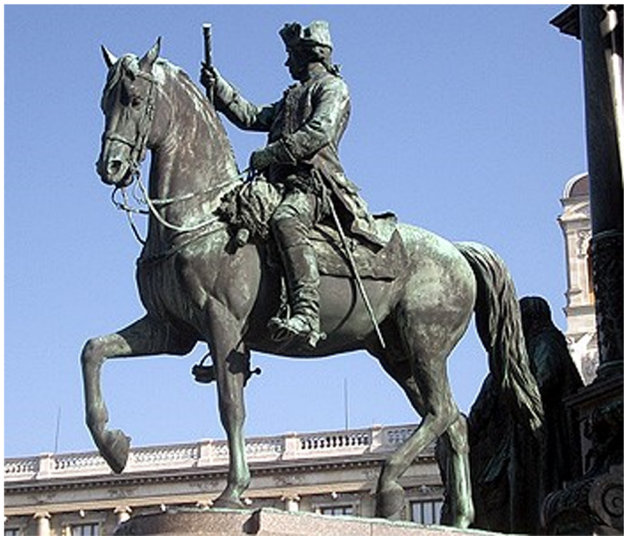
**Figure 9:** Gideon Ernst von Laudon of the Maria Theresa Memorial before conservation interventions 2013, Maria Theresa Square, Vienna. © University of Applied Arts Vienna.

The Maria Monument in Vienna (1887) with its four victorious generals on horseback is a work of art from the same period of Ringstrasse construction as the quadriga on the Austrian Parliament building just discussed. An exemplary sample was taken from the lower part of the horse's tail of General Gideon Ernst von Laudon equestrian statue before the restoration in 2013 (Figure 9). The optical image of the surface cross-section shows a black crust on the partially corroded parent metal (Figure 4a). The same region has been analysed by EDX for elemental mapping (Figure 10). The bulk alloy consists mainly of Cu (Figure 10a). In some alloy dendrites, which exhibit intersections with the surface, Cu was depleted in favour of Sn from the base

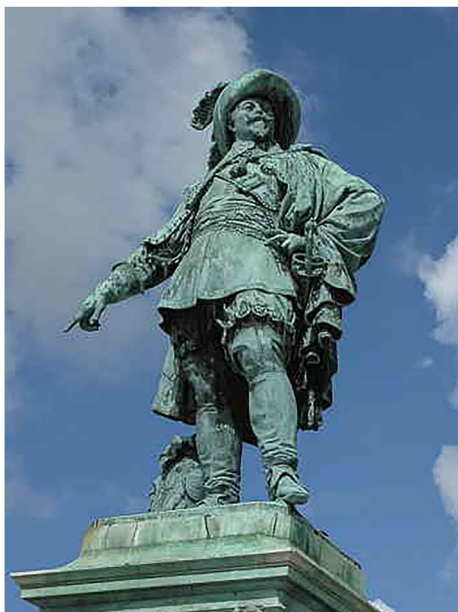
**Figure 11:** Gustav II Adolf Memorial, Gothenburg, Sweden (1854). Aspect from south. © University of Applied Arts Vienna.

Gustav II. Adolf, of the Vasa dynasty, was King of Sweden between 1,611 and 1,632 and one of the important figures of Swedish History and of the Thirty Year's War. His memorial in Gothenburg, Sweden, was unveiled in 1854 (Figure 11). A metallographic cross-section of a sample of the spur on the right boot (Figure 12) reveals a black crust (ca. 30  $\mu\text{m}$ ) on top of corrosion layers appearing yellowish and reddish in the cross section image (ca. 60  $\mu\text{m}$ ). The reddish component represents cuprite,  $\text{Cu}_2\text{O}$ , which is commonly the first bronze conversion layer.<sup>6,22</sup> The yellow phase may indicate the
