The effects of intensive rainfalls (flash floods) on the development on the landforms in the Kőszeg Mountains (Hungary)

Research article

Abstract: The effects of the intensive rainfall episodes in the years 2009 and 2010 in the Kőszeg Mountains were investigated. Channel profiles were constructed at various times during these periods, which were used to describe the channel changes. We measured the length of the incised and filled sections on multiple occasions. We could establish the degree and the direction of the changes using this data. The sediment veneer that developed in the area of Kőszeg town was mapped and its conditions of development were examined. The erosion and accumulation landforms developed during these years were classified and described. These forms are the following: rills, gullies, alluvial fans and sediment veneer. We distinguished and characterised those which had previously formed, but they were changed or increased (the channels). We established the conditions under which the sediment veneer can develop, furthermore those conditions which can increase the chance of the formation of this landform. These conditions are the following: the high density of ro

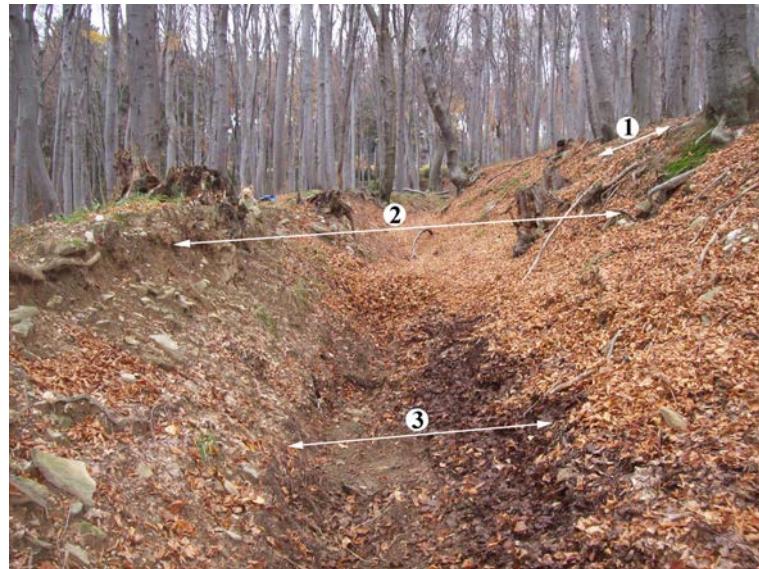
Figure 9. Gully developed in a hollow road in the placePlaceNameBozsoki PlaceTypeValley on 24.06.2009 (date of picture: 30.10.2009).
 Legend: 1. valley side, 2. deep road, 3. Gully.

(Fig. 9) and the incision of new gullies has also been observed.

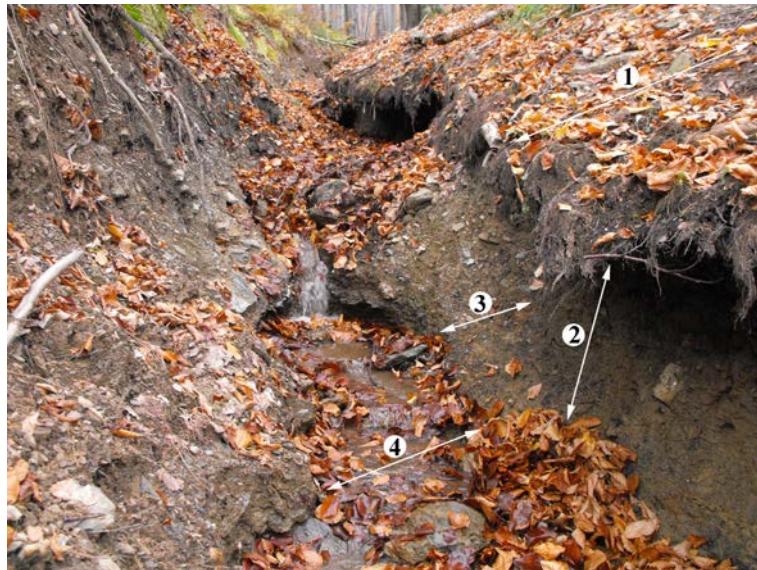
Figure 11. Channel of the Bozsoki Valley at the profile marked III. (time of picture: 30.10.2010)
 Legend: 1. older channel which developed before 24.06.2009, residual of channel floor, 2. overhanging channel slide, which developed during the repositioning of the channel line, 3. channel which developed on 24.06.2009, 4. channel which developed after 24.06.2010 (this probably developed on 22.09.2010).

Through incision of the channel floor, internal channels developed along some sections of the pre-existing channels (Fig. 11, Fig. 8). Various channel shapes developed by repeatedly renewed incision.

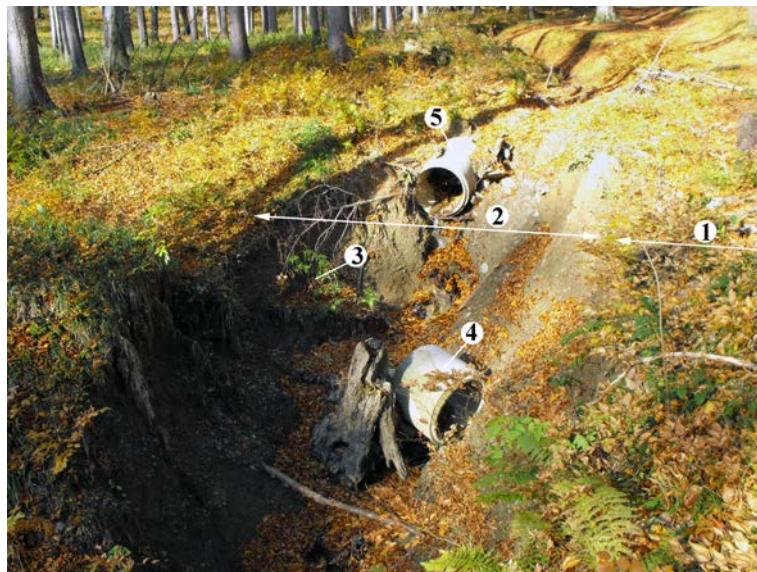
Figure 12. The channel of the Bozsoki Valley at profile marked I. (time of picture 30.10.2010)
 Legend: floor of Bozsoki Valley, 2. channel, 3. collapsed part of channel side, 4. moved bridge part (concrete ring), 5. concrete ring of the bridge which is stable.

Incised parts developed on the channel sections under the bridges of the channel of the Bozsoki valley (Fig. 12). The concrete rings of the bridges make parts of the channel more resistant. Therefore, the channel slope increased downstream of these well rings.

A considerable proportion of transported sediment accumulated on the channel sections upstream of the bridge, as the sediment filled the tubes of the rings of the bridges, contributing to this process. Thus, the water which flowed through or above the tube of the bridges, increased the efficiency of the work of the stream. Intensive channel deepening happened under the bridges in at least three places on the floor of Bozsoki Valley in 2009. The degree of deepening was greater than 3 metres at some places (Fig. 12, Fig. 8 at profile marked I). Steps also developed

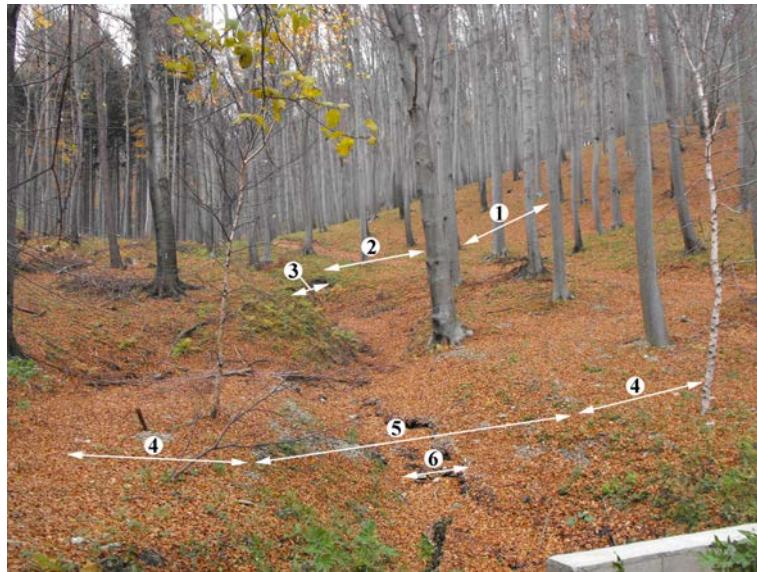
Figure 14. External alluvial fan from the floor of the Bozsoki Valley (time of picture: 30.10.2010)

Legend: 1. slope of Bozsoki Valley, 2. floor of Bozsoki Valley, 3. floor channel, 4. alluvial fan which developed on 24.06.2009, 5. channel on the alluvial fan, which developed after 24.06.2009, 6. new channel which developed after 24.06.2010.

In the mountains alluvial fans which developed in 2009 may be found within the channels (internal fans – Fig. 14) or outside the channels (external fans – Fig. 15). The internal alluvial fans of the channel developed in the depression (for example in channels), which were created by the rainfall or streams. The external alluvial fans are greater than the size of such depressions. Primarily internal alluvial fans developed during the intensive rainfall of 2009 in the mountains. The shape of the alluvial fans is controlled by the bearing channels, being of elongated shape in the direction of the bearing channel. The size of the alluvial fans may be several tens of metres along the strike of the channel with a width of a few metres. The downstream end of the structures are steep, while the upstream end smoothes gently into the channel with more fine grain deposit at their upper end.

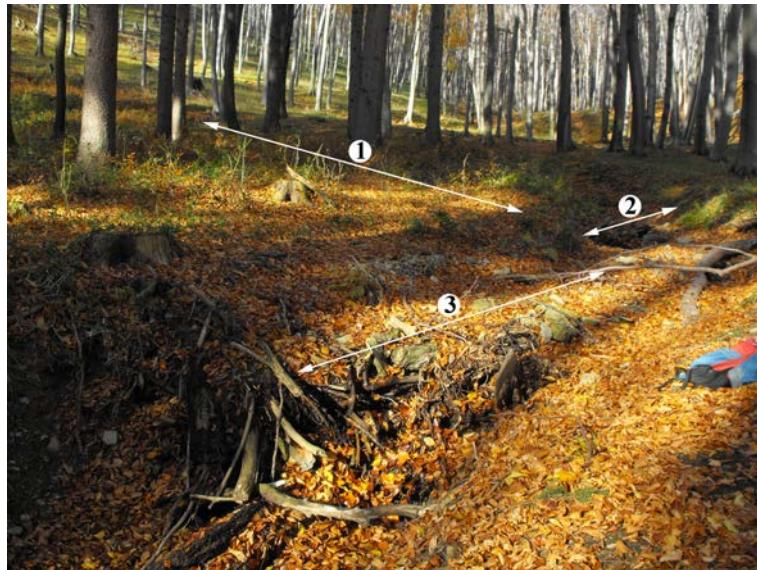
Figure 15. Internal alluvial fan (time of picture: 30.10.2010) Legend: 1. floor of Bozsoki Valley, 2. channel, 3. alluvial fan.
