# Failure Analysis of a New Turbine Parting Plane Stud

H. Roy\*, A. Saha, D. Ghosh, S. Ray and A.K. Shukla

## ABSTRACT

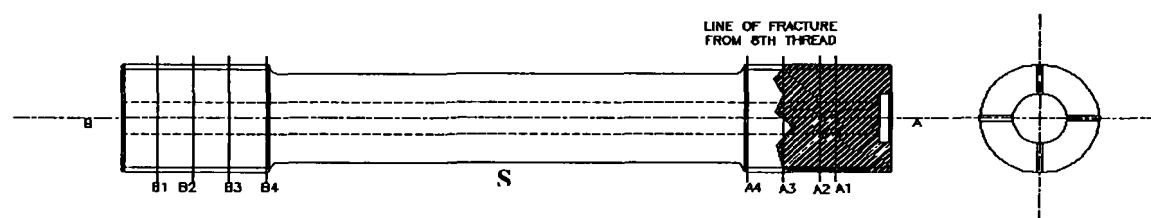
Fig. 4: Location of samples for SEM and Metallography

For conducting mechanical tests and microstructural characterization, samples were prepared from the threaded portion of the nut end, the other end, and shank of the stud, and were marked as 'A', 'B' and 'S' respectively as shown in Figure 4. The extraction of samples from the failed stud for conducting tensile and impact tests are shown in Figure 5.
