Inspection of Thick Composites for Near Surface Flaws

A. Fahr*, B. Roge, M. Brothers and D.G. Zimcik

*Structures, Materials and Propulsion Laboratory
Institute for Aerospace Research
National Research Council Canada
Ottawa, Ontario, K1A 0R6*

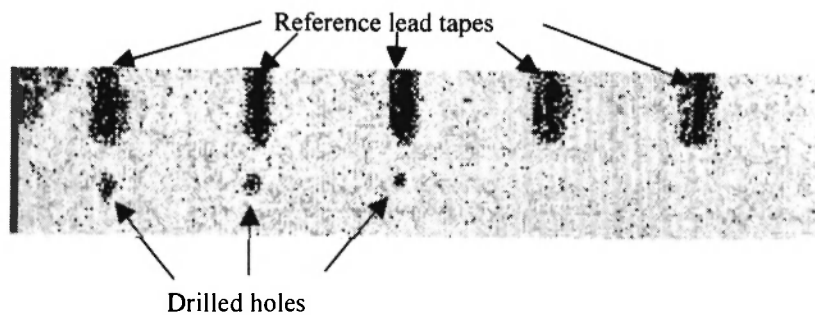
Fig. 5: Amplitude pulse-echo C-scan at Rayleigh wave angle. Probe characteristics are 10 MHz; focal length 12.5 mm; diameter 12.5 mm.
