Research Article

Emilio Trigueros, Manuel Cánovas*, Javier Arzúa, and Manuel Alcaraz

Stability of an abandoned siderite mine: A case study in northern Spain

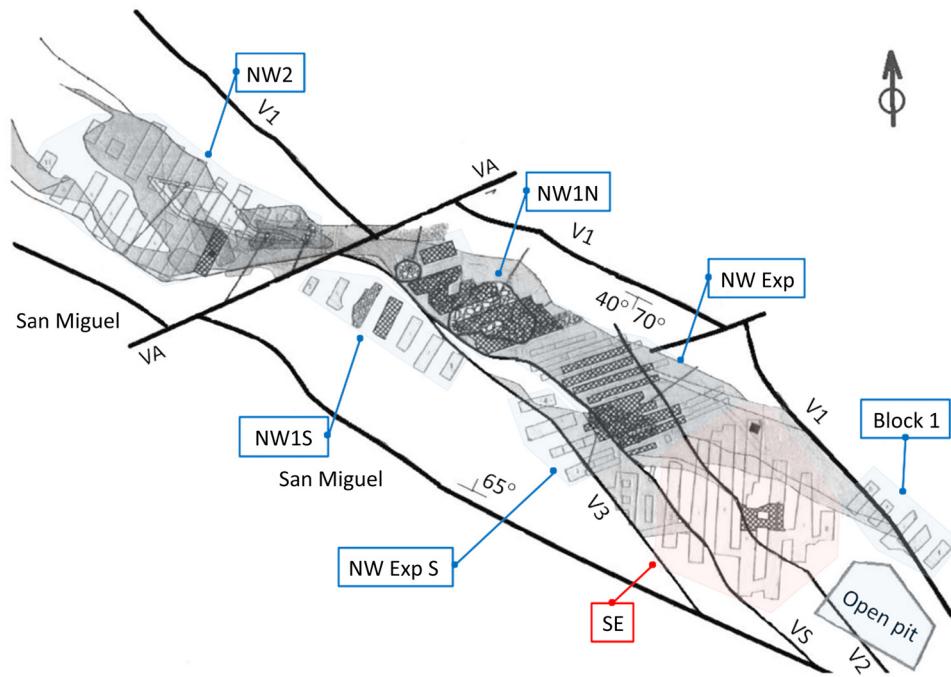
Figure 1: General plan view of the Bodovalle mine, showing the faults conforming the graben and the layout of the rooms. The study area is the SE zone, marked in red, and the remaining zones are indicated in blue.

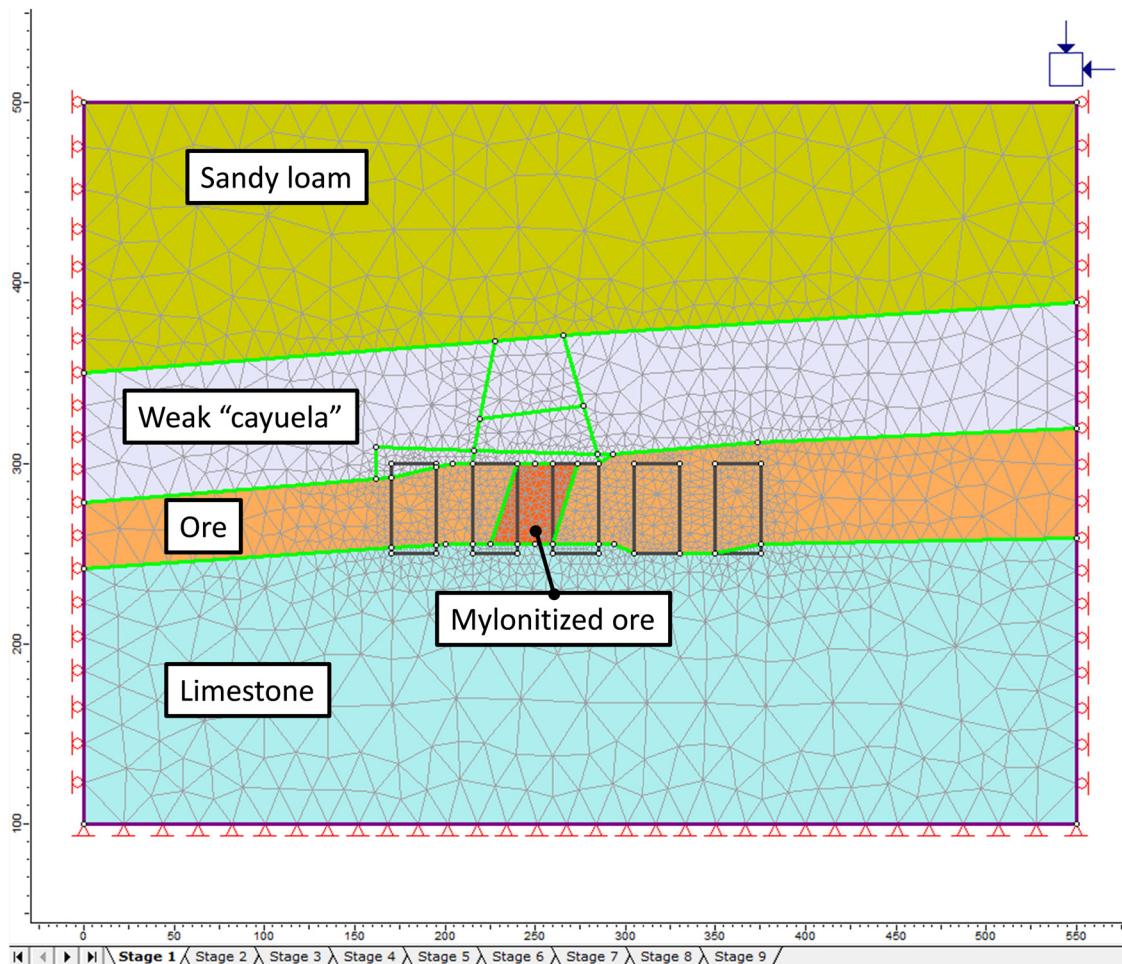
The main objective of this analysis was to fine-tune the geomechanical parameters of the different materials. A FEM of the NW1N zone (Figure 4) was performed according to the characteristics of the collapse as documented in the technical report of the failure:

Figure 4: Initial numerical model of NW1N zone rooms where the 1999 collapse occurred.

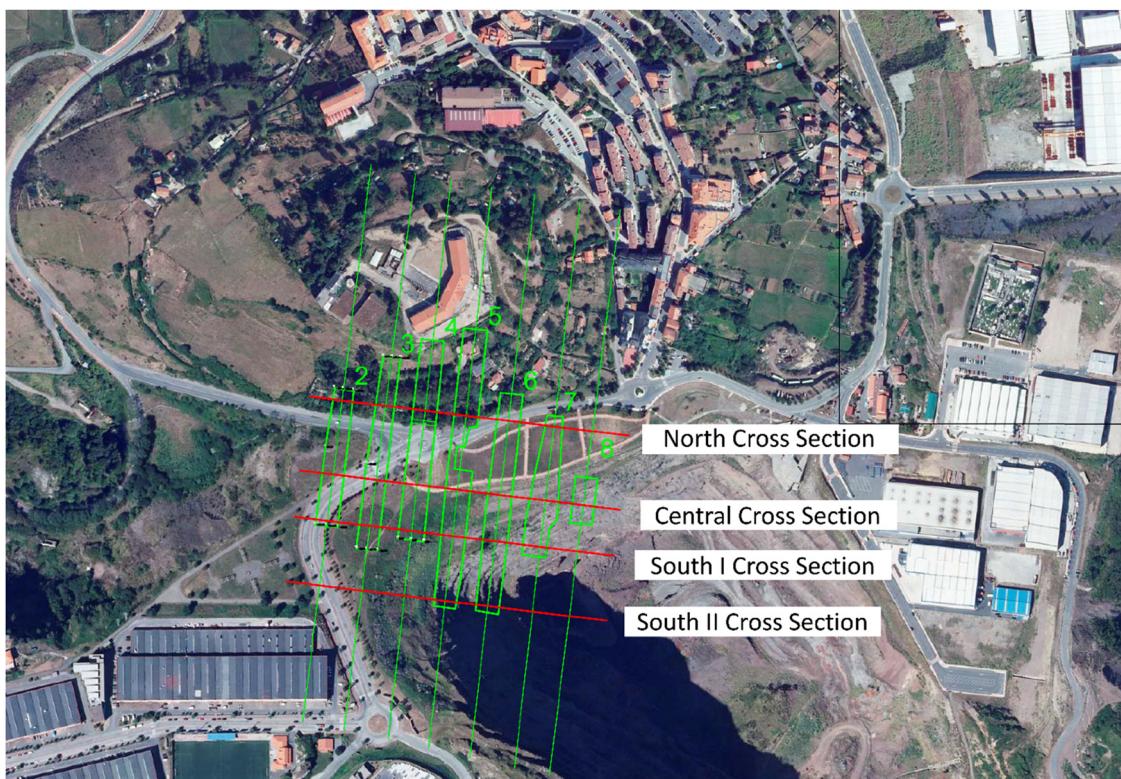
Since the geometry and locations of the rooms were different, four different cross sections of the SE zone were considered, as depicted in Figure 6, which shows the risky situation of the area located over rooms #3, #4, #5, #6 and #7 if any of these rooms collapsed.

Figure 6: Location and geometry of the SE zone rooms.

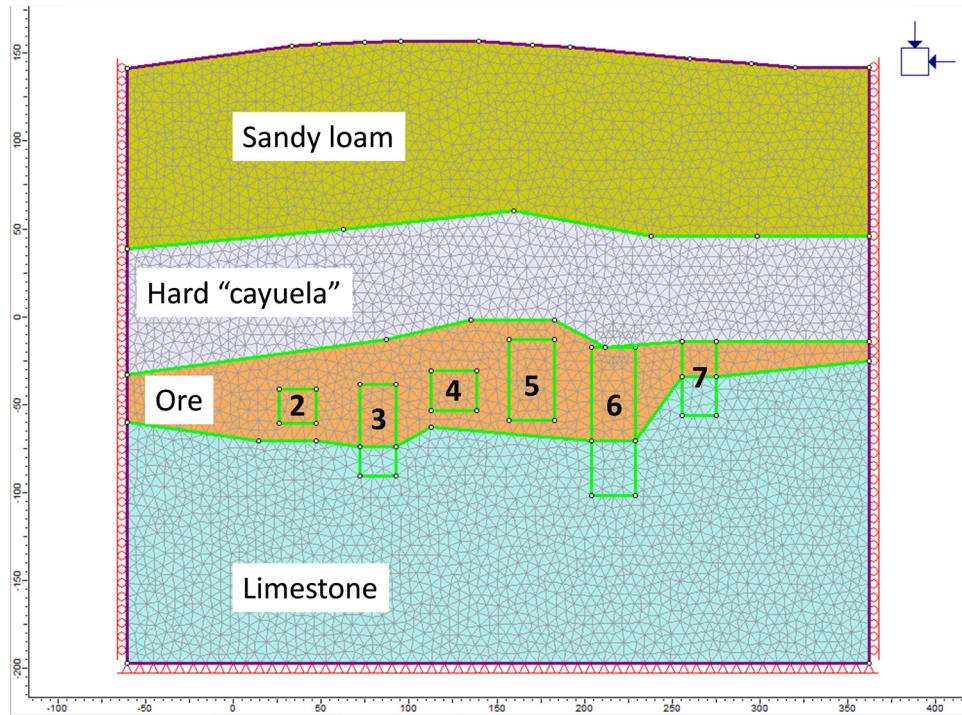
The northern cross section goes through rooms #3 to #6 and through the northern end of rooms #2 and #7 (Figure 6). This section was selected for analysis because of the road and the children's playground located over rooms #6 and #7. Figure 7 shows the FEM geometry and the materials. Note the different geometries of the rooms, going deep into the footwall of limestone in some cases and remaining far from the hard *cayuela* of the roof in other cases. This situation and the geometry are probably due to a lack of planning. Noteworthy is the extraordinary height of room #6 (84 m) and also the fact that, except for rooms #6 and #7, the rooms have ore in the roof.

Figure 7: Geometry and materials of the northern cross section of the SE zone rooms.

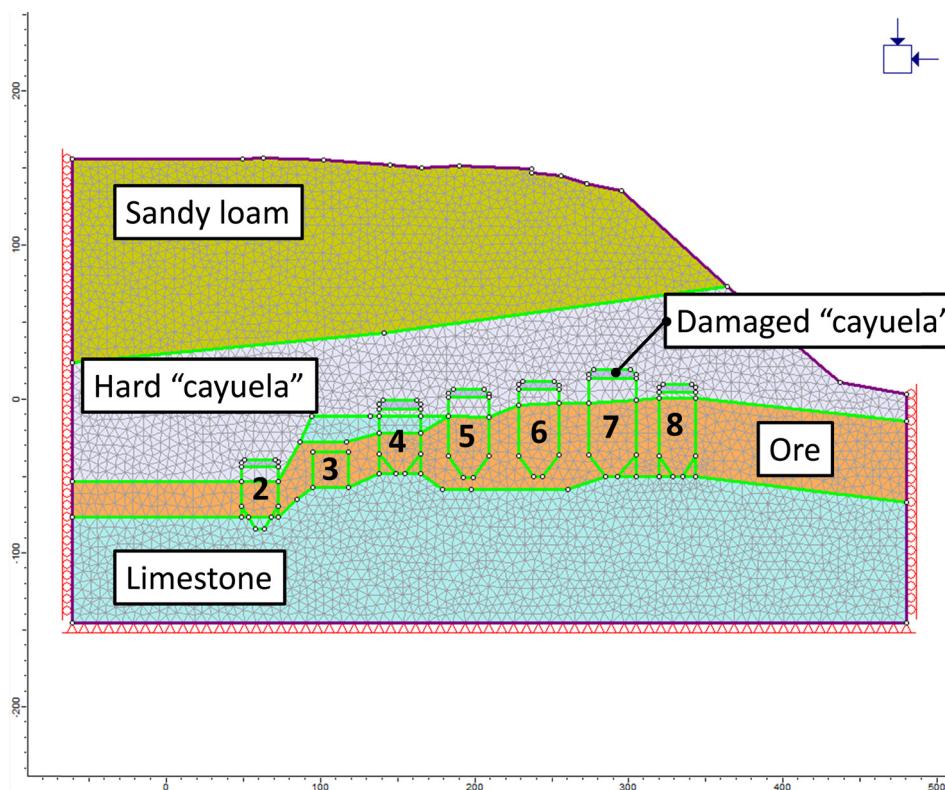
Some 60 million 3D points were scanned and the 3D point cloud was processed using Cyclone 9.0 software (developed by Leica). The digital geometry allowed the following conclusions to be drawn: (i) the widths of the three rooms and the pillars were practically identical to those documented in previous works; (ii) the extended range of the 3D laser scanner was insufficient to measure the total lengths of SE rooms #6 and #7 and (iii) the cross-sections of the rooms were not rectangular, the corners between walls and roofs were curved and the corners between wall and floor appeared funnel shaped (see Figure 9).

The central cross section goes through rooms #2 to #8. This section was selected because the slope of the open pit may affect rooms #7 and #8, as will be explained below. Figure 9 shows the FEM geometry and the materials. Contrasting with the northern cross section is the similar geometry of these rooms, with rounded corners in the roofs and funnel-shaped floors. A 5-m (determined as a function of the tension strength of the intact rock and the peak particle velocity originated by production blasting [45]) layer of damaged *cayuela* was added to the roof of each room to take into account the damage produced by production blasting.

Figure 9: Geometry and materials of the central cross section of SE zone rooms.

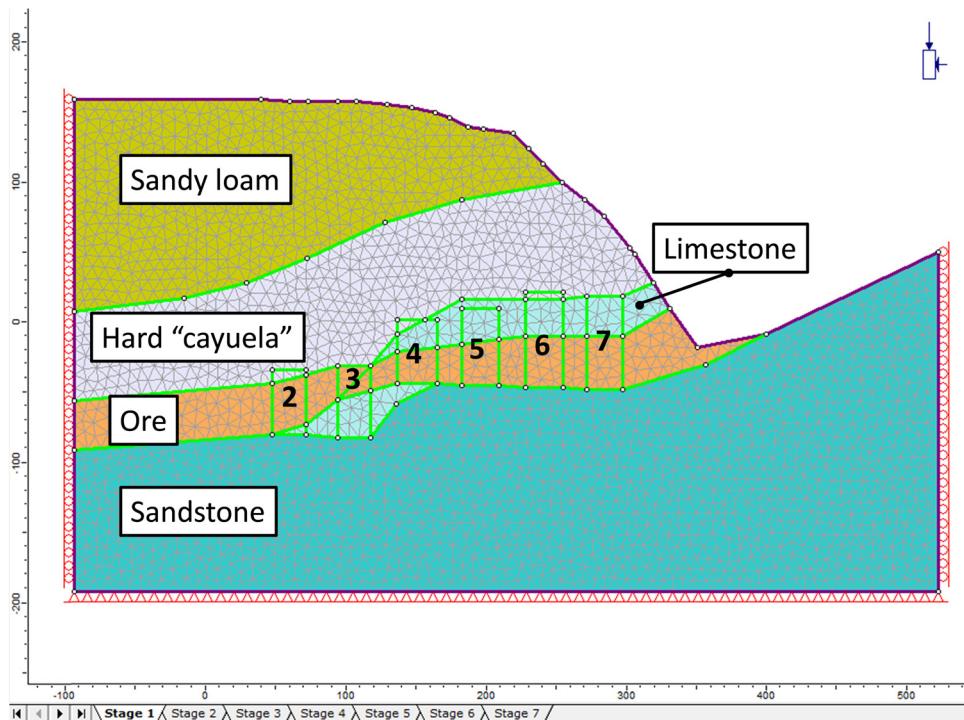
Figure 11: Geometry and materials of southern cross section I of the SE zone rooms.

Southern cross section I goes through rooms #2 to #7 and correspond to the southernmost end of rooms #2, #3, #4 and #7 (Figure 6). In this cross section, the road is above room #2 and the remaining rooms are at the current limits of the open pit. Figure 11 shows the FEM geometry and materials. Also located in this zone is a unit of sandstone below some rooms and mineralized rock that seems to go through the limestone unit.

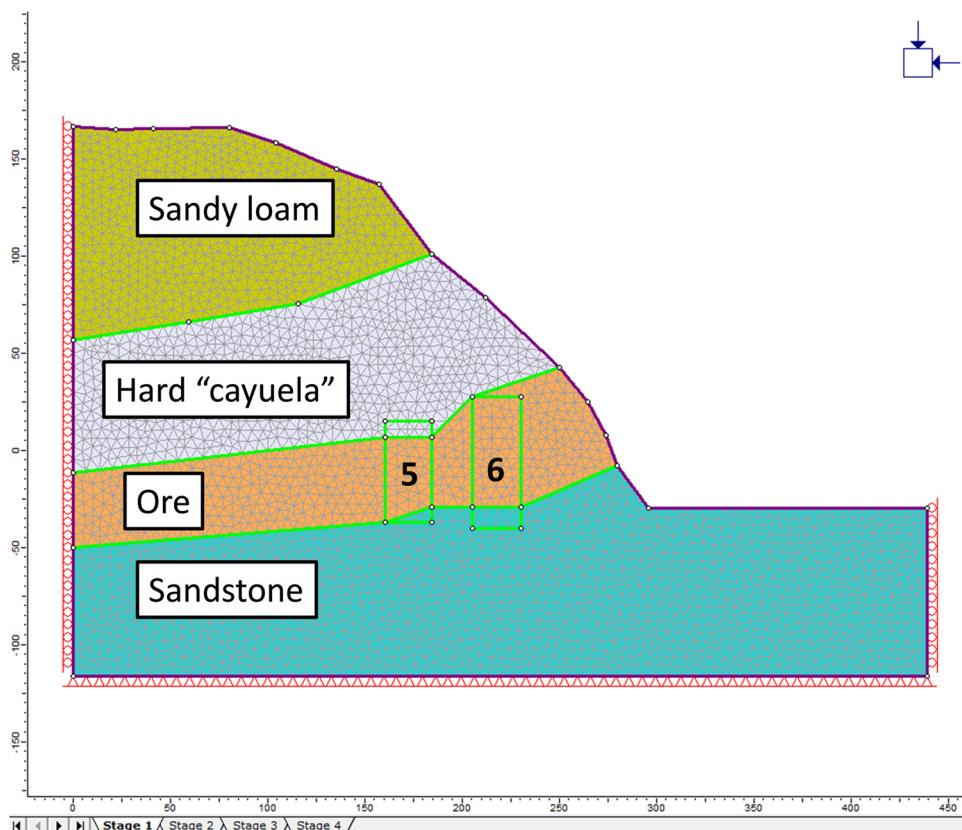
Figure 13: Geometry and materials of southern cross section II of the SE zone rooms.

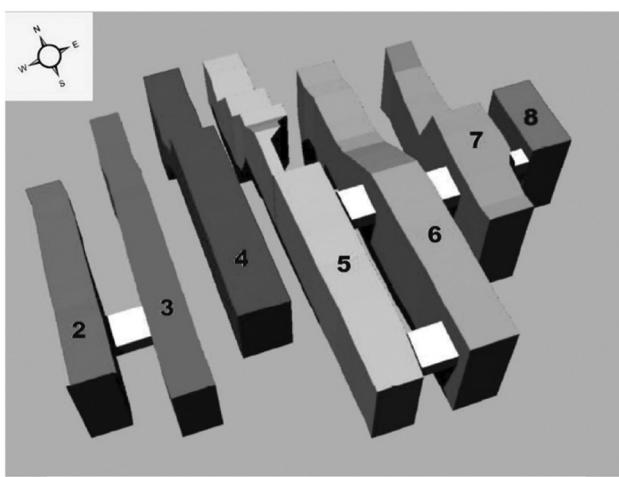
Figure 16: 3D boundary element method model of the SE zone and its rooms.
