## Research Article

# Performance assessment on a variety of double side structure during collision interaction with other ship

**Keywords:** Ship-ship collision; field survey; material testing; virtual experiment; double side skin (DSS); collision energy; damage characteristic

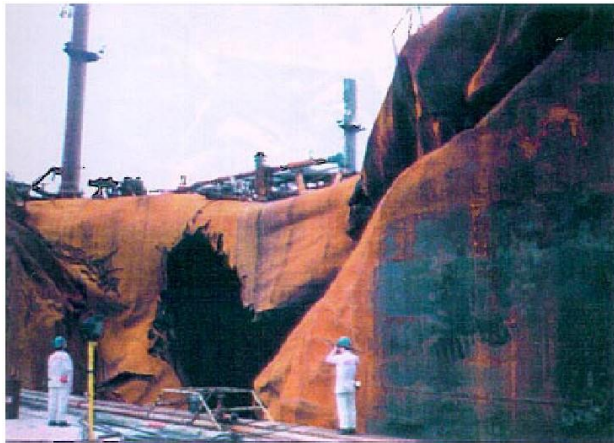
**Figure 1:** Damage in collision accident caused 10,000 tons oil was spilled [3].

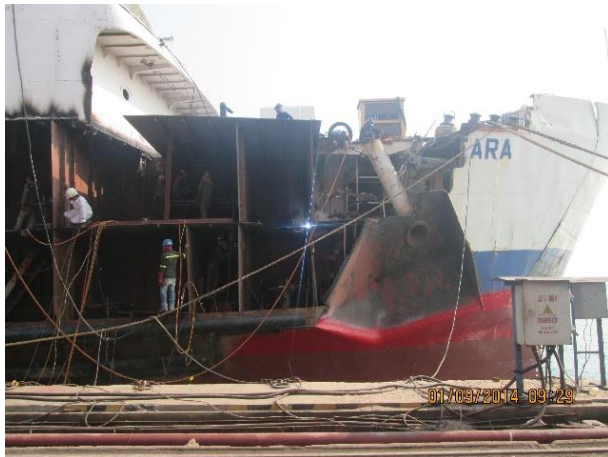
**Figure 2:** Repair process of side structure after a collision incident.

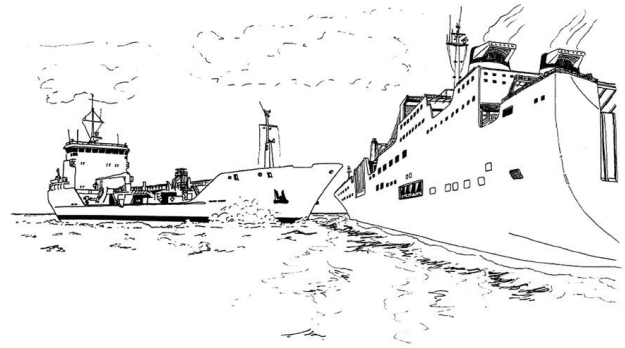
**Figure 3:** Collision between two ships [13].

In side collisions (Figure 3), Minorsky and Zhang described the analytical theory of this phenomenon. In this theory, the two objects *i.e.* involved ships are divided into two classes, the first is the striking ship and the second is the struck ship. The striking ship is introduced as the object which strikes the other object. In a ship collision process, this object penetrates into the other ship's structure. The struck ship is the other ship's structure in the previous statement which gets penetrated by the striking body. An illustration of these ships is presented in Figures 4 and 5. The angle formed by two ships during the collision process is represented by  $\beta$  or collision angle. Even though this theory is a simplified form due to the limitless possibility and scenario causing ship collision, the coordinate systems can be considered a good estimation in assessment.

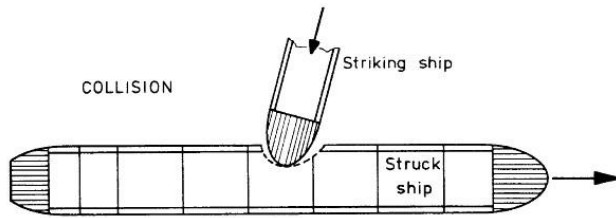
Figure 4: Side collision by upper view [14].

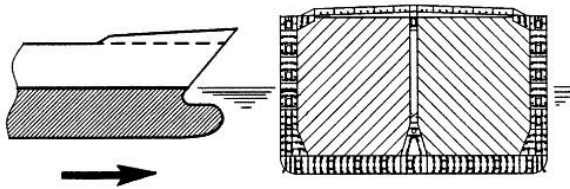
Figure 5: Side collision on perspective of front view [14].

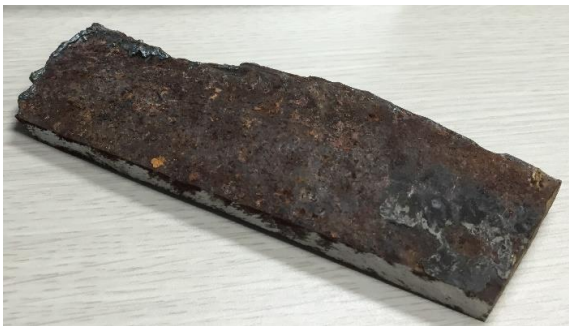
Figure 6: Destroyed material: medium-carbon steel 1030.

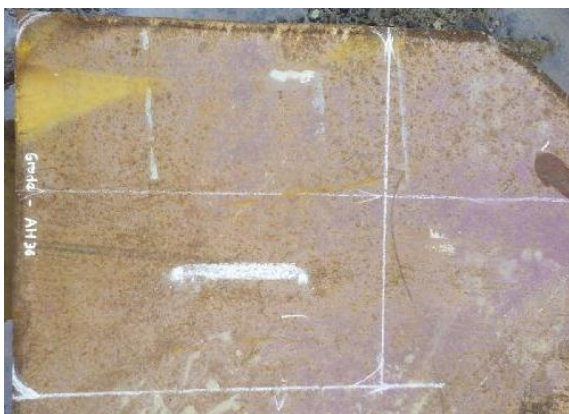
Figure 7: Repair material: steel grade AH36.

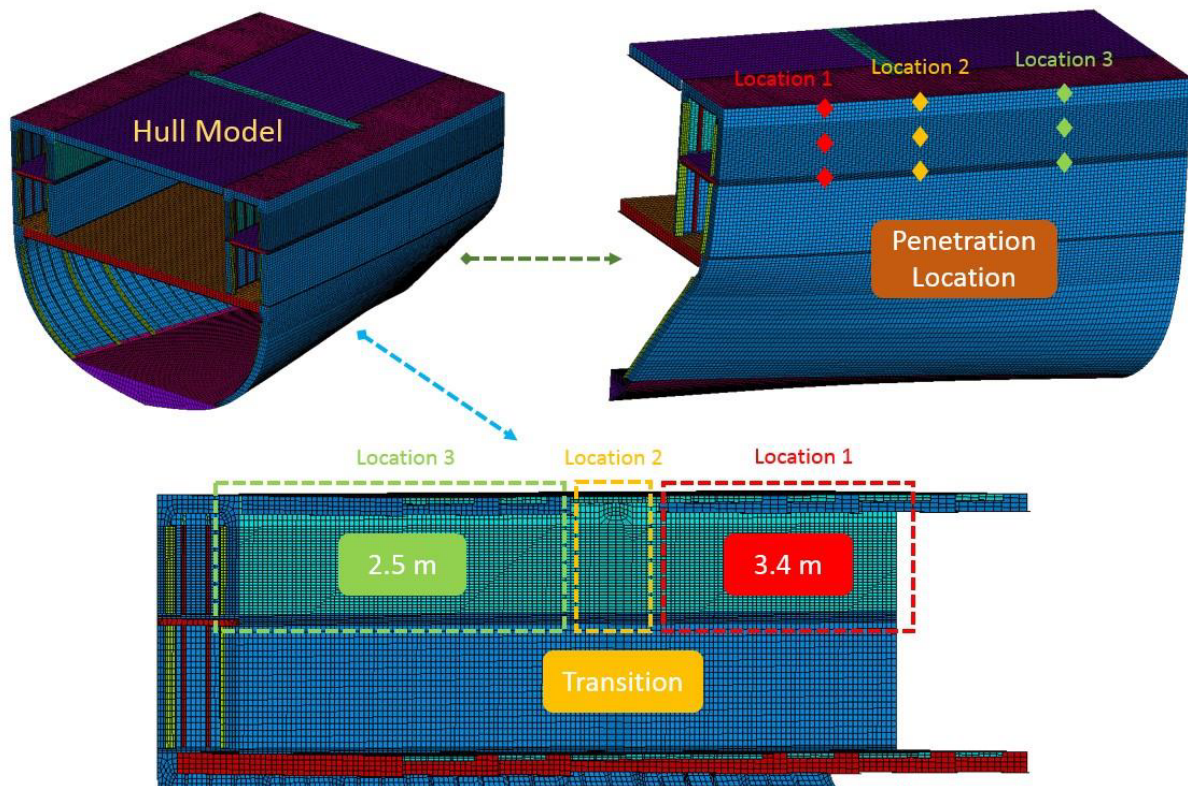
Figure 8: Penetration locations on struck ship DSS structure.

The two ship materials shown in Tables 3 and 4 were applied at the double side skin structure and were defined as plastic-kinematic material in the virtual experiment. The yield characteristic of this material is given in Equation 1. Three penetration locations were used as the location of the target point in this study as indicated in Figure 8. Location 1, represented contact on the hull region with the double skin width 3.4 m. Location 2, implied penetration point right on the transition position from double skin width 3.4 m to 2.5 m. Location 3 considered the contact point on the region with the double skin width 2.5 m.

In the virtual simulation, the striking ship moved with attached velocity 12 kts or 6.17 m/s to proposed target points while during the collision process, the displacement on the struck ship was set to be fixed at centerline with the ends of the model clamped. In the side ship model illustrated in Figure 8, the fixation was applied for the transverse frames and longitudinal girder in the end part of the structure model. At the end of side shell plating, axial displacements were restrained. The element choice for present research was Belytschko-Leviathan element. The element-length-to-thickness (ELT) ratio within the range of 5-10 was applied, especially into the deformable structure model of the struck ship so that the local stress and strain fields could be captured well. Fine mesh with size 80 mm was applied on the core area of the struck ship and fine mesh with size 90 mm and 100 mm were applied on the transition and the outside area respectively. The element-length-to-thickness (ELT) ratio for this area in range 8-10. The area of the rigid element of the striking ship model was divided into two parts: the first area would experience direct contact with the struck ship. A fine mesh with size 340 mm was applied at this area. The second was the rest area, where a fine mesh of size 680 mm was applied

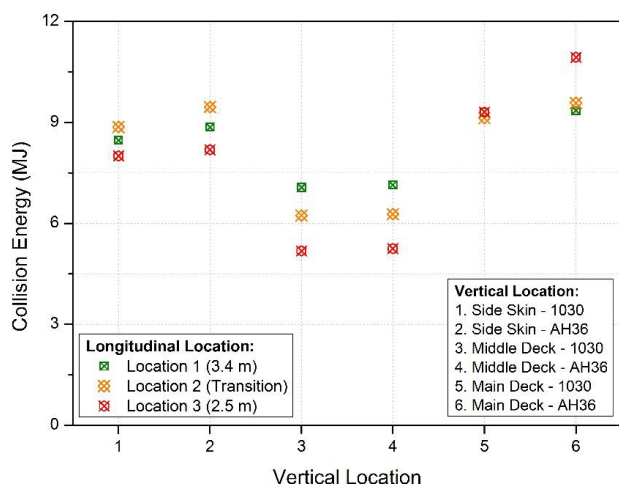
**Figure 9:** Global pattern of collision energy.

The observation in this sub-section was performed on characteristic results globally. After dynamic collision simulations were performed, the calculation of finite element code showed the internal energy of the global phenomenon system. This energy was defined as the energy needed to plastically deform or even destroy the structure during the impact process. In this work, the terms of *energy* and *collision energy* refer to the terms of the virtual calculation results of internal energy. The trend line on collision energy as presented in Figure 9 indicated that the double skin structure (DSS) with wider width between outer and inner skin absorbed bigger energy in the collision process. In terms of ship materials, steel grade AH 36 produced bigger collision energy than medium-carbon steel 1030. The response of energy subjected to material was directly proportional with the mechanical properties especially the yield strength of destroyed and repair material. The difference between these two materials was not signif-

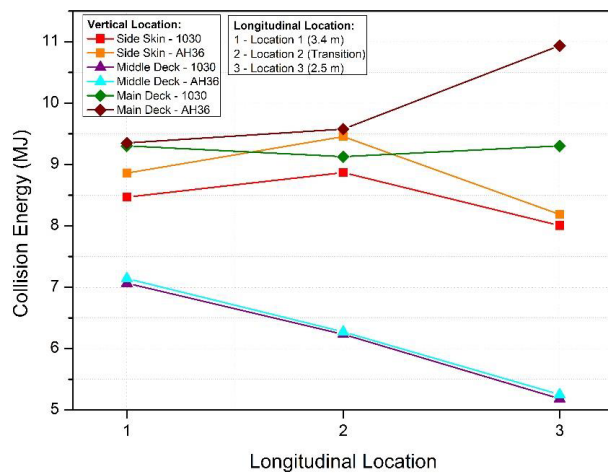
**Figure 10:** Material effect to energy magnitude after collision process.

icant with the value below 1.5% and results also indicated the yield strength of these materials could be used to estimate the energy magnitude in the impact phenomenon process namely collision and grounding. The comparative graph for material response on all locations is presented in Figure 10. Besides direct analysis of the physical response, statistical results of the proposed scenario are also presented in Table 6. Collision energy and damage on DSS structure were taken as the main observation. The calculation of mean, median, mode and deviation standard were performed to obtain the conclusion regarding the data distribution. These calculations were intended to present the overall structural behaviour after collision happened on the middle region compartment. The more specific calculations, such as per impact location and applied material are presented in the Appendix.

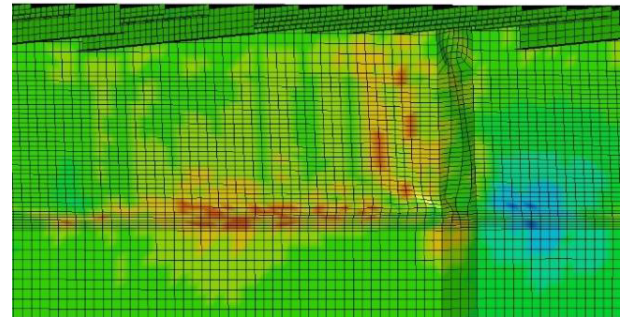
**Figure 11:** Pressure contour after collision at Location 1.

The results between collisions at shell and main deck were not significantly different if they were compared to results for the middle deck at three locations. The contour of all locations indicated that, after collision at the Locations 1 and 3, distribution of strain and pressure were not as remarkable as at the transition location. The contour illustration of three different locations is given in Figures 11-13. If bigger ships or a higher velocity collided with this ship at this specific location, the striking object was predicted

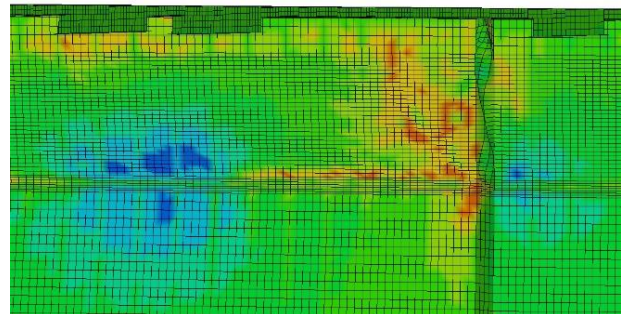
**Figure 12:** Pressure contour after collision at Location 3.

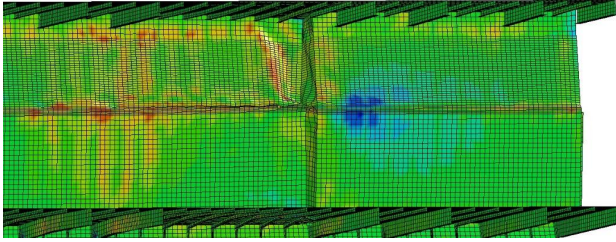
Figure 13: Pressure contour after collision at Location 2.

the shell at Location 2 or Transition produced the highest plastic strain which means the collision at this location caused skin plating to be more deformed than in other locations. The same result pattern was also obtained in terms of pressure. At the same location, produced pressure was the highest among all proposed locations.

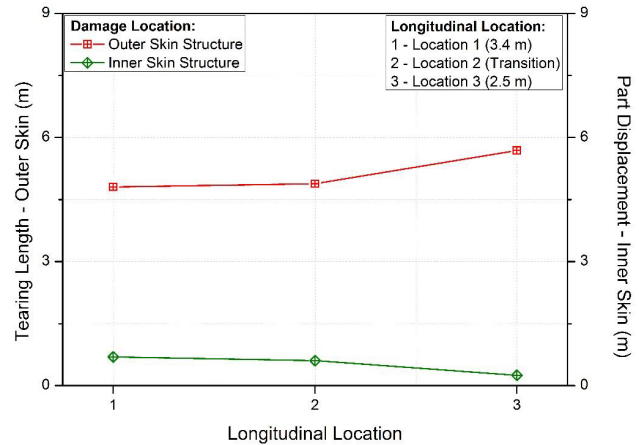
Figure 15: Comparative damage between outer and inner skin.

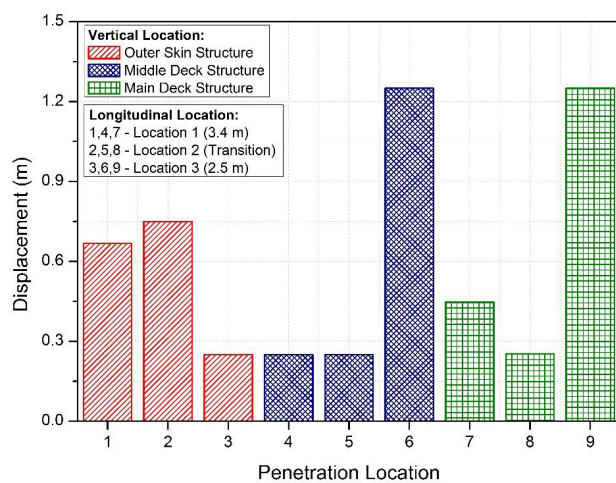
**Figure 16:** Displacement tendency of inner skin on 9 different locations.

In terms of damage, the size of DSS structure affected the damage on outer and inner skins. The location on this research, besides being divided by vertical direction, also was divided by longitudinal direction. On the longitudinal axis, the partition was performed according to width between outer and inner skin. Figure 15 represents the relation between DSS dimension and damage on its component subjected to the impact load. The graph indicated that the greater damage experienced by outer shell, less the inner skin structure would be displaced after collision process. The tendency on Figure 16 also shows that the big-

ger the width between the two skins, the less the inner skin would experience displacement in a side collision.

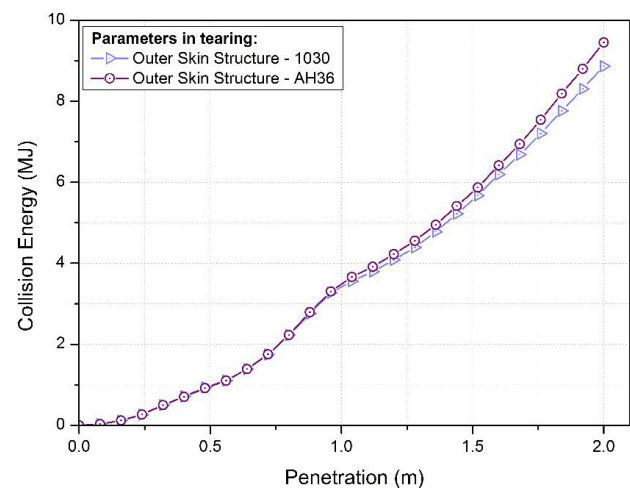
**Figure 17:** Energy pattern during hole formed in the end collision process.

The energy pattern and damage on this scenario are presented in Figures 17-19. The comparison of collision energy between destroyed material medium-carbon steel

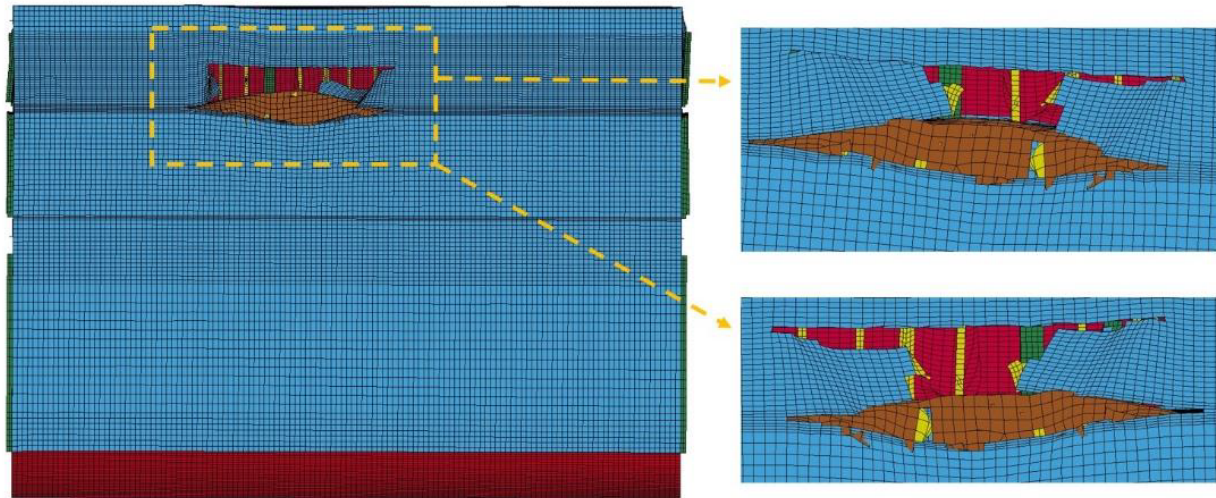
**Figure 18:** Deformation on DSS outer skin after collision on outer skin structure – 1.

After all collision simulations were conducted, two collision scenarios at transition zone (Location 2), a hole was formed in the inner skin and tearing damage was formed after the collision on the outer skin structure directly by the end of the collision process. The characteristics and condition of the inner shell still demand bigger
