# The influence of river training on the location of erosion and accumulation zones (Kłodzko County, South West Poland)

**Abstract:** The channels of the main rivers in the Kłodzko County, South West Poland, have been strongly influenced by human activities since the end of the nineteenth century. The reasons, type, and time frame of these changes are very similar to those which occurred in other European mountain regions but the magnitude is different. Kłodzko County is an area with a well-developed river network. Since the Middle Ages, human activities were noticed in the river valleys of this region. The main cause of the most anthropogenic transformations of the river channels was changes in the volume of sediment supply and, thus, the channel load and its erosive and transport capacities. The ultimate effects of human impact are manifested in the changes of channel pattern, depth and sinuosity, and the location of erosion and accumulation zones. Morphological transformations are most intensive immediately after the regulation works. The influence of channel training is noticeable; however, there is no clear correlation between the occurrence of engineering structures and the

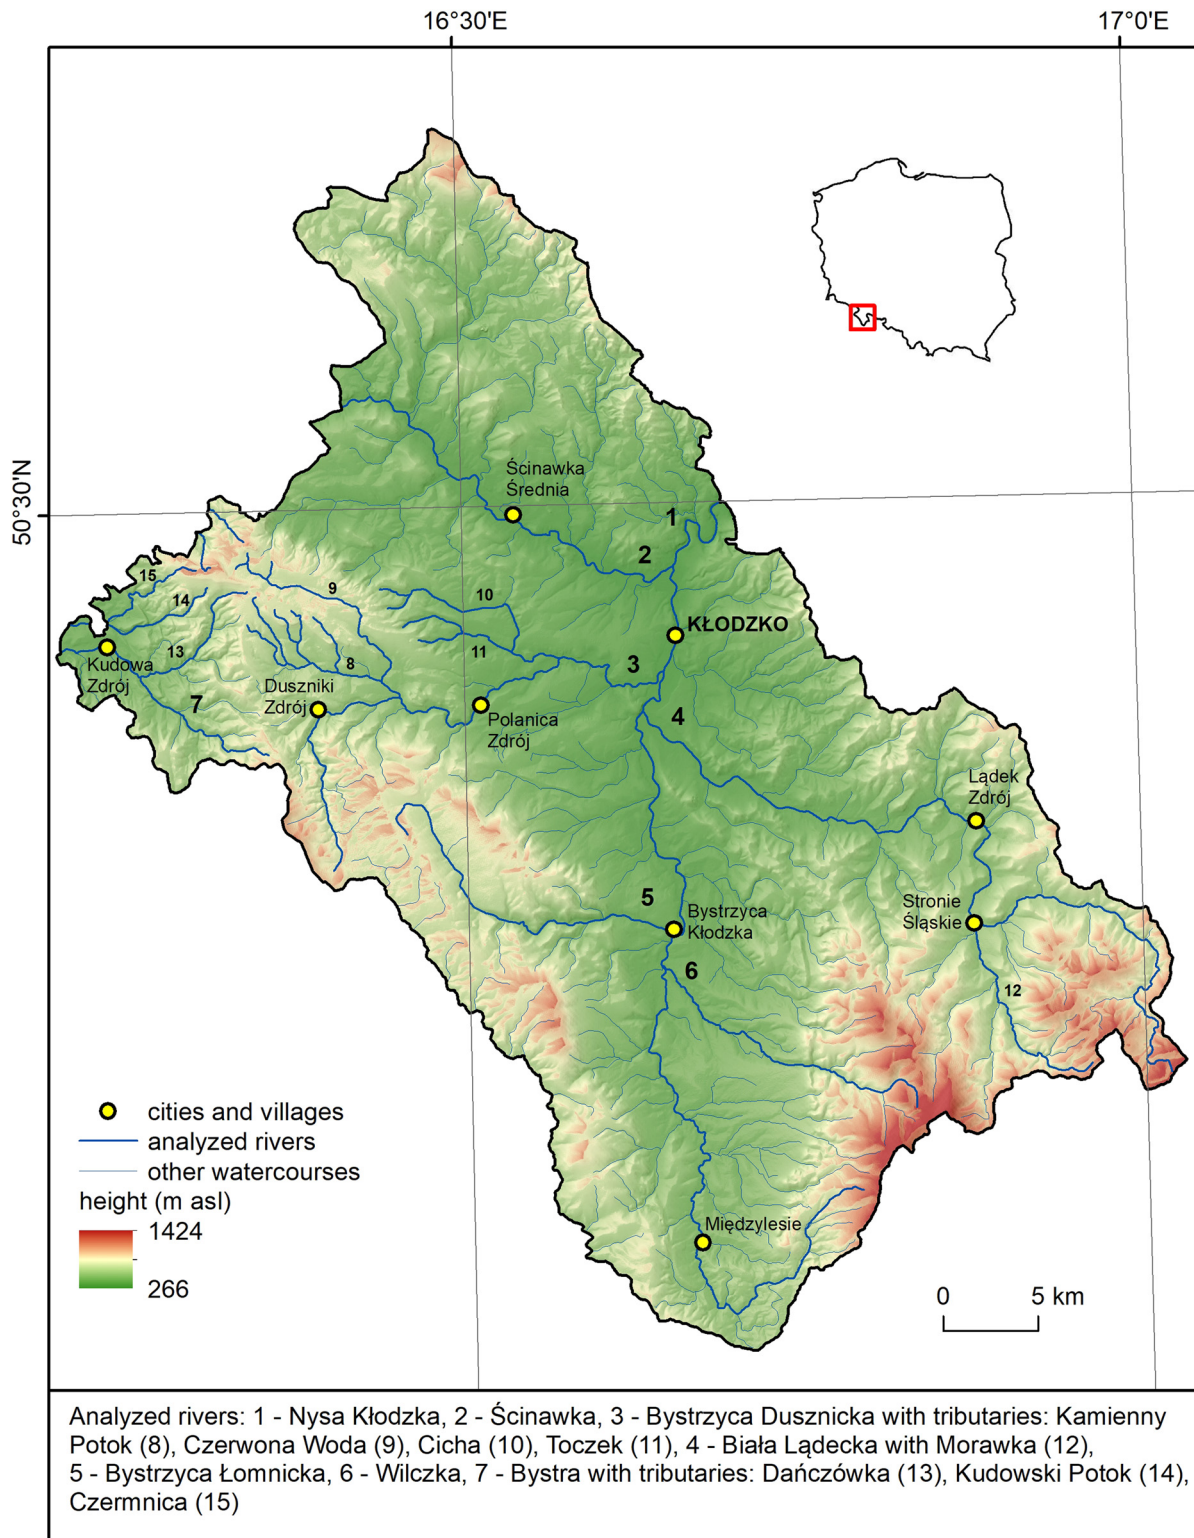
**Figure 1:** Study area: Kłodzko County with analyzed rivers.

Kłodzko County, with an area of 1,643.37 km<sup>2</sup>, is located in South West Poland, in the central part of the Sudety Mountains (Figure 1). The morphology of this area is very varied and shares the main morphological features of the entire Sudeten region (numerous isolated mountain ranges and massifs separated by valleys of various origins and foothill areas). The river network is well-developed. River valleys in many cases are directly related to lithology and refer to the course of tectonic structures and the resistance of the ground rocks. The main morphological features of all the valleys studied are similar. In the highest parts of the slopes, river channels have the form of slope streams. The valleys are poorly developed. Streams often flow through several undeveloped low-flow channels upon the slope surface. Below the headwater sections, they flow in shallow channels incised into the boulder lag deposits. Low bedrock or boulder steps are found in these channels. The height of steps is often increased by accumulation of organic materials, mostly small wood debris. The bed of most channels is formed of medium- and coarse-grained mineral sediments, which are the product of selective slope erosion mainly transported during floods. The characteristics of river channels changes in the foreland of the mountain ranges and within the mid-mountain basins.

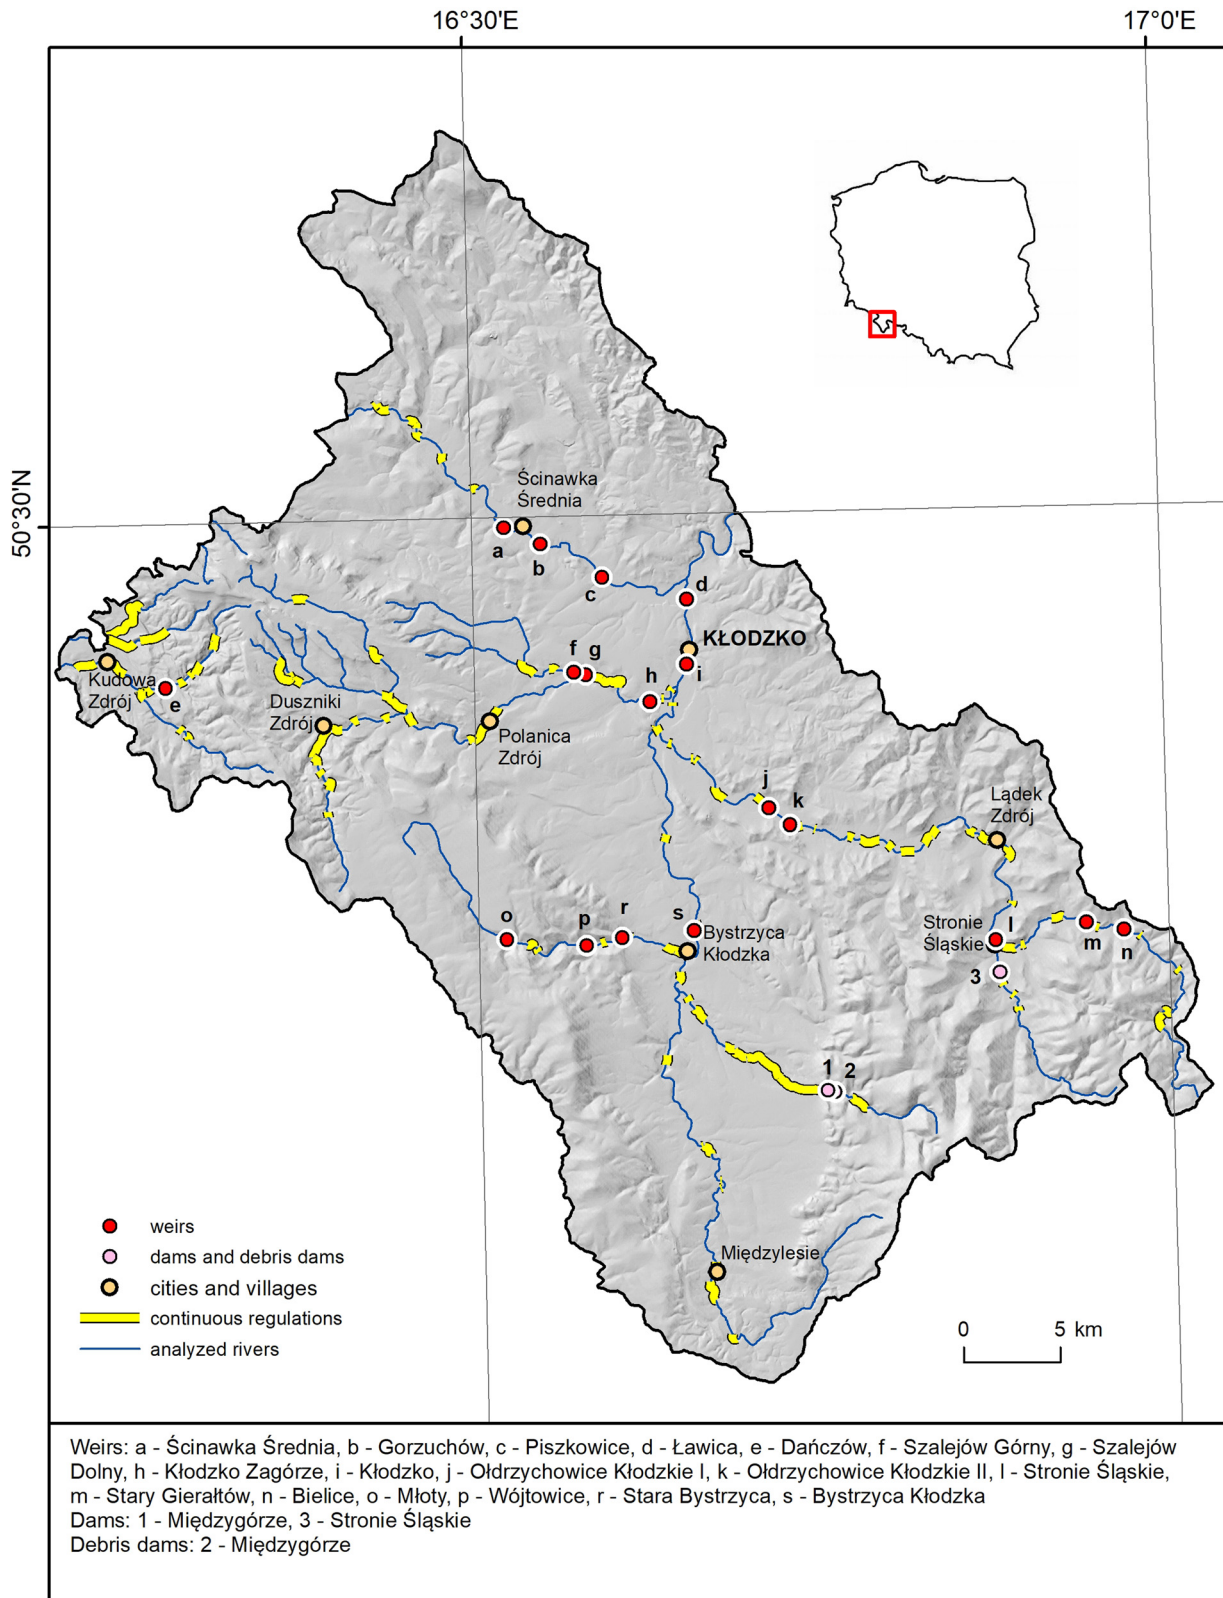
**Figure 2:** Location of the most important hydrotechnical objects and channel sections with continuous regulations (beginning from 2018).

length (Figure 2 and Table 2). Changes in the settlement development in river valleys have been observed in this region since the Middle Ages [26]. It was then that the first hydrotechnical constructions appeared in the channels. These objects were initially related to basic human needs such as water supply (small dams and water reservoirs) and communication (fords and bridges) and later to rapidly developing economic activity. From the eighteenth century, water mill construction was intensive in the Kłodzko County, and later came other types of industries using flowing water. Training works have been undertaken on a larger scale since the beginning of the nineteenth century. Channels were changed most intensively at the turn of the nineteenth and twentieth centuries. Various types of transversal and longitudinal training structures were built, e.g., weirs (about 1.5–2.5 m high), drop structures (up to 1.0 m high), hydroelectric power plants, leats (millraces), artificial channels, and different types of bank reinforcements (Figure 2). The next stage of systematic training works began in the early 1960s. These were projects mainly concerning bank protection (retaining walls) and new road bridges. The course of many channel sections was changed at that time. They were straightened, shortened, and narrowed. Transversal structures reduced the channel gradient and bed load transport. The verification of the functionality of the most hydrotechnical and bridge constructions in the channels came with the extreme floods in 1997 and 1998. Many facilities were destroyed or seriously damaged and had to be rebuilt. There was a short but intense period of training works after these events. Some objects were rebuilt using new technologies. Many training works have been started since 2007 as part of projects financed by the European Union and in fulfillment of *The program for the Odra 2006*. Some works are still in progress.

Nowadays, the rivers in the Kłodzko County area are regulated mainly for flood protection purposes. Training works comprise channel straightening and deepening and construction of hydrotechnical facilities and bank reinforcement (retaining walls, ripraps, and gabions). The number of hydrotechnical objects and the length of longitudinal structures vary among channels and even along sections of specific rivers (Table 2). An increase in the number of river and civil engineering structures is closely related to the settlement network and the main roads in the region. Facilities associated with old industrial activities are usually concentrated in the middle and lower sections of the channels. In the upper parts of the channels, regulated sections are mostly located in the vicinity of settlements (present as well as those already depopulated).

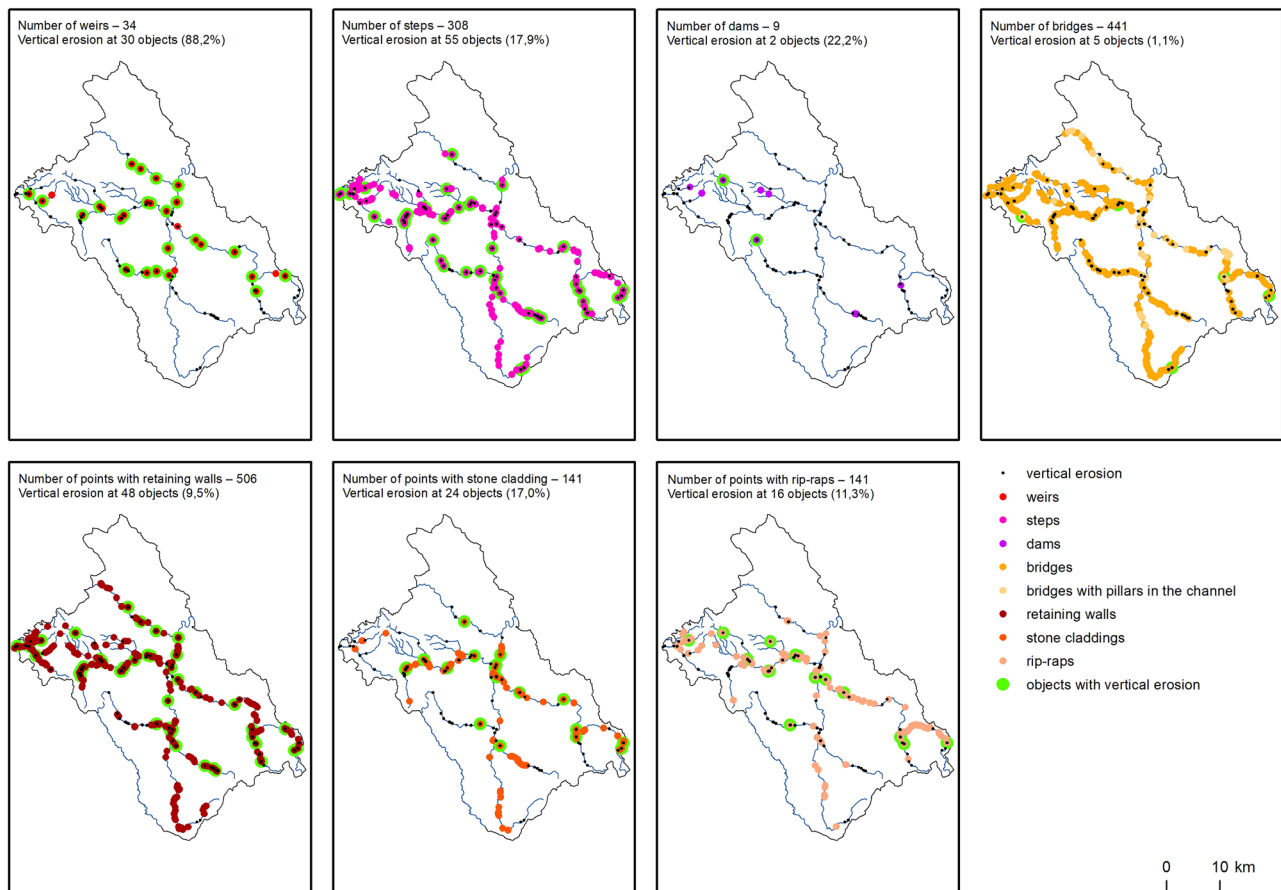
**Figure 3:** Location of the objects affected by vertical erosion.

A relationship was also observed between the size of the erosional bed forms and the length of time since the construction of regulation structures. Channel incision is definitely more intense in the downstream of older structures. In the downstream of the sections with new regulations, no erosional bed forms were generally observed. The only exception is the Wilczka channel in Wilkanów, where only 2 years after the completion of training works, initial erosional bed forms were visible. In some cases, erosional bed forms were also found directly downstream the small drop structures, e.g., in the Wilczka channel in Wilkanów. These forms were observed below 18% of all the steps in the investigated

channels (Figure 3 and Table 3). In four study sites (in the Dańczówka, Wilczka, and two sites in the Biała Łądecka channels) below the drop structures, the river incised to bedrock and the bedrock steps were observed. In the Kłodzko County river channels, downcutting is ineffective during normal flows. This process intensifies during flood events.

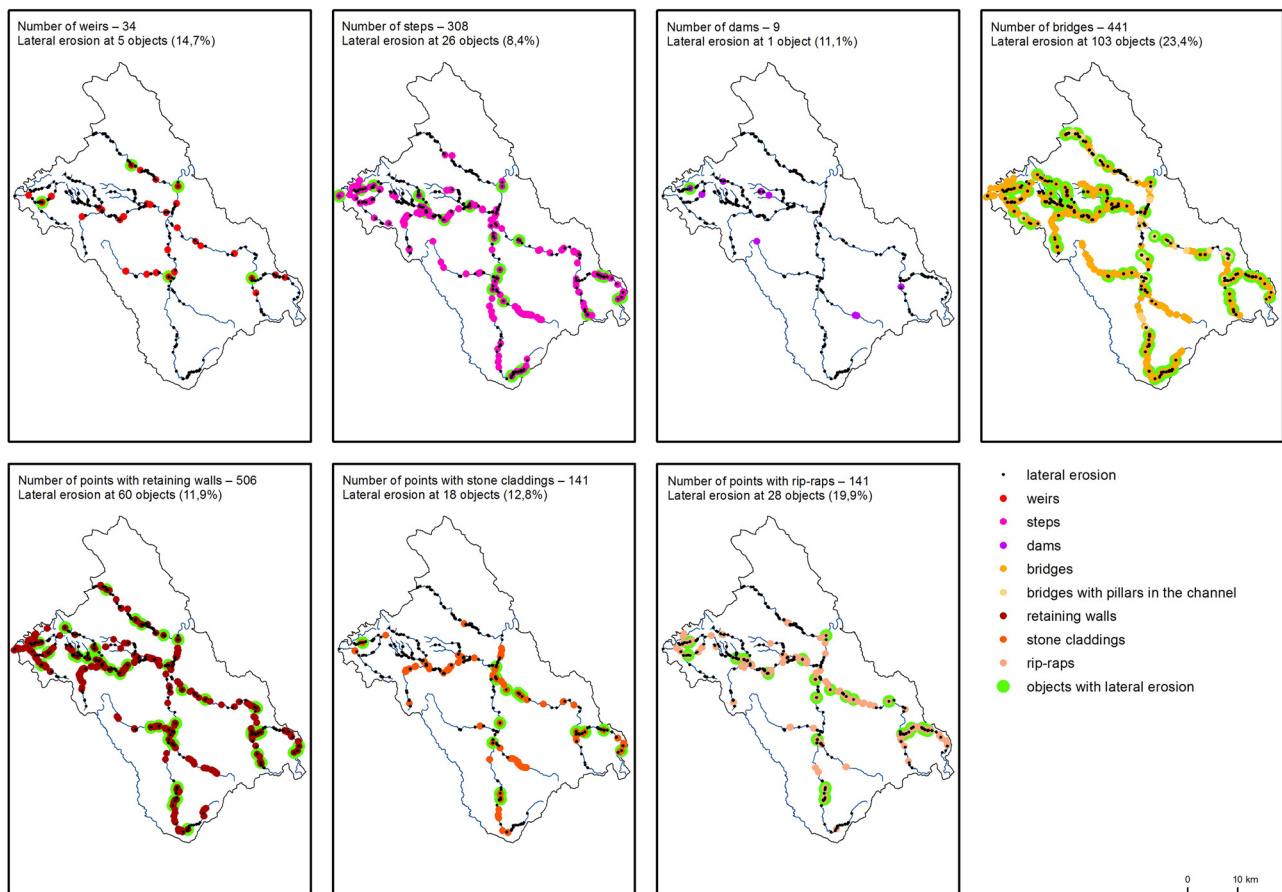
**Figure 4:** Location of the objects affected by lateral erosion.

mainly in the vicinity of the objects located in upper river sections of the channels, undermining of bank reinforcements was observed. This mainly concerned old, partially destroyed training structures. Zones of intense lateral erosion were observed at 15% of the damming objects analyzed (Figure 4 and Table 3). In the most spectacular cases, the channels widened by 50% of their width. Lateral erosion forms are formed directly below the cross section of the objects with retaining walls. In the vicinity of other hydrotechnical structures, small changes in the course of banks occur; however, the erosional forms do not reach considerable dimensions.

Lateral erosion also gets activated at the anthropogenic objects connected to road infrastructure. Undercuts are observed at almost 23% of all structures (at 37% of bridges with at least one pillar located directly in the riverbed [Figure 4 and Table 3]). Erosional forms occurred at almost all bridges regardless of their location in the channel. In some channels (e.g., Nysa Kłodzka, Biała Łądecka), more forms of lateral erosion are found in the upper river sections. However, these forms are definitely smaller than the undercuts forming in the middle and lower sections. In the studied channels, the undercuts adjacent to channel bars are the most common erosional forms occurring close to the road structures. However, there are also rivers in whose channels these undercuts hardly form at bridge constructions (e.g., in the Wilczka

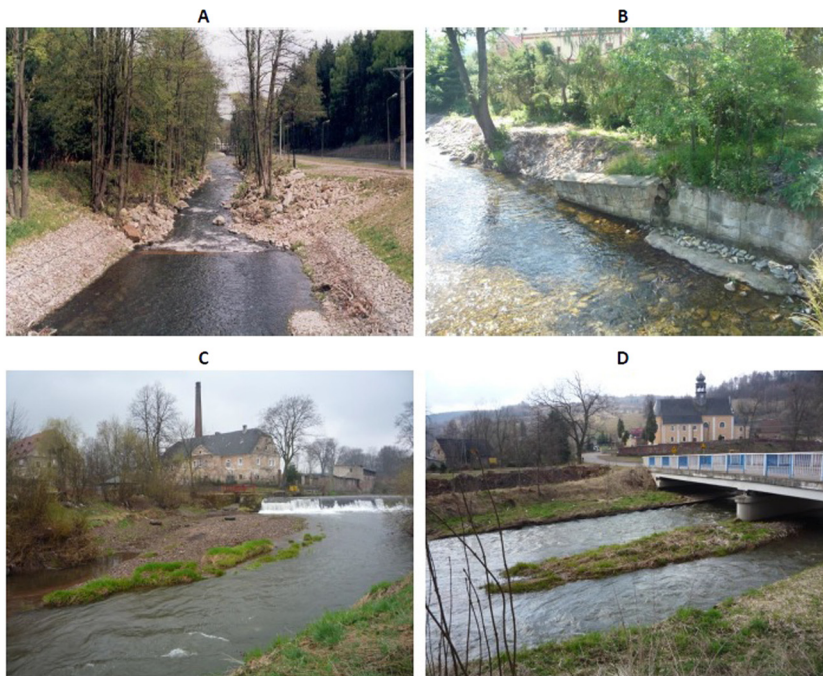
**Figure 5:** (A) Intensification of lateral erosion in peripheral sections of bank reinforcement in Polanica-Zdrój, Bystrzyca Dusznicka River; (B) destroyed retaining wall in Stronie Śląskie, Biała Łądecka River; (C) accumulation zone below the weir in Piszkwice, Ścinawka River; and (D) sediment shadow below the bridge in Tłumaczów, Ścinawka River.

A characteristic phenomenon observed in peripheral sections of bank reinforcement in all analyzed channels is the intensification of lateral erosion in the areas of contact between protected and natural banks (Figure 5A and B). The occurrence of zones of increased lateral erosion was observed for nearly 90% of such areas [23,25]. In these places, new cutbanks were formed. These forms vary in scale, ranging from several centimeters to 1.5 m. In most cases, only the intensification of erosion takes place; cutbanks are larger than those in other fragments of regulated channel sections (Figure 5A). However, there are places where lateral erosion below the regulated sections is so strong that the retaining walls break and sometimes collapse (Figure 5B). Some undercuts are stable; during the period of observation, no signs of bank retreat were noticed. Most erosional forms, however, are constantly active, with progressing bank retreat. In the undercuts, landslides occur and turf overhangs and the exposed roots of trees growing on the banks are visible. Although

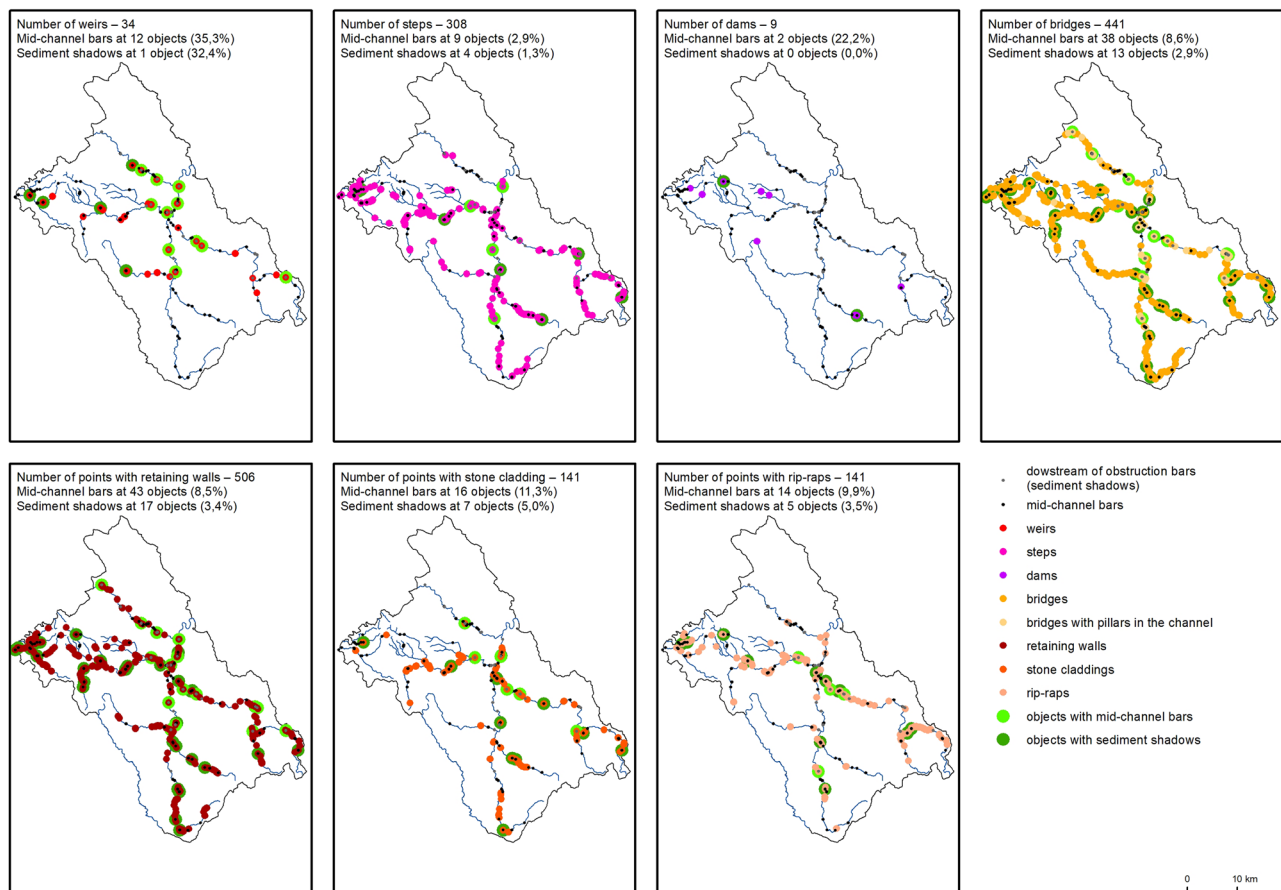
**Figure 6:** Location of the objects affected by sediment accumulation (mid-channel bars, sediment shadows).

Changes in the distribution of accumulation zones in river channels of the Kłodzko County are mainly related to the location of damming objects and road infrastructure facilities (Figures 6 and 7). Accumulation forms are generally scarce because of limited sediment supply from the slopes to the regulated sections of channels. It should be noted that the analyzed rivers do not transport large amounts of sediment, and the material accumulated in the channels originates mainly from bank erosion. In fact, lateral erosion in regulated channel sections has been completely stopped; hence, no accumulation forms are observed in these sections.

zone downstream of these objects (Figure 6 and Table 3). These forms are usually composed of fine materials transferred through the structure and deposited just below it. These bars are usually triangular in shape and elongated in the direction of flow. Some of them have the form of classic elongated channel bars (Figure 5C). As mentioned above, incomplete historical data preclude the estimation of the enlargement rate of these forms. The exceptions are bars formed at the largest weirs, for which it is possible to reconstruct their dimensions from the past, e.g., the accumulation form below the weir in Kłodzko (Nysa Kłodzka River). In general, accumulation zones below the damming objects are not longer than about 50–100 m. In the vicinity of just a few objects (Kłodzko, Bystrzyca Kłodzka, Oldrzychowice Kłodzkie I – the largest forms approximately 250 m long), these zones are longer, but they do not have a homogeneous compact form. They are rather sets of individual forms of different dimensions. The bars below the damming objects are at various stages of stabilization. In most cases, they are partially covered with grassy vegetation, but there are also forms on which bushes and small trees are already growing (Kłodzko). Accumulation zones below larger damming structures occur near all objects in the Ścinawka channel, nearly 64% of facilities in the Bystrzyca Dusznicka channel and Kamienny Potok, 50% of the structures in the Nysa Kłodzka channel, and around 44% of damming objects in the Biała Łądecka channel (Figures 6, 7 and Table 3). The accumulation zones below the structures are not formed at all objects with a height of up to 1 m, or the bars do not have a compact clear form that can be measured. The results of our observations also reveal the following relationship – these accumulation zones are formed primarily below the damming objects located in the middle and lower sections of the channels, where sediment accumulation is usually more efficient than in the upper sections.

A significant role in the formation of accumulation zones is played by objects related to road infrastructure, in particular bridges, especially those that have structural elements located directly in the channel. The bars adjacent to river banks were most often formed in bridge cross sections (at 34% of all objects), as did mid-channel bars located downstream of pillars situated in the channels (at 30% of all objects) and wood jams (at 25% of all objects [Figure 6 and Table 3]).

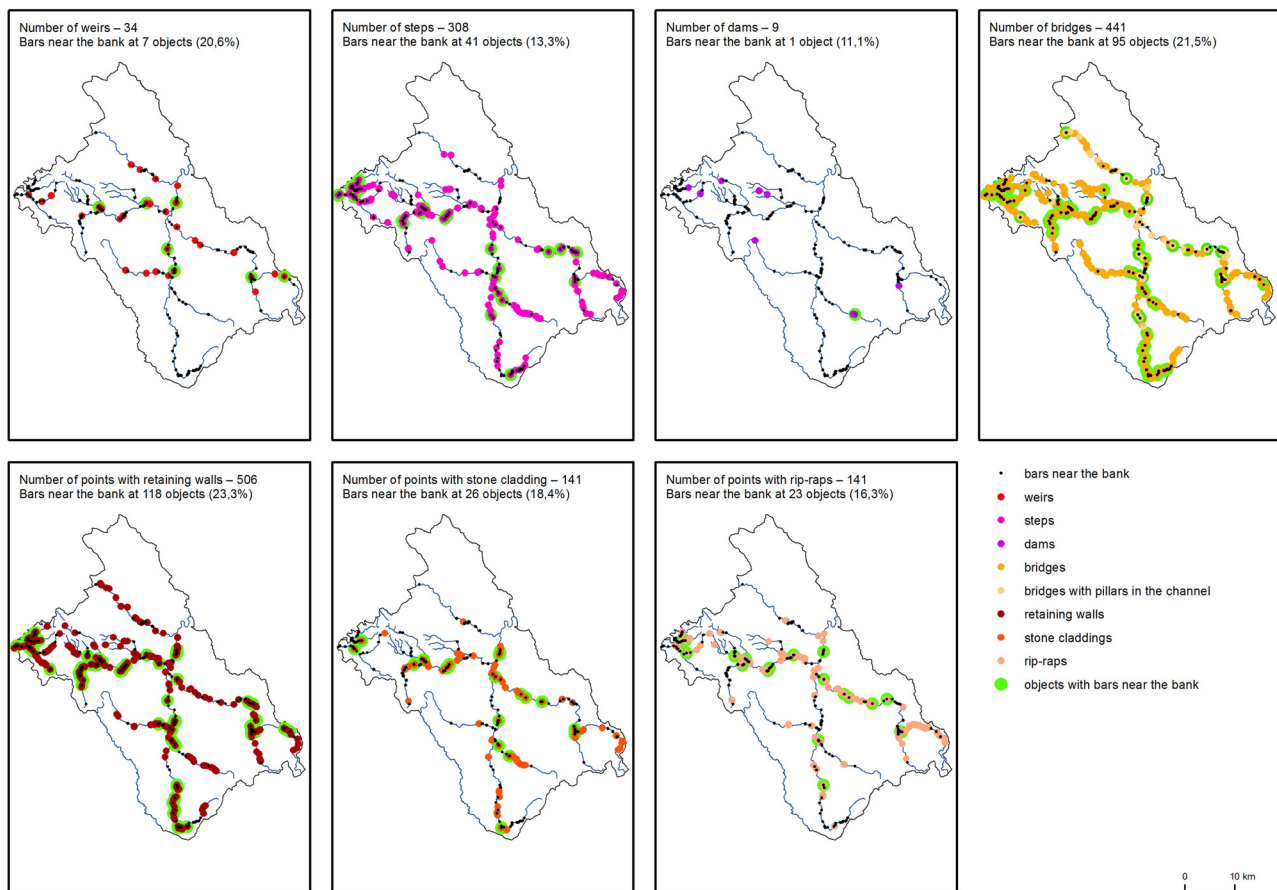
**Figure 7:** Location of the objects affected by sediment accumulation (bars near the bank).
