# Belgian class II nuclear facilities such as irradiators and accelerators: Regulatory Body attention points and operating experience feedback

*The aim of this paper is to present the Regulatory Body attention points and the operating experience feedback from Belgian “class IIA” facilities such as industrial and research irradiators, bulk radionuclides producers and conditioners. Reinforcement of the nuclear safety and radiation protection has been promoted by the Federal Agency for Nuclear Control (FANC) since 2009. This paper is clearly a continuation of the former paper [1] presenting the evolution in the regulatory framework relative to the creation of Bel V, the subsidiary of the FANC, and to the new “class IIA” covering heavy installations such as those mentioned above. Some lessons learnt are extracted from the operating experience feedback based on the events declared to the authorities. Even though a real willingness to meet the new safety requirements is observed among the “class IIA” licensees, promoting the safety culture, the nuclear safety and radiation protection remains an endless challenge for the Regulatory Body.*

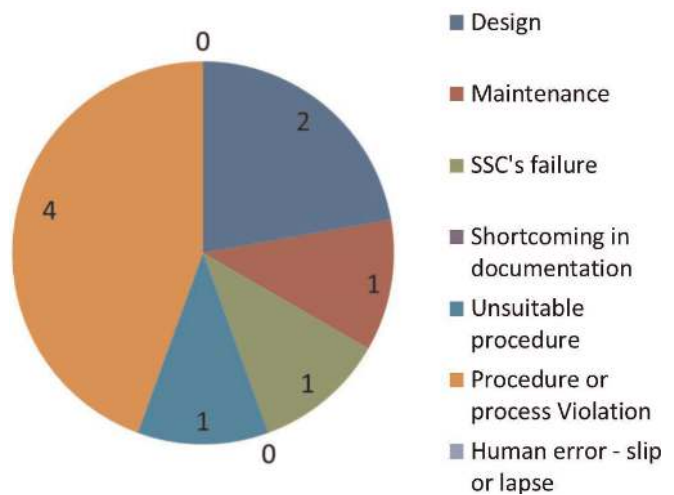
Fig. 1. Distribution of the identified events causes for the four incidents "Safety layer by-pass" that occurred at the Belgian industrial and research irradiators facilities (2009–2015)

Figure 1 shows the distribution of the detected causes for these events. It is obvious that a procedure violation was noticed in four cases. It brings up many questions to observe that there has been a voluntary action of one operator or one responsible to by-pass a safety system. Clearly, it must be noted that the routine activities can lead to less operator's focus or to operator's exasperation. The facility manager has to be aware of these phenomena. Another mechanism leading to the violation of procedures might be the stress to gain time or to guarantee the production. Also in this case, the message delivered by the manager and by the Health Physics Department is of first importance to avoid risky behaviours.

Nevertheless, it would be too simplistic to only point out at the operator's behaviour. It is obvious that these events have multiple causes. Indeed, we observe that the facility design, the licensee's organisation, the lack of maintenance on systems or a failure are also detected as causes of event. For both irradiation facilities, we notice that the sources driving mecha-

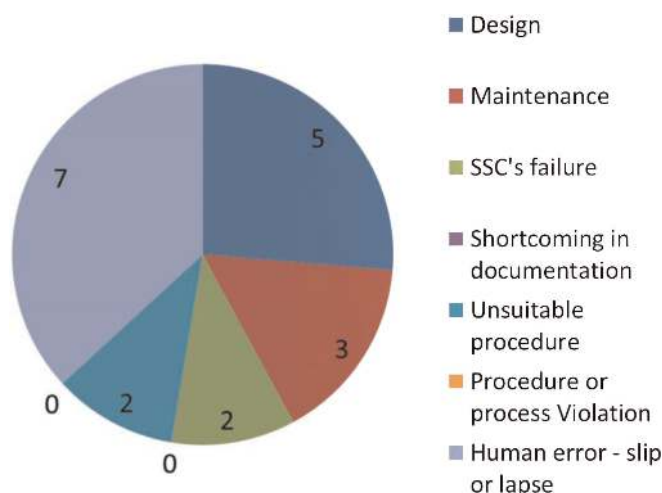
Fig. 2. Distribution of the identified causes for the ten events generating unintentional radioactive gaseous effluents declared by the Belgian radionuclides producers and conditioners facilities (2009–2015)

- Preventive replacement of the bag was decided.
- The five other events did not lead to releases exceeding the daily release limit. The causes of these releases are similar to the ones already mentioned. An analysis to detect the main causes of these ten events was performed. See Fig. 2.

- It is clearly observed that human error (mainly by lapse) and inadequate design constitute the most frequent

causes of event. The lack of maintenance of some components is also frequently observed.

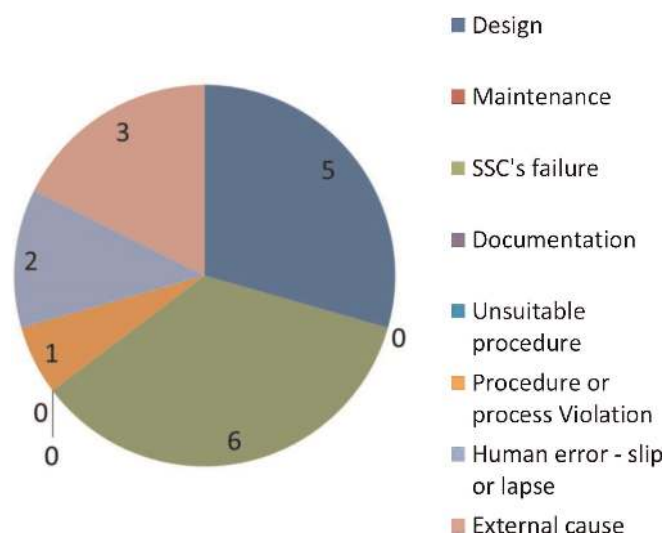
Fig. 3. Distribution of the identified causes for the ten events declared by the Belgian cyclotron facilities producing  $\beta^+$  emitters (2009–2015)

The identified causes of these ten events concerning cyclotrons are presented on Fig. 3. Inadequate design and structures, systems and components failures represent together two third of the causes of events. The procedure violation which consists in the placement of a by-pass on the vault door and the “slip or lapse” human errors are proportionally less abundant than those for the industrial and research irradiators (see § 3.1 of the present paper). The three external flooding of the radio-pharmaceutical laboratories and the cyclotron due to abundant rainfall and infiltration from an adjacent building construction phase are particularly site specific events.
