# Earth-based construction material field tests characterization in the *Alto Douro Wine Region*

**Abstract:** The *Alto Douro Wine Region*, located in the north-east of Portugal, a UNESCO World Heritage Site, presents an abundant vernacular building heritage. This building technology is based on a timber framed structure filled with a composite earth-based material. A lack of scientific studies related to this technology is evident, furthermore, principally in rural areas, this traditional building stock is highly deteriorated and damaged because of the rareness of conservation and strengthening works, which is partly related to the non-engineered character of this technology and to the knowledge loosed on that technique. Those aspects motivated the writing of this paper, whose main purpose is the physical and chemical characterization of the earth-based material applied in the *tabique* buildings of that region through field tests. Consequently, experimental work was conducted and the results obtained allowed, among others, the proposal of a series of adequate field tests. At our knowledge, this is the first time field tests are undertaken for *tabique* technology. This informat

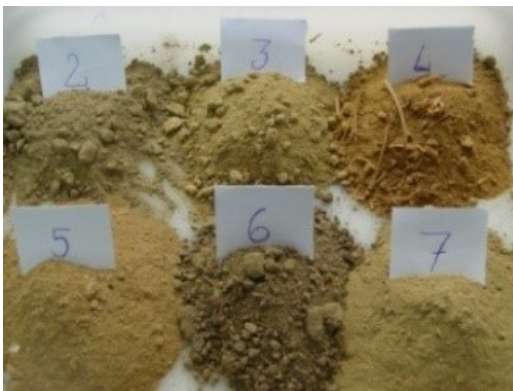
Figure 2: *Tabique* building studied.

In the scope of this study, fieldwork based on technical visits and collection of information and samples performed by Cardoso [3] in the municipality of *Lamego* in the *Alto Douro* allowed the collection of several EBM samples. EBM samples were collected from six *tabique* buildings located in *Lamego* municipality, [3, 12], a portion of each of these samples is illustrated in Figure 2.

These *tabique* buildings are rural *tabique* dwellings of two floors with exterior and partition *tabique* walls. In each building, one EBM sample with an average weight of one kilogram was collected and the adopted sample designation correspond to C2, C3, C4, C5, C6 and C7, (Figure 2). The sampling locations can be found in [3, 12].

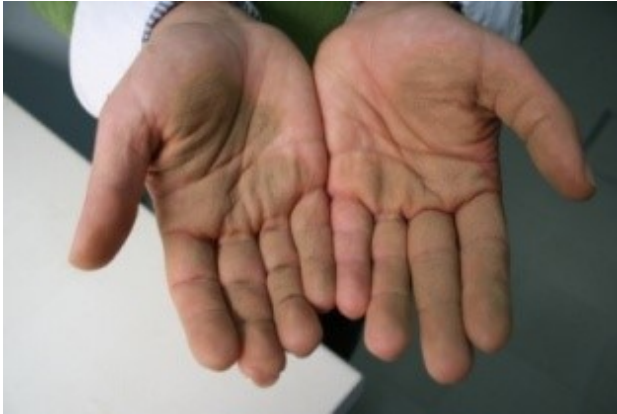
**Figure 5:** Washing hands test.

In the nibble test, a very small quantity of the EBM samples is crushed lightly between the teeth, a sandy soil grinds between the teeth and produces a disagreeable sensation, if it can be ground between the teeth, without a disagreeable sensation the soil is silty. Clayey soils, on the other hands, gives a sticky, smooth or floury sensation [17]. In the washing hands test, a humid EBM sample is rubbed between the hands, if the grains can be distinctly felt, it indicates sandy or gravelly soil, if the sample is sticky, but the hands can be rinsed clean fairly easily the EBM is silty, if the EBM has a soapy feel and the hands cannot be rinsed easily the EBM is clayey, [17]. Figure 5 illustrates the hands aspect after this operation.

As indicated in Table 4, the nibble test and washing hands test classified the EBM samples as silty, except for sample C4 who was classified as clayey.

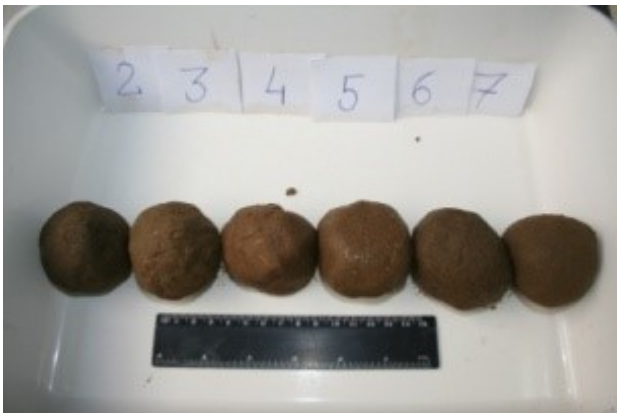
**Figure 6:** EBM balls.

consistency test, a moist portion of each EBM sample is formed into a 3 cm ball diameter so that it sticks together but does not stick to the fingers, Figure 6 illustrates these ball samples.

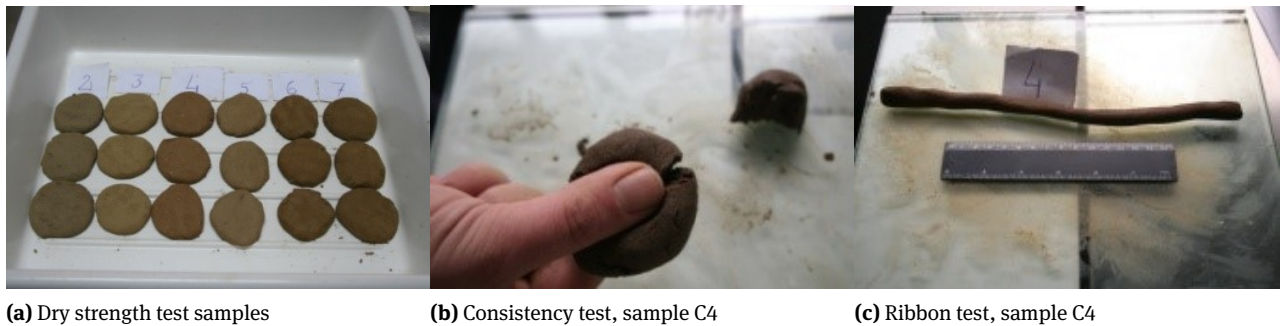
**Figure 8:** Dry strength, consistency and ribbon test.

The plasticity evaluation of samples C2, C3, C4, C5, C6, C7 was concluded with the dry strength test, consistency test and ribbon test. For the dry strength test, we form three pats of EBM for all six samples. The pats were put in an oven until they were completely dried, (Figure ??-a)). Then we observe how easy the pats are to pulverize between the thumb and index finger. If the pat pulverizes easily, the EBM is silty or fine sand and has a low clay content, if the pat can be crushed to a powder with little effort, the EBM is silty or sandy clay, finally if the pat is hard to break and will not pulverize, the EBM has a high clay content, [17].

In the consistency test, (Figure ??-b)), the EBM samples are formed into a ball. If it crumbles before forming a ball, then the EBM as a high silt or sand content. If the ball can be crushed between the thumb and forefinger only with a lot of force, the clay content is high. If the ball cracks and crumbles, then the EBM as a low clay content, [16]. In

For the ribbon test, (Figure ??-c)), each EBM sample is carefully rolled in the form of a sausage with the maximum length that the EBM sample will support. A long ribbon is indicative of the high clay content, a short ribbon on the other hand indicates a low clay content.

The adhesion test classified the EBM samples as sandy. Nevertheless in this test it is very difficult to measure the variation of the force applied to the spatula, since it is a manual operation. This generates questions about the precision of the results. The dry strength test classified almost all the samples as silty-clay. We observed that when the pats broke they divided into three parts, except sample C4 which broke into four parts.

The results of the consistency test and ribbon test are presented in Table 7. We observed that the ribbon length varies between 16 cm and 26 cm, which in means they correspond to medium plasticity.

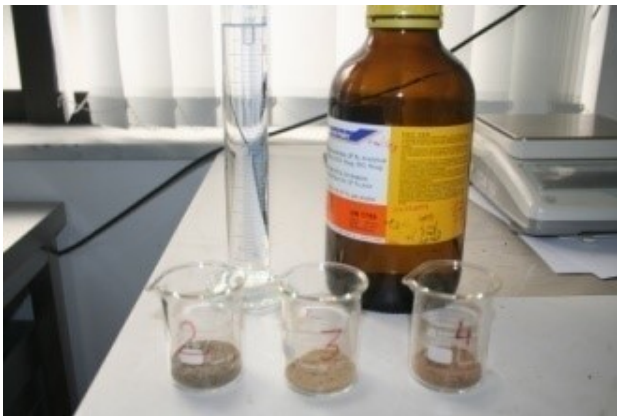
**Figure 9:** Acid test samples.

It is common practice in the *Alto Douro* region to use EBM enriched with hydraulic lime in the *tabique* walls since lime is does not exist in that region. Which means lime can be present in the EBM applied in *tabique* constructions or rehabilitation. In order to define the lime content, one drop of a 20% solution of chloridric acid, presented in Figure 9, is added the samples using a glass or a timber rod.

The efflorescence indicates the presence of lime, if there is no efflorescence, the lime content is less than 1%. If there is a weak, brief efflorescence, the lime content is between 1% and 2%; if the efflorescence is significant though

brief, the lime content is between 3% and 4%; and if the efflorescence is strong and long lasting, the lime content is more than 5%. The acid test results presented in Table 8 reveals that the samples do not react with the chloridric acid thus they do not have lime in their composition or if they have it is in a very small quantity. The results are the same as those obtained with EDS analysis results reported in [3, 12].
