Supplementary material

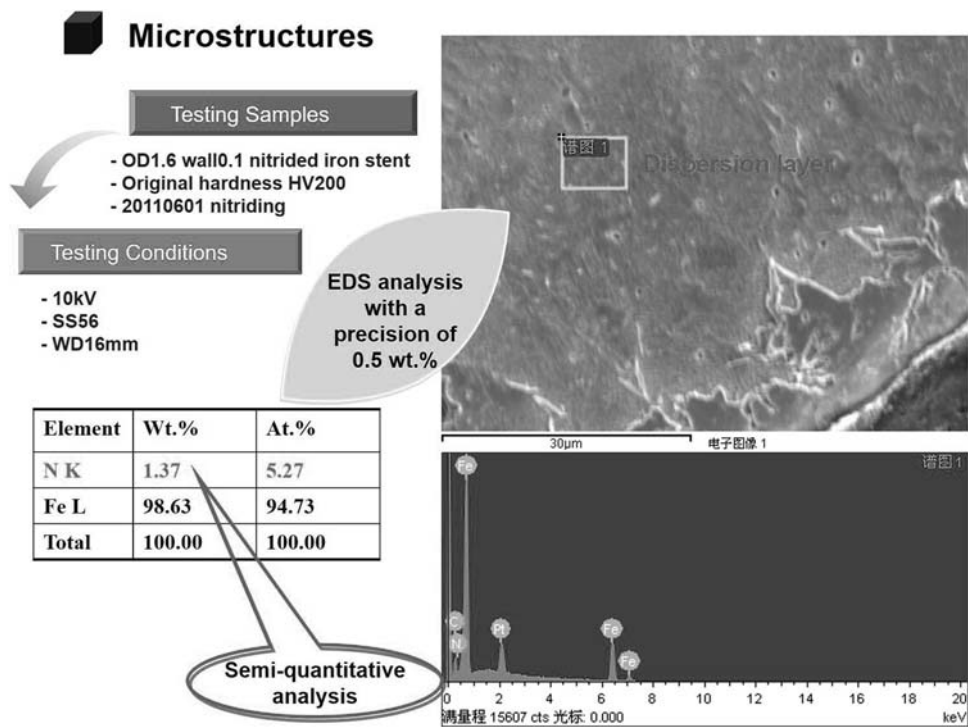
Figure S1: The SEM observation of the nitride iron surface and the corresponding EDS analysis.
